# SERVICE BULLETIN

SB No. 83 Issue No. 2

**TITLE** INSPECTION FOR FOUL BETWEEN NO.2 RUDDER PEDAL PAD PIVOT AND NOSEWHEEL STEERING ROD ARM

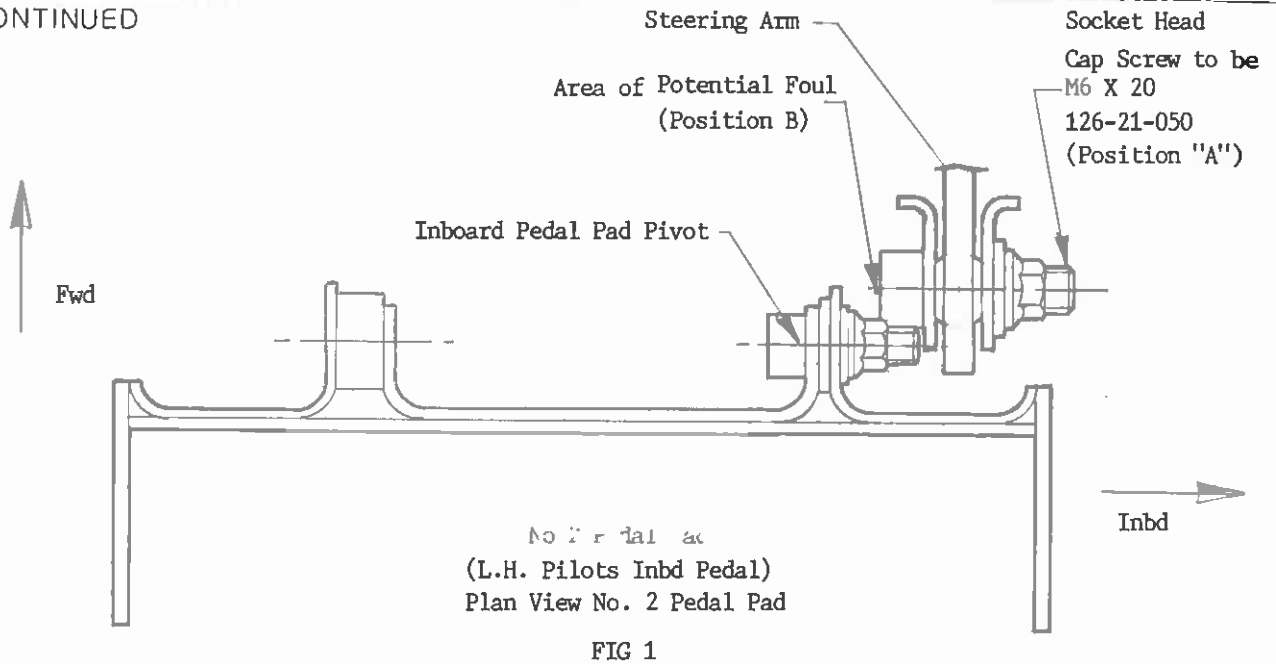
Cases have been reported during the build of the T-3A variant of the Firefly, of a potential foul between the No.2 pedal (left hand pilots inbd pedal) inboard pivot bolt tail and head of nosewheel steering rod arm attachment bolt.

This foul is to be found at extreme forward pedal adjustment full rudder deflection.

Additionally a case has been reported of a short bolt having been fitted at the nosewheel steering rod to arm attachment. The consequence of this is that the nut may not be properly locked.

1. At Position 'A', check that bolt at nosewheel steering rod.arm attachment measured 20mm long measured from under head. If not replace with M6 x 20 126-21-050, Ref Fig. 1, orientated as shown.
2. At Position 'B', with No.2 pedal fully adjusted forward and with full right rudder check for clearance between bolt tail and bolt head Ref Fig. 1.
