Service Bulletin

S.B. No: 175

Title: INSPECTION OF CONTROL COLUMN HOUSING BRAZING

Applicability: T67A, T67B, T67C, T67M, T67M-MkII, T67M200, T67M260 and T67M260-T3A.

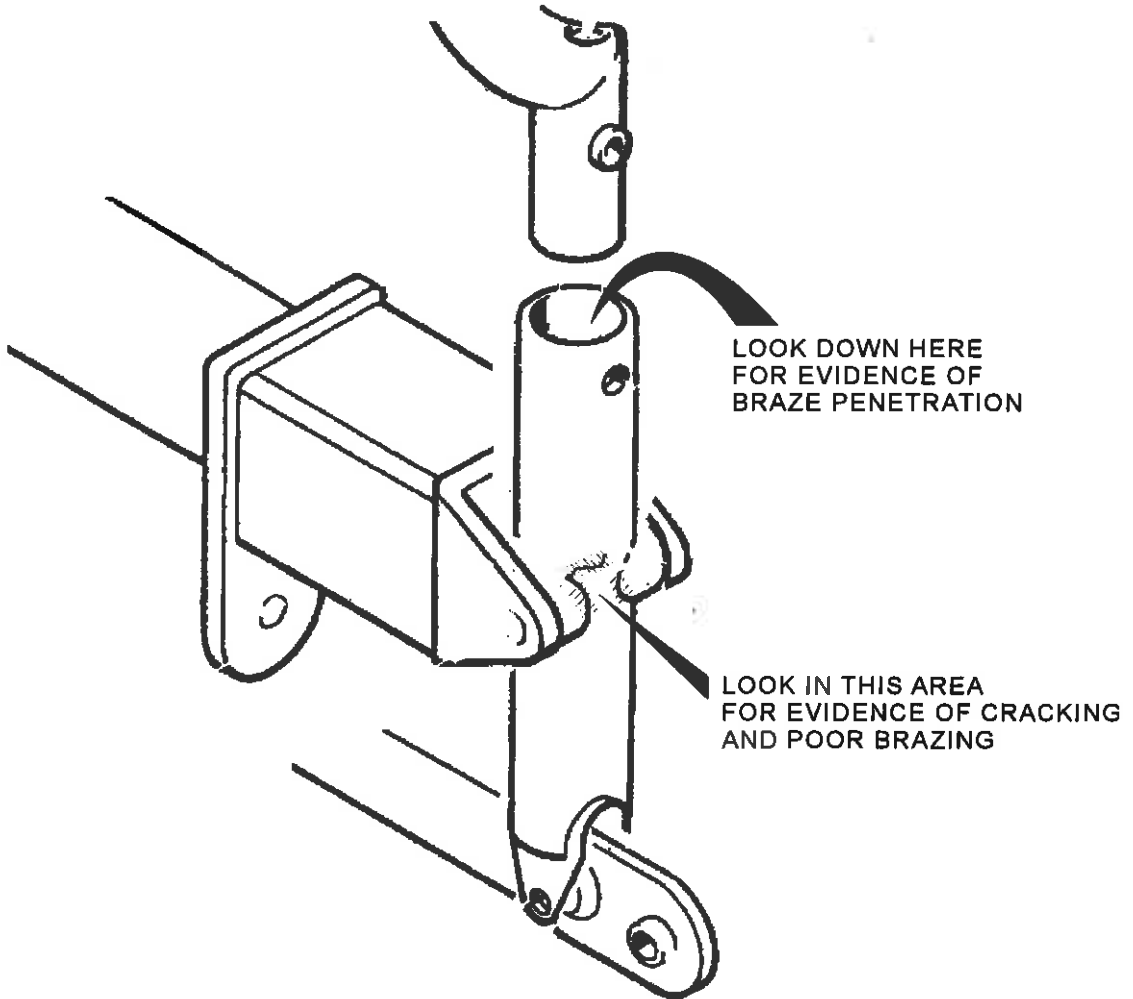
FIGURE 1

Cases have been reported of cracking in the area of the joint between the bearing housing and the vertical tube into which the control sits.

On inspecting the individual housings, one crack was found in the brazed joint and another crack was found in the vertical tube itself. The latter crack had occurred during sub-contractor manufacture and had been brazed over.

1. Check master switch, ignition switch and fuel are OFF. Disconnect external power and hangar aircraft if required.
2. Gain access either through gaiter or remove access panel.
3. Visually inspect for cracking as indicated by Figure 1 page 2.
4. If cracking found remove item and replace with new item T67B-45-217.
5. If no cracking present but if unsure, or poor brazing is suspected then:
 - a. Remove control column and visually check for braze penetration.
 - b. Remove paint locally and perform NDT (dye penetrant) crack test.
6. If either 5a. and/or b. are unsatisfactory, then replace with new T67B-45-217 item. If satisfied re-protect bare metal and re-assemble.
7. Annotate logbook "SB 175 complied with" and finally at fitting of new item "SB 175 complied with new item fitted."
