SERVICE BULLETIN

SB No. 131 Issue No. 1

TITLE INSPECTION FOR CENTRE CONSOLE FIXING SCREW FOULING
 ELECTRIC TRIM SYSTEM

T67M260-T3A, T67M260 (Not Works No. 2072) and T67C Post Mod M443 (Electric Trim)

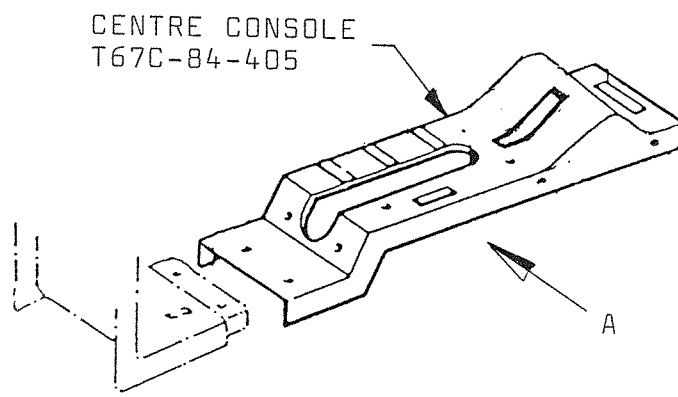
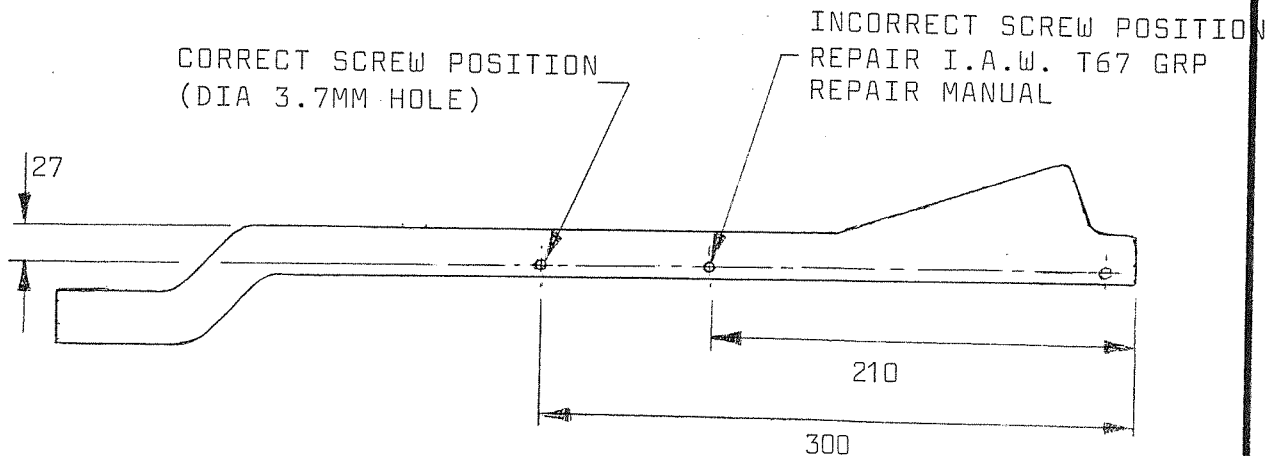
FIG 1 - POSITIONING OF SCREWS ON CENTRE CONSOLE PORT SIDE

A case has been reported of a foul between the electric trim up limit microswitch and the centre console forward attachment screw on the port side.

Following investigation, it was found that the foul is due to incorrect placement of the centre console, left hand forward attachment screw.

1. Remove seat cushions.
2. Inspect L/H side of centre console and establish whether forward attachment screw centre is 300mm (11 13/16") from the rear attachment screw centre (correct position) or 210mm (8 1/4") from the rear attachment screw centre (incorrect position). Ref: Fig. 1 View on Arrow A.

3. (i) If screw was in incorrect position (210mm) check whether a foul has occurred, by inspecting the electric trim up limit microswitch (forward switch) and wiring for any chafing damage.
 (ii) If chafing has resulted in significant damage, renew appropriate components as required. Ensure that wiring is routed well away from any possible chafing points.

4. Remove centre console. Remove hole at 210 (8 1/4") by standard repair (Refer T67 GRP Repair Manual) and if required drill 5.1dia hole at 300 (11 13/16") position. Ref: Fig. 1 View on Arrow A.
