SERVICE BULLETIN

SB No. 68 Issue No. 3

TITLE
CANOPY LATCH CORRECT OPERATION INSPECTION
CLASSIFICATION

T67C, T67M and T67M200 Aircraft, Post Mod M129 (Split Canopy), T67M-MkII, T67M260 and T67M260-T3A.

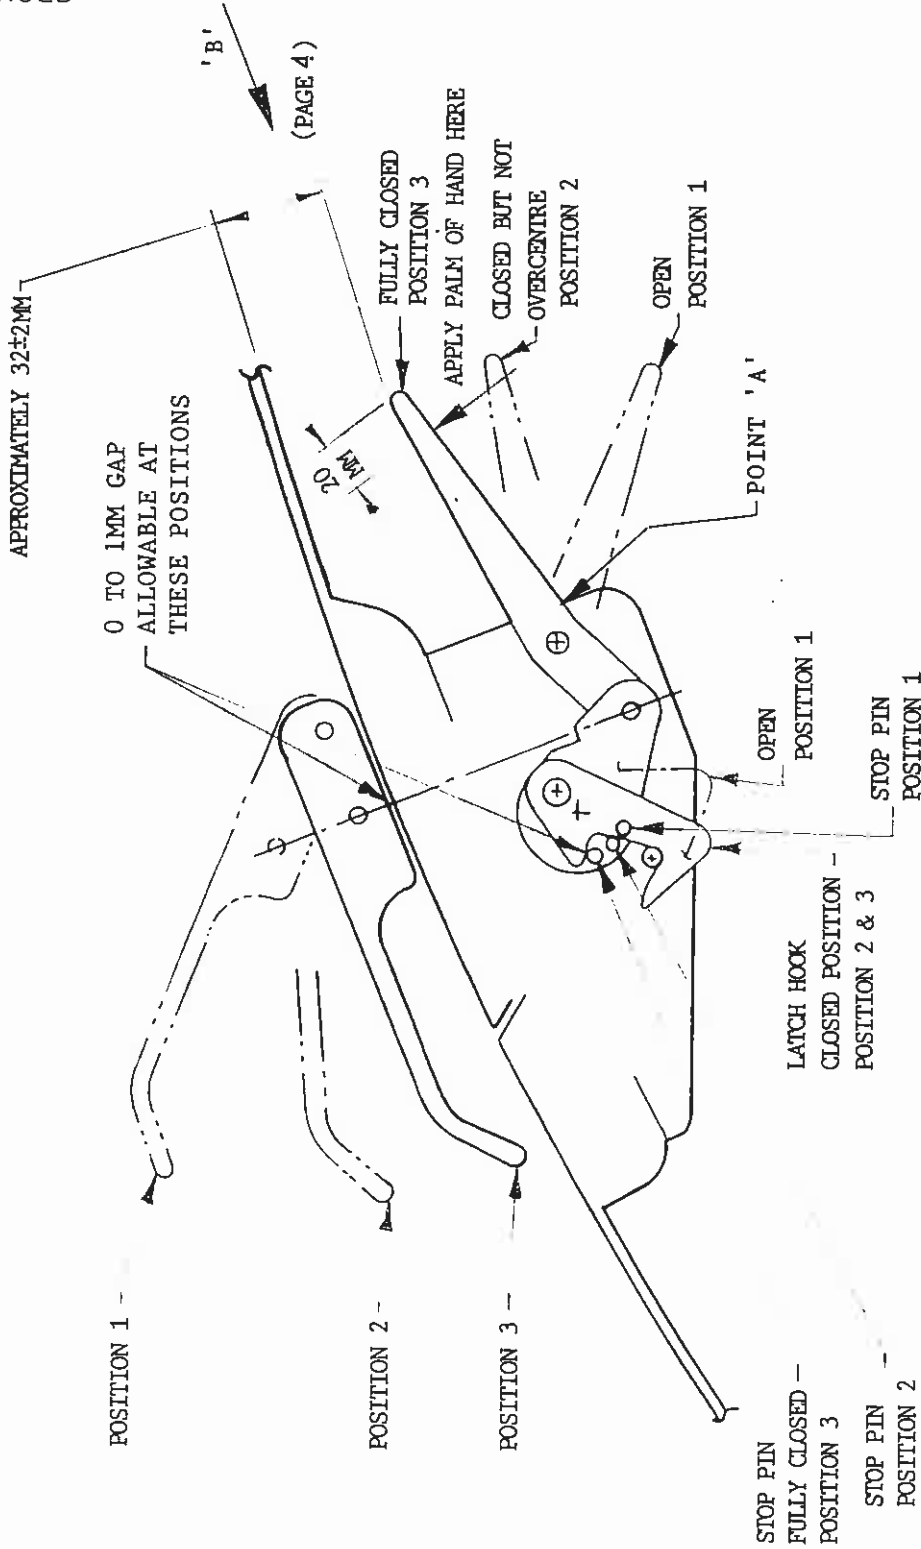
Fig 1

An incident has occurred where the canopy latch was apparently closed correctly but when engine revs were increased beyond 1500 RPM the canopy opened.

Fig. 1 page 2 shows 3 positions of the canopy mechanism:

Position 1 - Open/Unlatched

Position 2 - Latched but mechanism not over centre

Position 3 - Correctly closed, mechanism fully over centre.

- (i) Remove canopy mechanism and latch covers
- (ii) Close canopy fully. Ensure internal handle is in its correct position and external handle is in its correct position, ie touching bush or no more than 1mm gap. Fig. 1.
- (iii) Check that stop pin is just touching latch hook or no more than 1mm from it. If not adjust in accordance with Maintenance Manual, Section 3, paragraphs 3.2.
- (iv) If (ii) and (iii) cannot be met after adjustment, then it is acceptable to slot latch block Ref. Fig. 3. Suitably re-protect cut surfaces and re-identify block as Part Number T67G-17-531 Post Mod M713B. Annotate Logbook accordingly.
- (v) Check closure. By positioning palm of hand at point indicated, ref. Fig. 1, push up latch handle, which should close with reasonable resistance but without using excessive force.
