SERVICE BULLETIN

SB No. 001

Issue No. 1 Aircraft Type T67A

Aileron Control Circuit Inspection

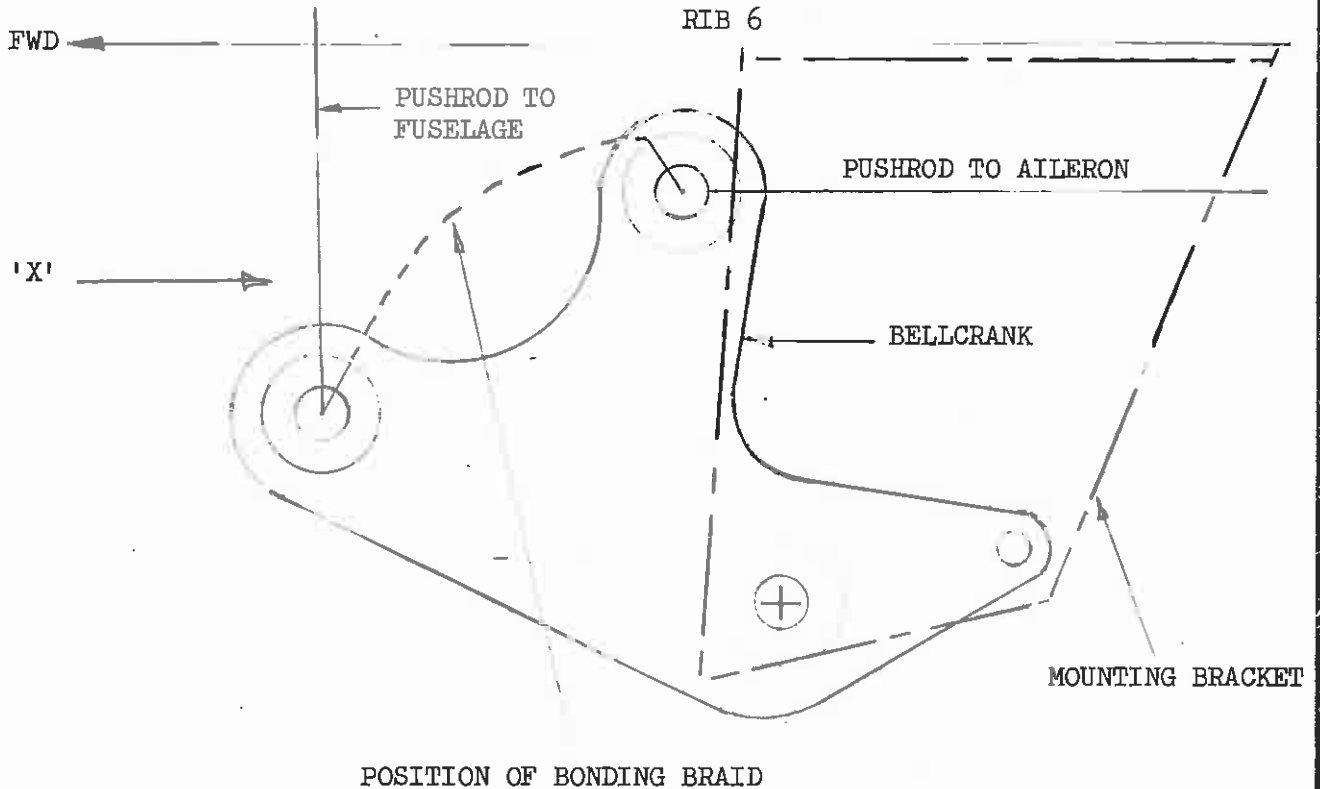
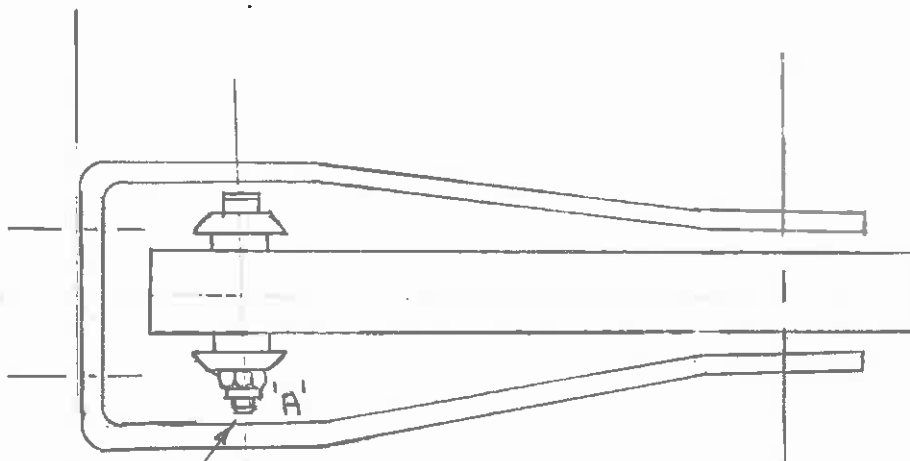
FIG 1

Remove the outboard inspection cover from each wing. Check the clearance between the bolt tail and the bellcrank mounting bracket in area 'A' of Fig.1 is at least 1.5mm (0.060"). If the clearance is less than this the bolt tail must be shortened.

MINIMUM CLEARANCE
1.5mm (0.060")

Ensure that the bolt is still in safety by at least 2 thread pitches 1.6mm (0.063").

When replacing the nut ensure the bonding braid is re-positioned as shown in Fig.1
