## Service Bulletin

S.B. No: 188

**Title: INSPECTION FOR RUDDER PEDAL CLEARANCES BETWEEN RUDDER PEDALS AND THE AIRCRAFT STRUCTURE AND COMPONENTS ALSO INSPECTION FOR GROUND TOWING DAMAGE.**

**Applicability:** T67B, T67C series, T67M (excluding works no. 1999), T67M-MkII and T67M200 (excluding works no. 2264 & 2265).

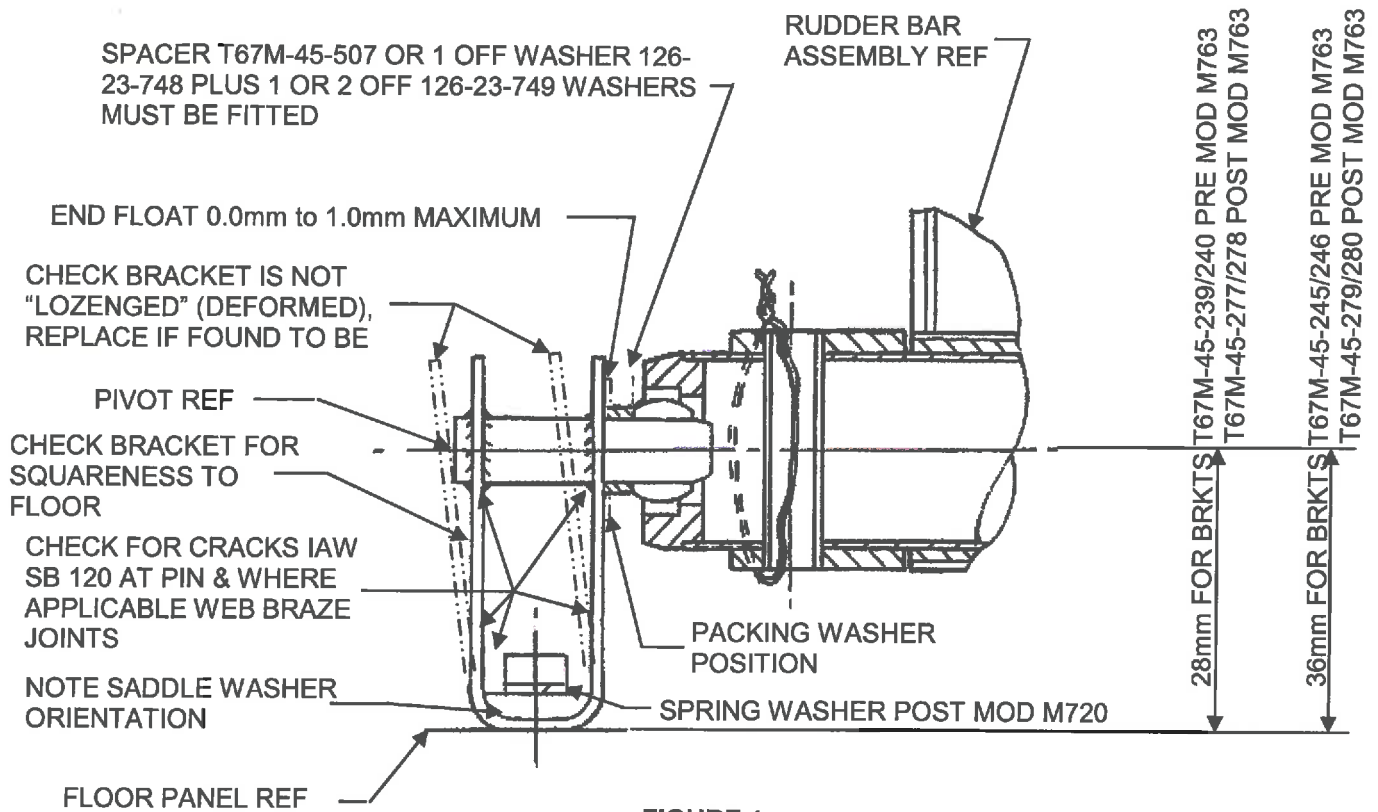
FIGURE 1

3. Check rudder pedal bar end float is no greater than 1.0mm. Acceptable end float is 0.0mm to 1.0mm. If end float is greater than 1.0mm then rectify end float IAW paragraph 14. Refer Figure 1.

**RUDDER BAR END FLOAT AND ITS SUPPORT BRACKET**

14. Referring to Figure 1 ensure at each rudder bar pivot position that there is one spacer T67M-45-507 or one off washer 126-23-748 and up to a maximum of two off washers 126-23-749, i.e. 3 washers maximum.

If end float greater than 1.0mm, then 1 off packing washer may be added at each pivot position as required, i.e. 126-23-105 washer or 126-23-748 washer or 126-23-749 washer.

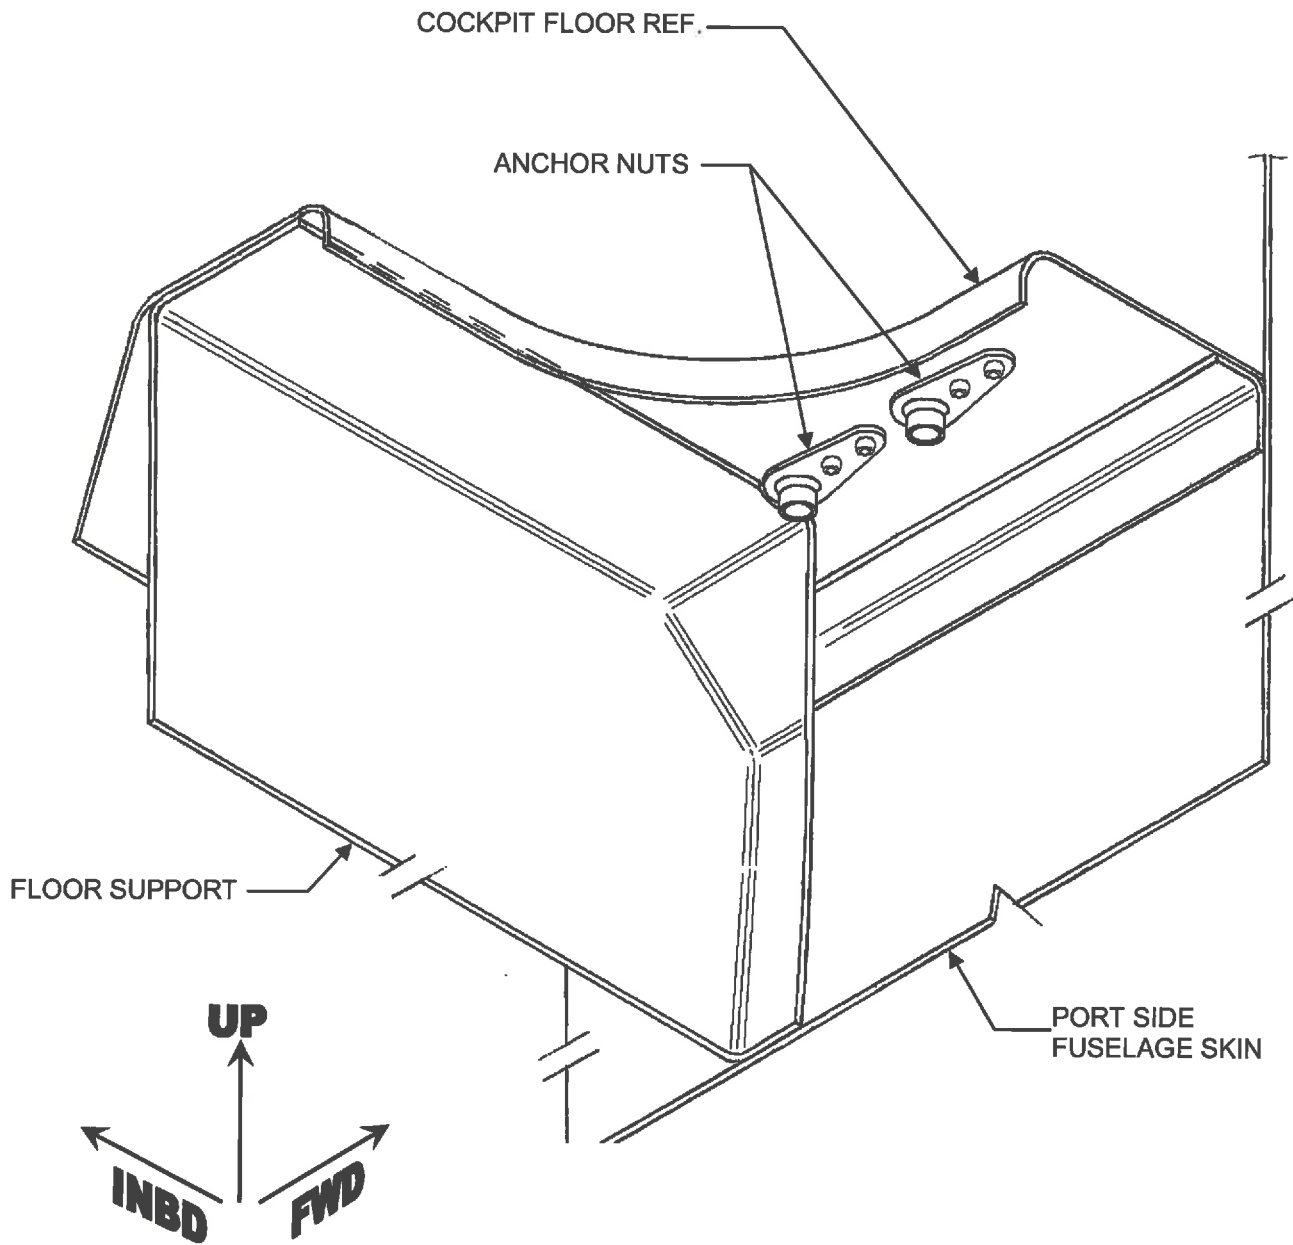
**FIGURE 2A**

5. Establish Mod status of floor with regards to whether full incorporation of Mod M919 has been implemented as per DOI T67C-149 issue 5, Figure 2C refers. Un-modified floor will be as shown by Figure 2A. Aircraft Modified IAW DOI T67C-149 issue 1, i.e. only doubler plate fitted, see Figure 2B. If DOI T67C-149 issue 5 has been recorded incorporated, then there is no further requirement to remove panels with respect to this Service Bulletin unless damage is noted during course of the inspection, an incident or noted during normal maintenance.

**SHOWING PRE MOD M919 CONFIGURATION  
REQUIRES REPAIR MODIFICATION IAW DOI T67C-149 ISSUE 5 & SUBS**

6. If floor under port outboard support bracket position is found to be cracked or broken or not modified IAW Mod M919 Figure 2C, then repair IAW DOI T67C-149 issue 5 and subsequent, to fully incorporate Mod M919. If the full Mod M919 has been previously incorporated i.e. to DOI T67C-149 issue 4 and floor is found to be damaged, inform MSAC.

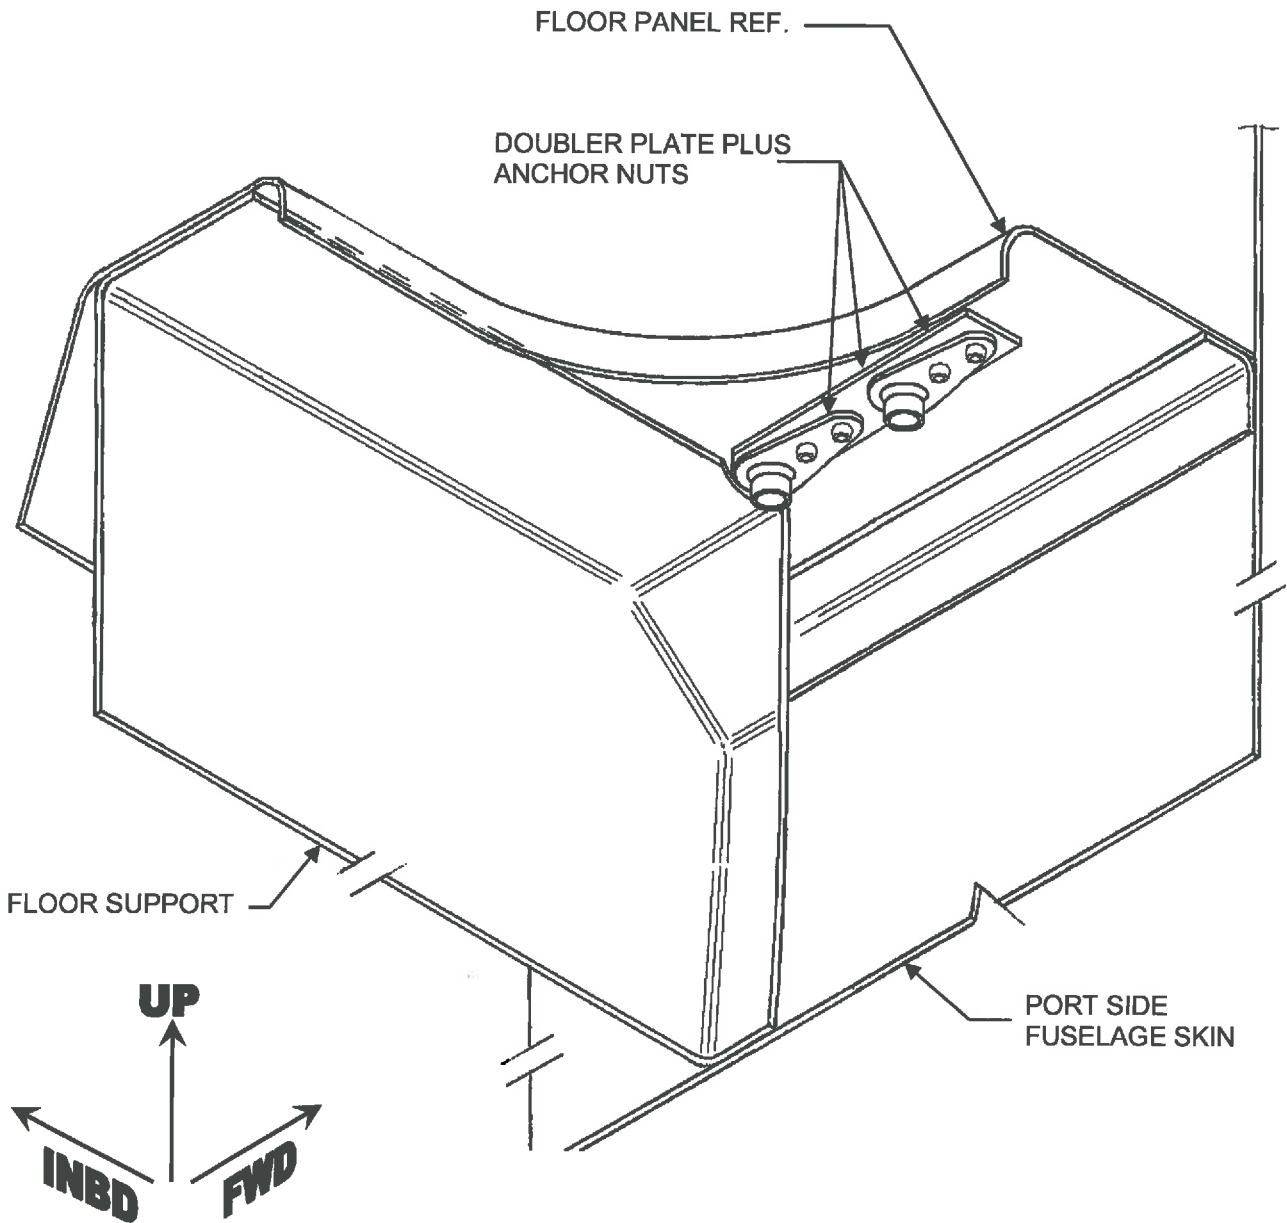
**FIGURE 2B**

**SHOWING PART MOD M919 INCORPORATION  
REQUIRES REPAIR MODIFICATION IAW DOI T67C-149 ISSUE 5 & SUBS**

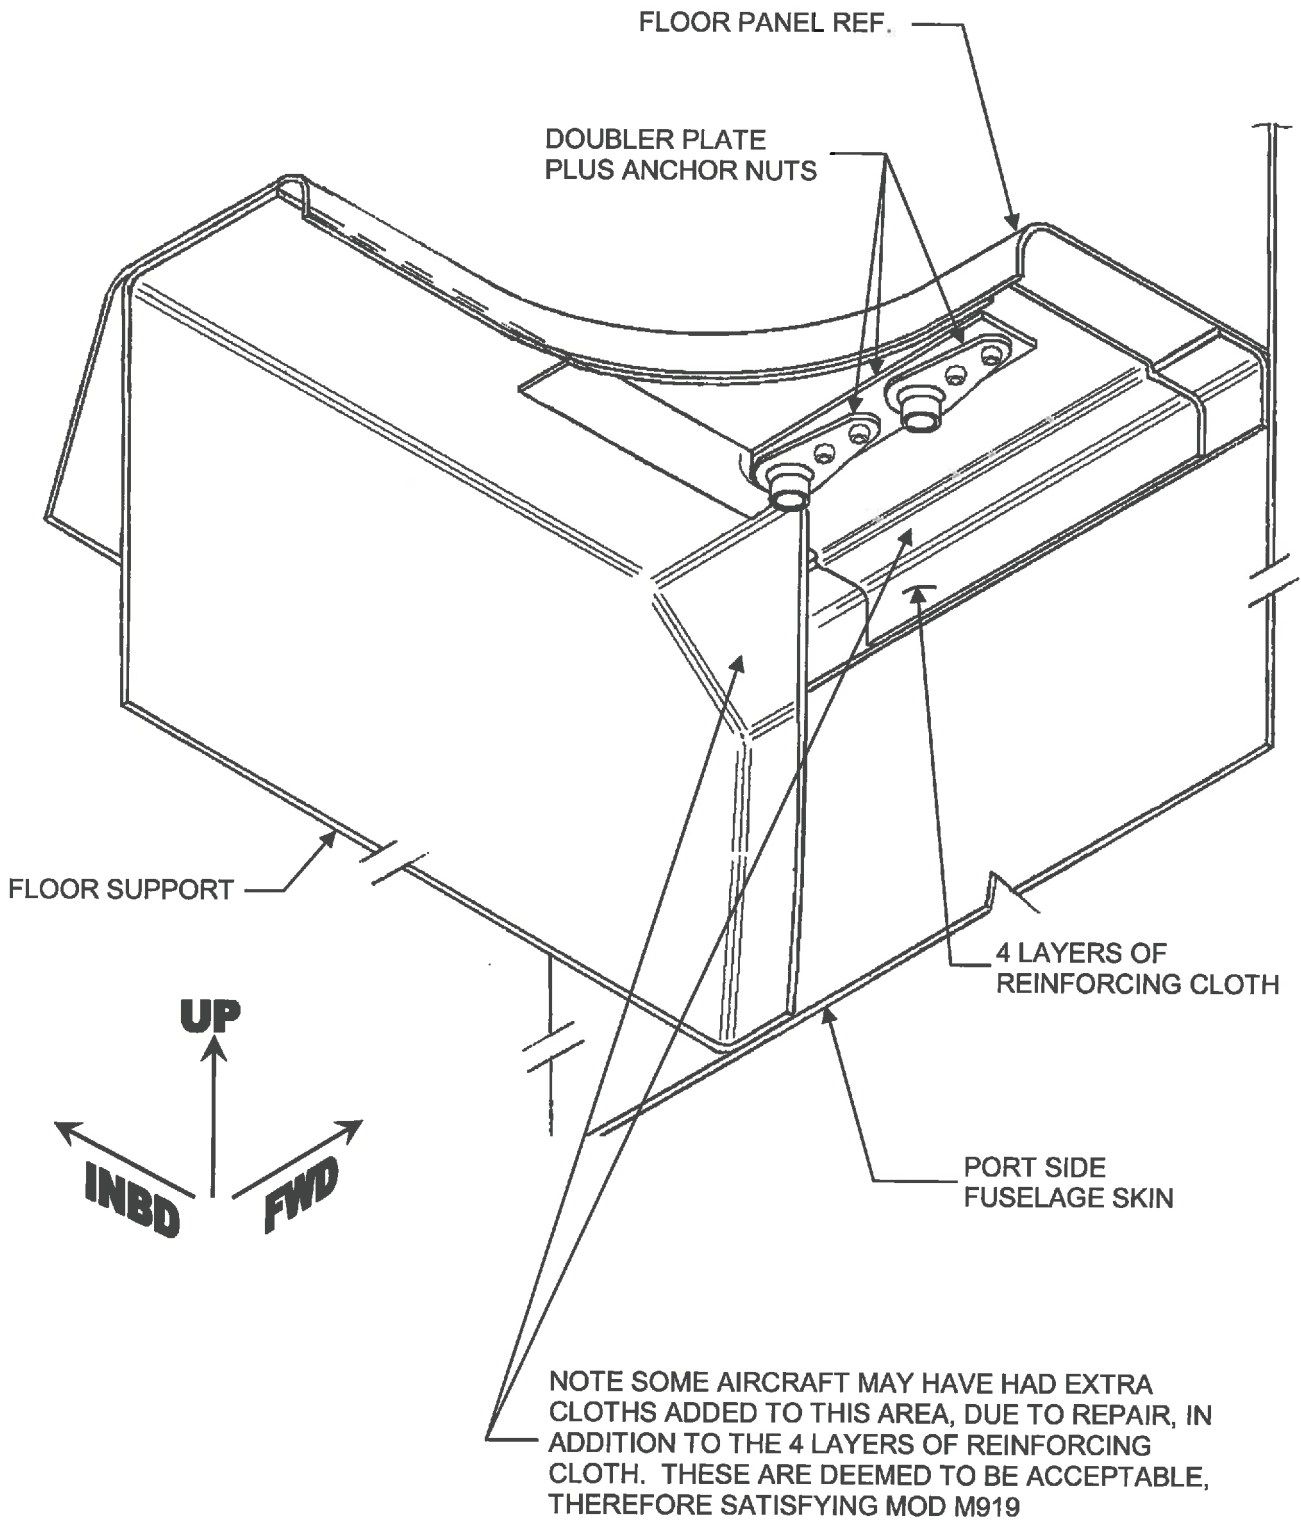
**FIGURE 2C**

**SHOWING FULL MOD M919 INCORPORATION  
NO FURTHER ACTION REQUIRED**

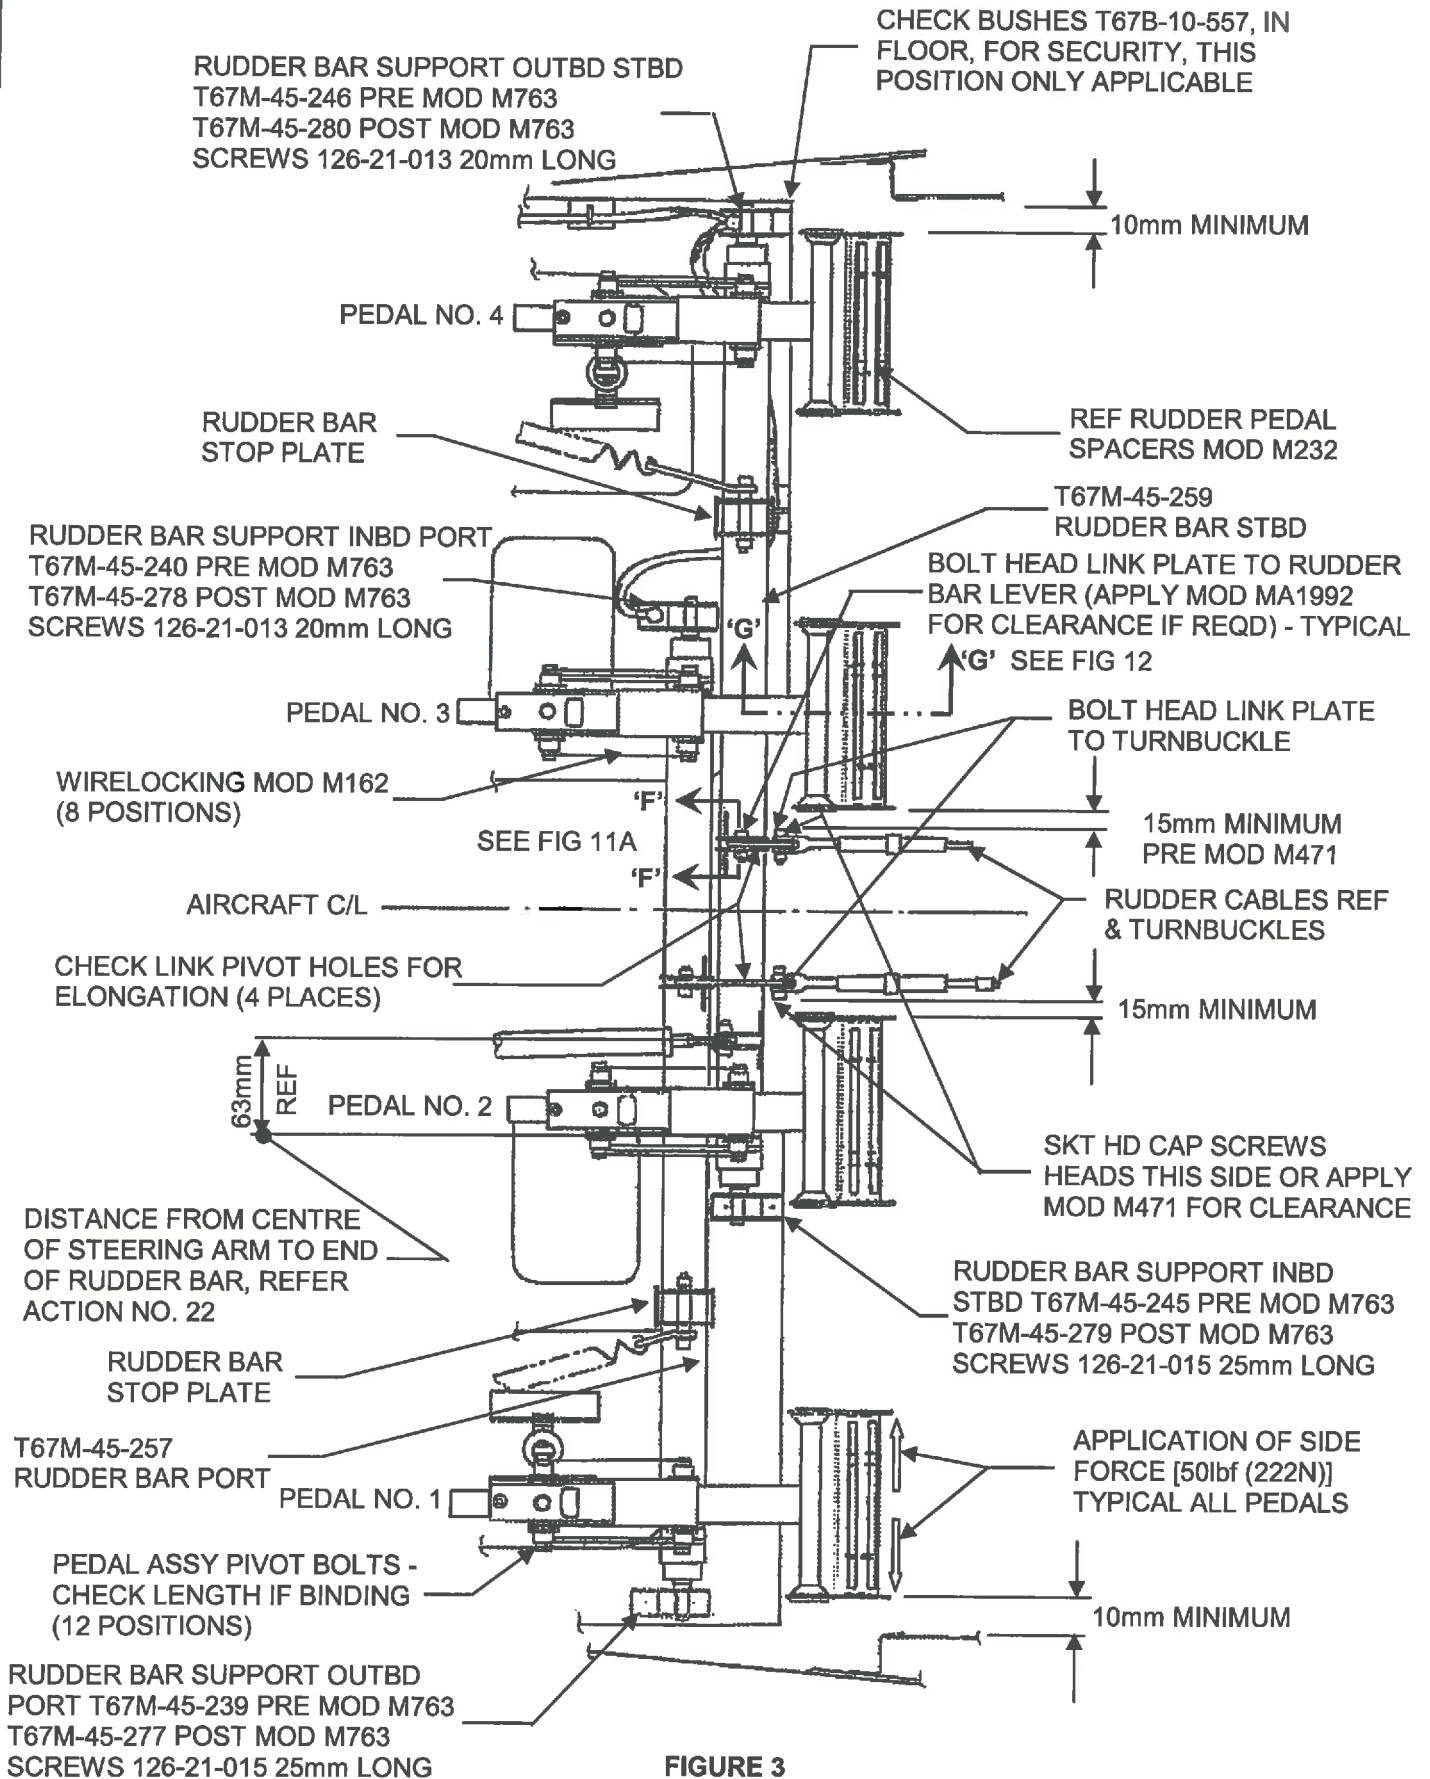
FIGURE 3

(b) Referring to Figures 3, 11A and 11B, check the Right Hand pilot's left pedal (Pedal No. 3) for clearances from: i) starboard rudder cable attachment bolts to link plate and ii) link plate to rudder bar lever post. Clearances should be a minimum of 15mm and 16.5mm respectively. Clearance checks to be performed at all four pedal adjusted positions, but especially; with pedal adjusted fully forward (or past last adjustment position), with full left rudder applied, together with a left hand side force applied to the pedal – refer Figure 3 – and that any slack in the rudder cable is taken up in the starboard direction - see notes below.

**RUDDER PEDAL CLEARANCES TO SIDE PANEL AND RUDDER CABLES**

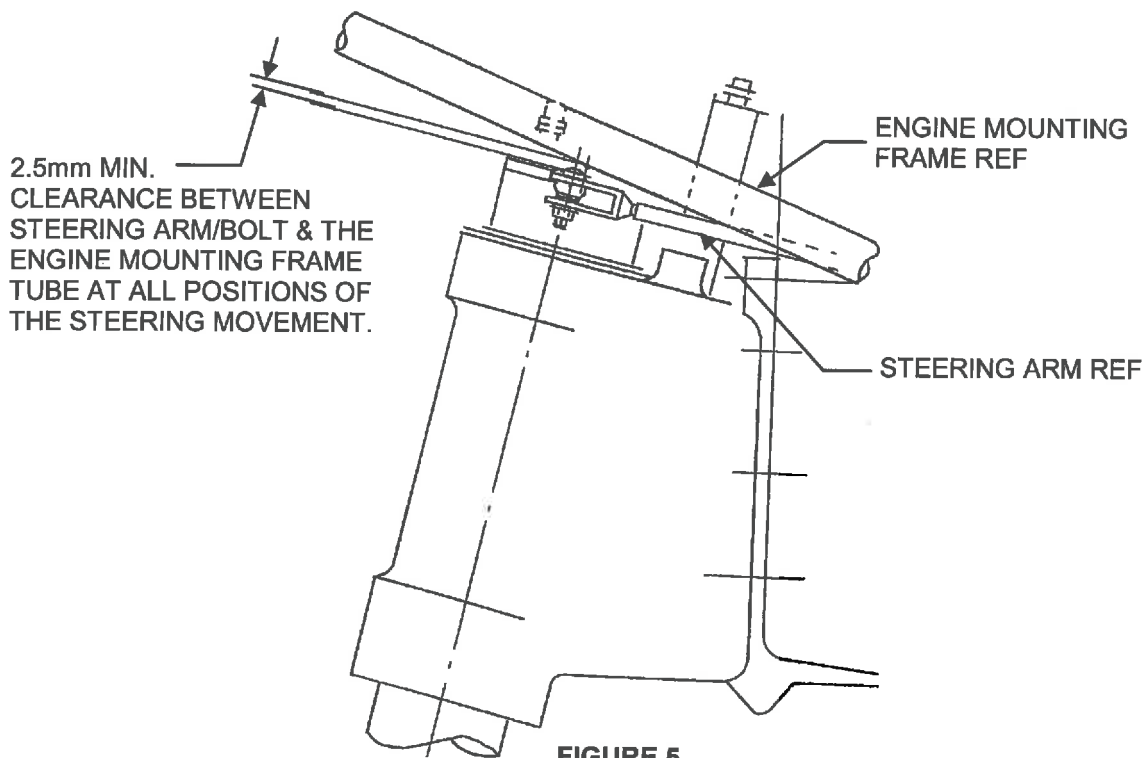
FIGURE 5

29. Ensure on aircraft fitted with the Fairey Hydraulic undercarriage, (Post Mod M468 or Mod M791), that there is a minimum clearance of 2.5mm with steering linkage to engine mounting frame, see Figure 5. Ensure there is no damage to engine mounting frame if clearance is less than 2.5mm. If engine mounting frame is damaged then aircraft must not be flown until damage is rectified, consult MSAC. Also if clearance is less than 2.5mm embody Mod M575 "Introduction of Offset Steering Arm Pin – Ref Fairey Hydraulics Nose U/C", if Mod M575 is fitted and clearance is less than 2.5mm inform MSAC.

STEERING ARM ENGINE MOUNTING FRAME CLEARANCE

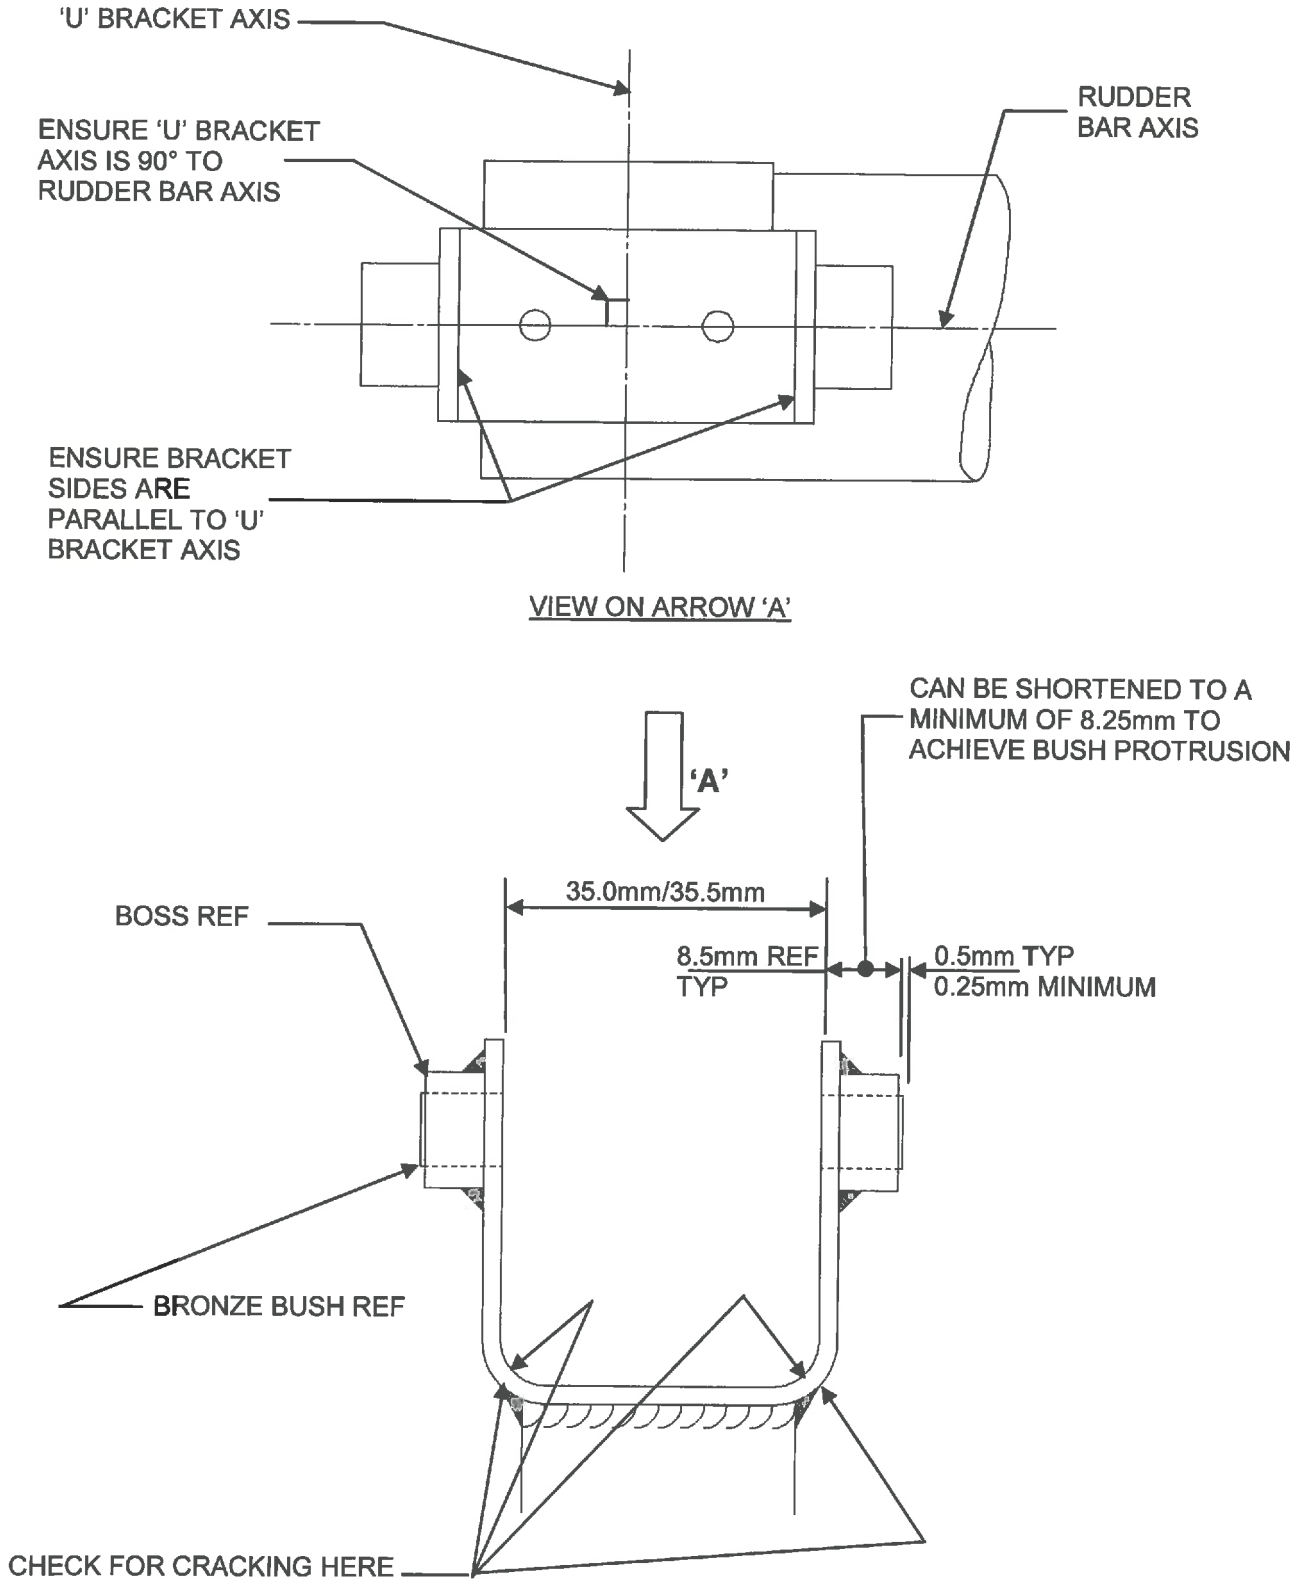
**FIGURE 7**  
**'U' BRACKET ON RUDDER BARS**  
**(4 POSITIONS)**

15. Check that the 'U' brackets are free of any deformation, and are parallel and square to the rudder bar axis; Figure 7 View on 'A' refers. Also ensure the rudder pedal carriages have full and free movement. If binding is suspected then check the 'U' bracket internal dimension. This should measure 35.0mm to 35.5mm, also check that the pivot bush protrudes from its boss by at least 0.25mm, see note 3 below. If the bracket internal dimension is greater or less, or if out of alignment then the bracket should be checked for cracking, refer Figure 7. If cracking is found then return rudder bar to MSAC for rework. Finally check length of carriage pivot bolts, reference Figure 3, if binding is noted then replace bolts with bolt part number T67B-08-537 this introduces a bolt 15 mm long, measured from under head, and invokes Mod M808

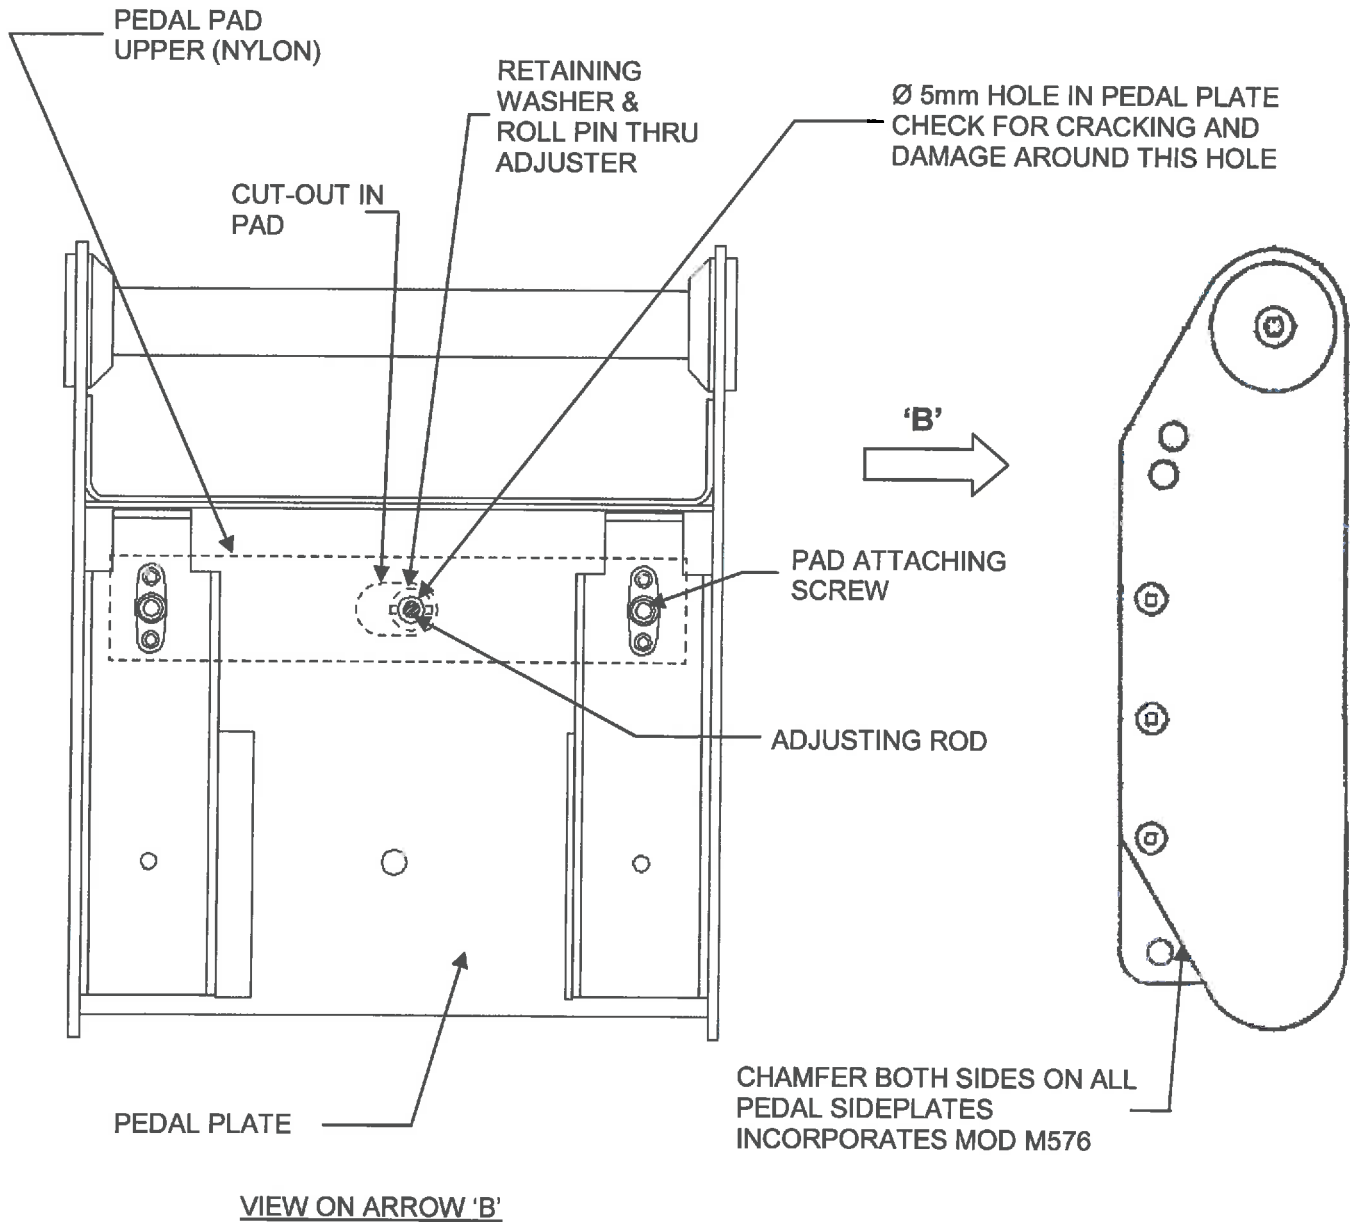
FIGURE 8

26. Check structural integrity of pedal pad assembly especially around adjuster pushrod hole pedal plate, Figure 8 View on Arrow 'B' refers, if plate is cracked or damaged the pedal pad is to be repaired. Ensure riveting is secure, if rivets are loose then they have to be rectified. Ensure that the pad pivots are not worn and that the nuts are tight, but allow pad to pivot, nuts to be retained with adhesive 126-51-067. Replace pedal pads if worn. Contact MSAC for new pedal pad assembly, materials and any applicable repair scheme.

MOD M576 PEDAL SIDEPLATES WITH CHAMFER

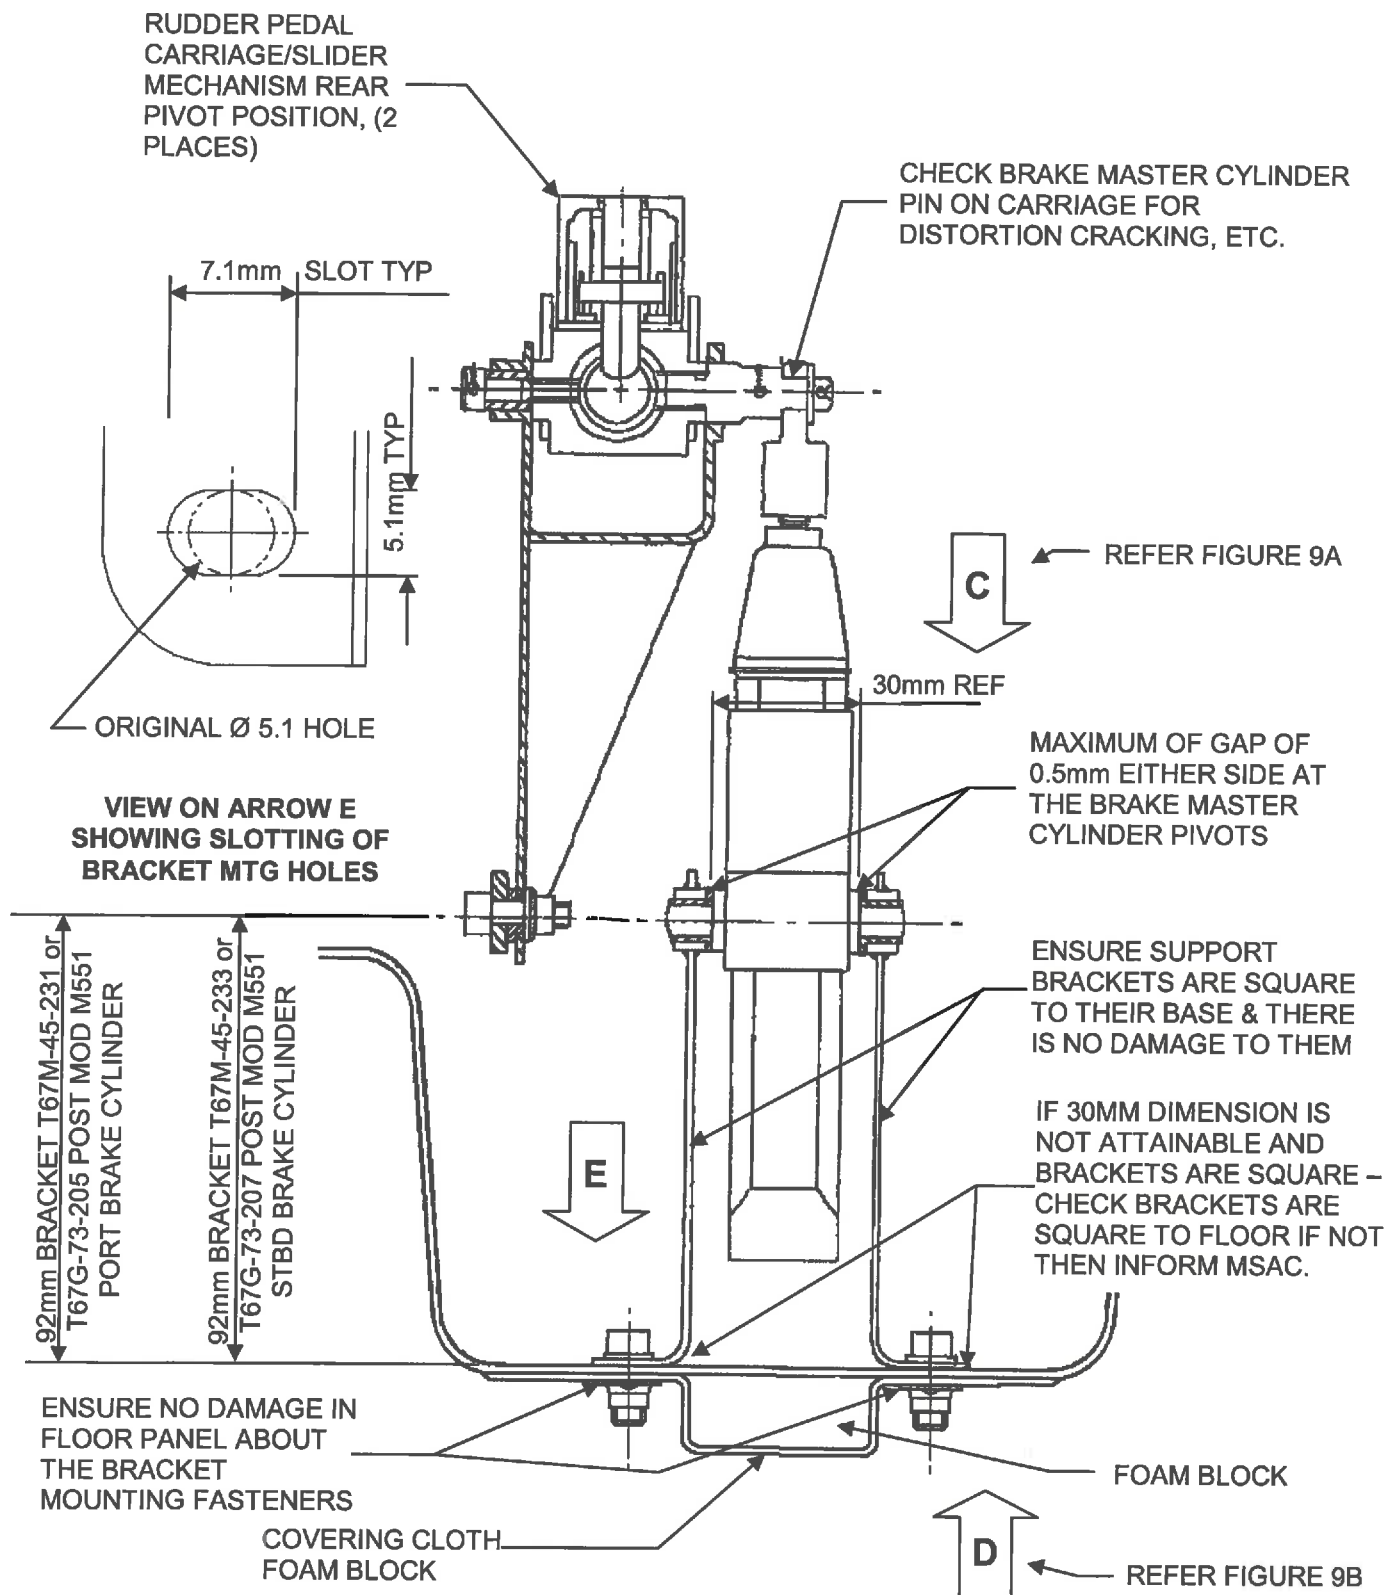
10. Referring to Figure 9, ensure that there is either no gap or a gap either side of no greater than 0.5mm, at the brake master cylinder pivot points and that the support brackets are securely mounted to the floor panel, i.e. not loose. Brackets should not deflect if base fastenings are sound. If bracket is seen to be suspect, i.e. out of square, twisted or bent, remove brackets and replace with new brackets if damaged. Check that there is no damage to the bracket anchorages in the removable floor panel. Damage will show as whitening in the laminate surrounding the anchor nuts and foam reinforcement block, ref. Figures 9A and 9B, if in doubt remove panel and check anchor nuts for security. Figure 9 refers. The floor panel if found to be damaged is to be repaired or new panel fitted, refer to MSAC Product Support Department. If damage found then proceed as indicated by paragraphs 11 and 12. When rectified ensure all clearances and checks are accomplished as related to in this Service Bulletin.

Note: This check should be accomplished with the rudder pedal and brake system operating through to their extremes, as a gap can appear during the operation of the system, if the system is not correctly aligned or assembled. Some brake master cylinder support brackets have slotted mounting holes to assist in achieving correct alignment. If the bracket's mounting holes are not slotted then it is permissible to slot the holes as detailed at Figure 9, View on Arrow E.

**FIGURE 9**  
**BRAKE MASTER CYLINDER SUPPORT BRACKETS**

12. If damage is found ref. Paragraph 10, then brake master cylinder to rudder pedal carriage attachment pin is to be checked for deformation/cracking, Figure 9 refers.

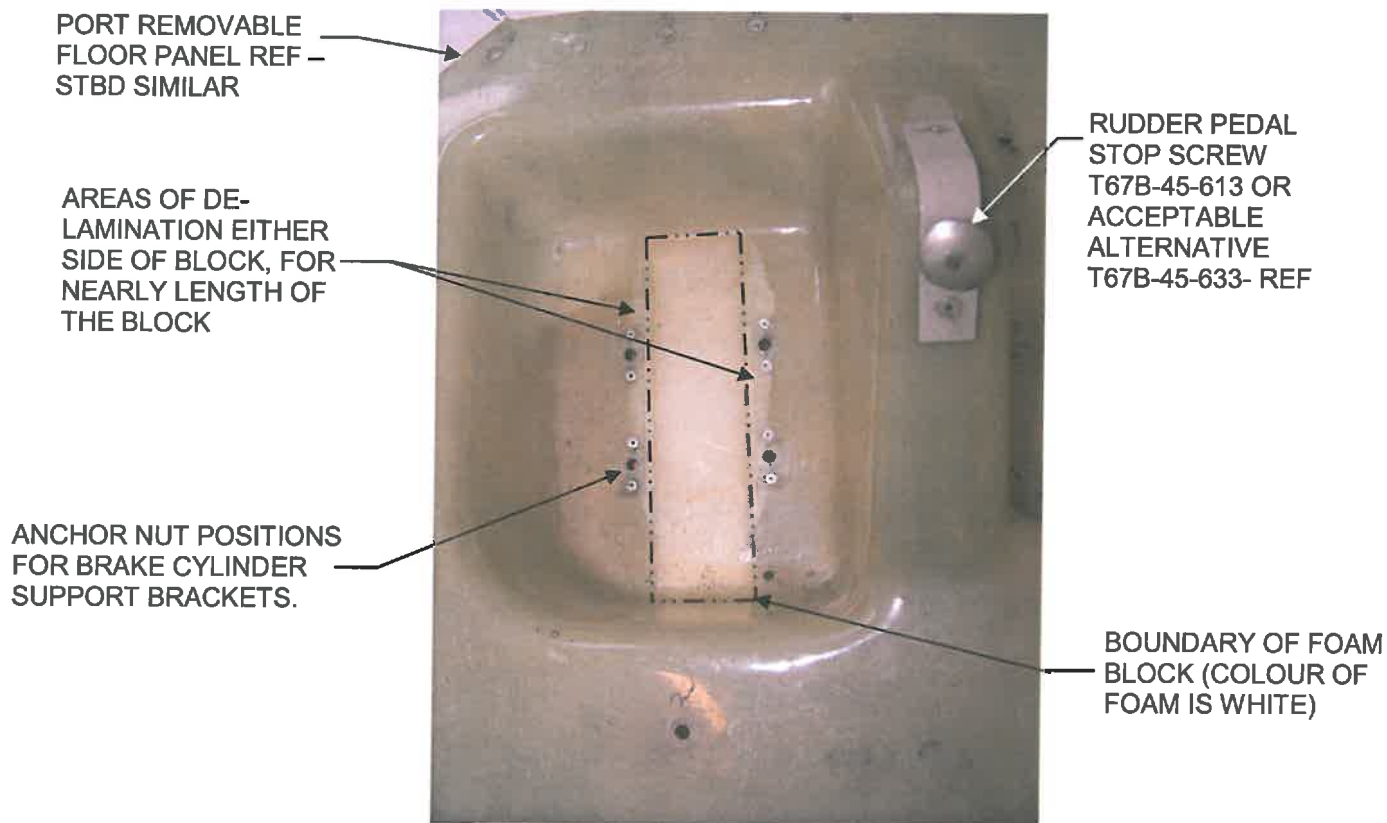
**FIGURE 9A**

Further to issue 2 an incident has been reported of the brake master cylinder becoming detached from its support brackets causing de-lamination to the port GRP floor panel. This failure occurred during aircraft taxiing. The failure was the direct result of the aircraft towing angle being exceeded.

The investigation concluded that the most probable cause of the problem was the result of exceeding the vehicular towing angle and/or incorrect positional assembly of the brake cylinder support brackets. It should be noted that the port cylinder support brackets are shorter than their counterparts on the starboard side and they must NOT be interchanged.

**PHOTOGRAPH ON ARROW C  
VIEW INTO TOPSIDE OF REMOVABLE PANEL SHOWING EXTENT OF DE-LAMINATION**

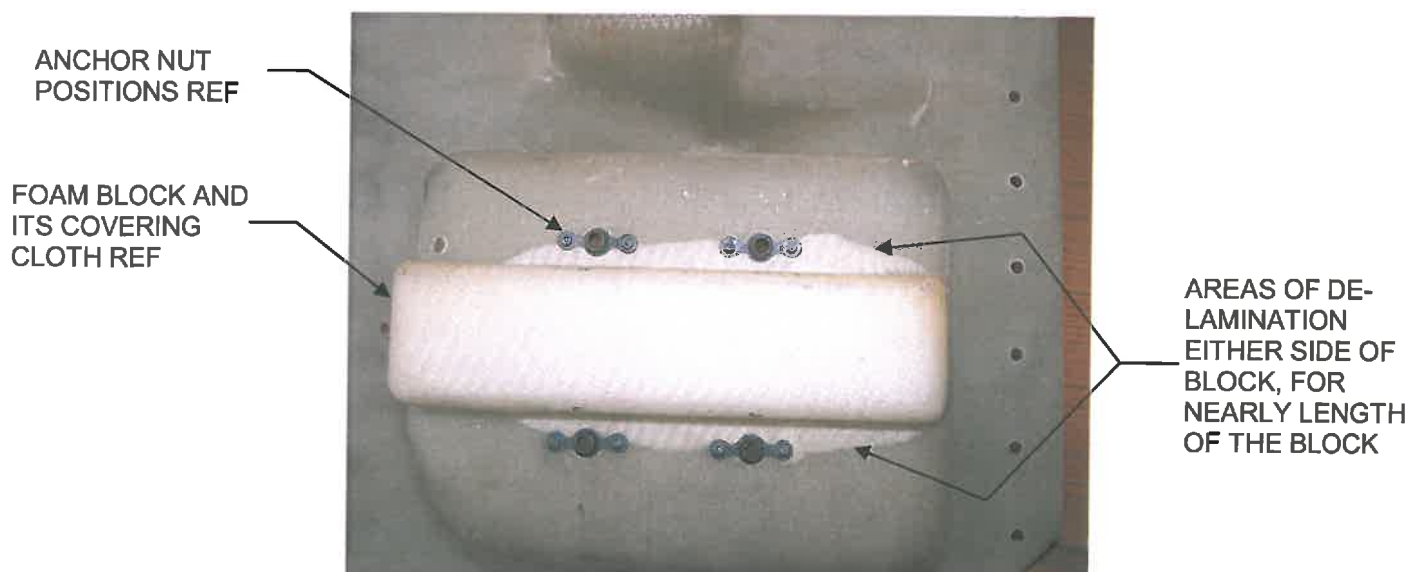
**FIGURE 9B**

**PHOTOGRAPH ON ARROW D  
VIEW ON UNDERSIDE OF REMOVABLE PANEL SHOWING EXTENT OF DE-LAMINATION**

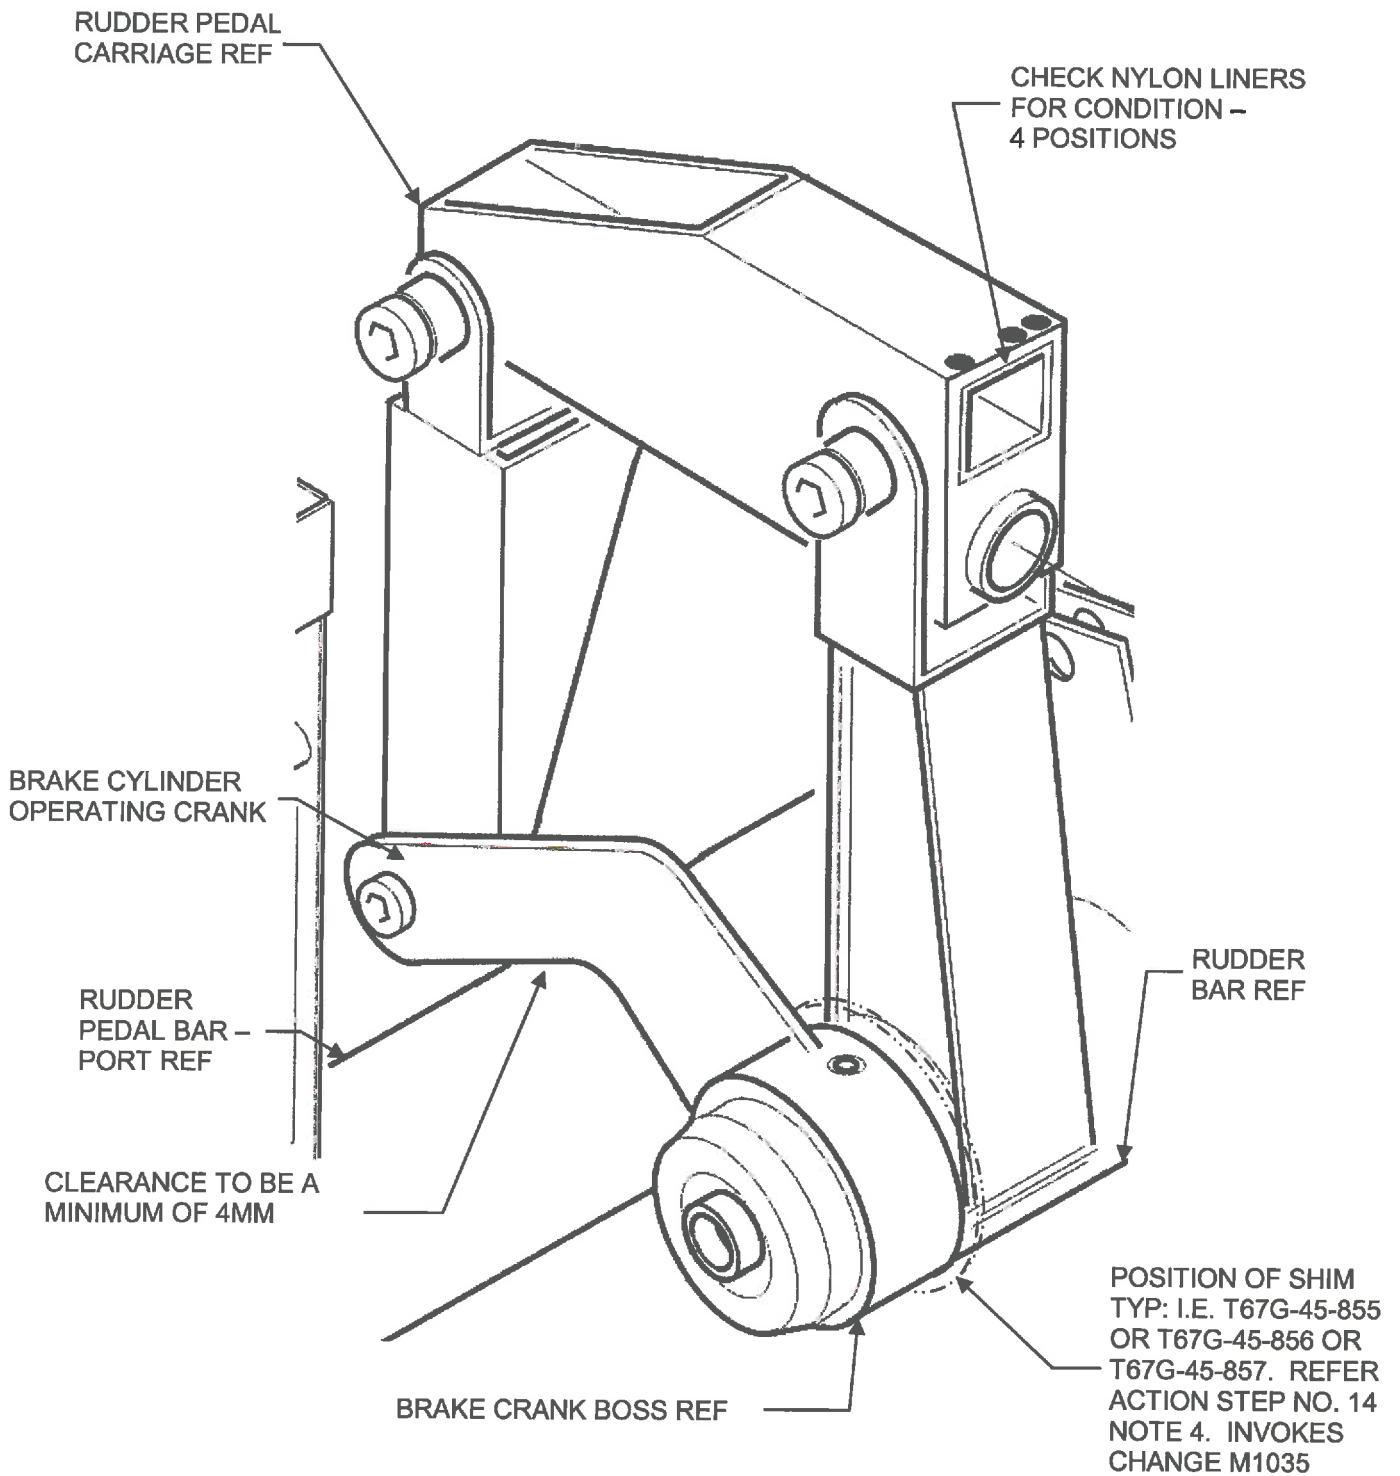
FIGURE 10

24. Ensure that all the nylon liners in the rudder pedal carriages are fitted, (4 pieces per carriage in Pre-Mod M450\* aircraft, 1 piece liner in Post Mod M450) and are in a good condition and not worn, Figure 10 refers, replace liners if unsatisfactory. Return carriages to MSAC for replacement of liner.

27. Ensure that the brake operating crank, as shown at Figure 10, has a minimum clearance of 4mm relative to the rudder pedal bar following all checks and rectifications. Allow for various brake conditions, refer paragraph 30.2. Should bar show signs of chaffing check depth of groove. If depth is 0.0mm to 0.5mm, remove rudder bar, blend out groove, repaint and refit. If the groove is to a depth greater than 0.5mm, remove rudder bar and return to MSAC for repair or replacement.

**BRAKE CRANK CLEARANCE AND NYLON SLIDER POSITION**
