## Service Bulletin

S.B. No: 188

**Title: INSPECTION FOR RUDDER PEDAL CLEARANCES BETWEEN RUDDER PEDALS AND THE AIRCRAFT STRUCTURE AND COMPONENTS ALSO INSPECTION FOR GROUND TOWING DAMAGE.**

**Applicability:** T67B, T67C series, T67M (excluding works no. 1999), T67M-MkII and T67M200 (excluding works no. 2264 & 2265).

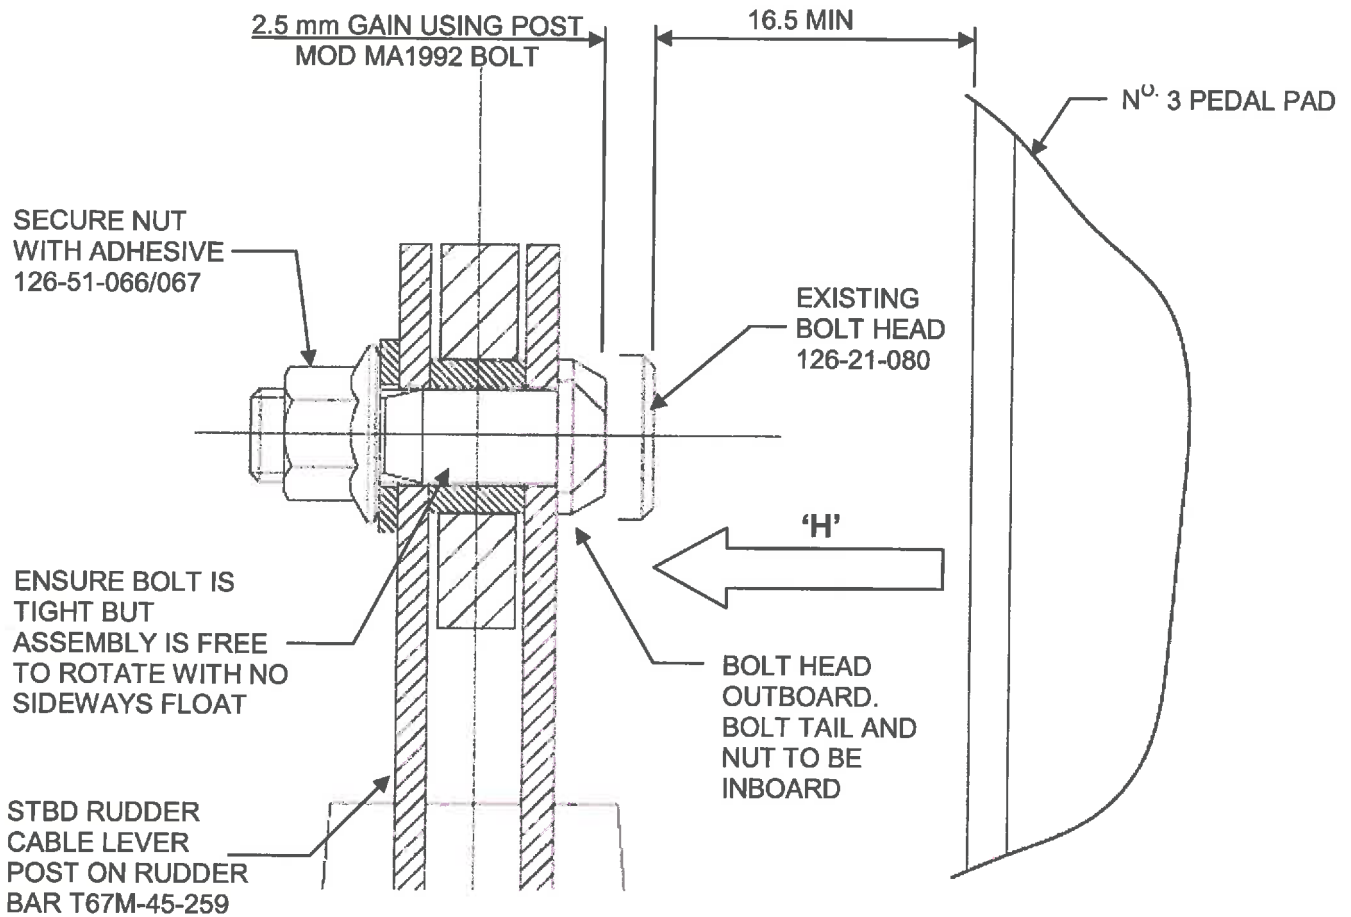
(b) Referring to Figures 3, 11A and 11B, check the Right Hand pilot's left pedal (Pedal No. 3) for clearances from: i) starboard rudder cable attachment bolts to link plate and ii) link plate to rudder bar lever post. Clearances should be a minimum of 15mm and 16.5mm respectively. Clearance checks to be performed at all four pedal adjusted positions, but especially; with pedal adjusted fully forward (or past last adjustment position), with full left rudder applied, together with a left hand side force applied to the pedal – refer Figure 3 – and that any slack in the rudder cable is taken up in the starboard direction - see notes below.

Note 2: ensure there is no end float in the bolts, i.e. that they are tight but not tight enough to restrict rotation. Ensure Loctite is applied to stiffnut after adjustment or replacement, MSAC code 126-51-066 or 067, Figure 11A Section F-F refers.

**FIGURE 11A**  
**SECTION 'F-F' (REFER FIGURE 3)**

**STBD RUDDER CABLE BOLT HEAD TO PEDAL NO. 3 CLEARANCE (PORT RUDDER CABLE OPPOSITE)**

Note 3: if clearance of 16.5mm cannot be achieved then fit special low head bolt T67M-45-0579 thus invoking Mod MA1992. Mod kit T67A-05-1992 to be obtained from MSAC Product Support.

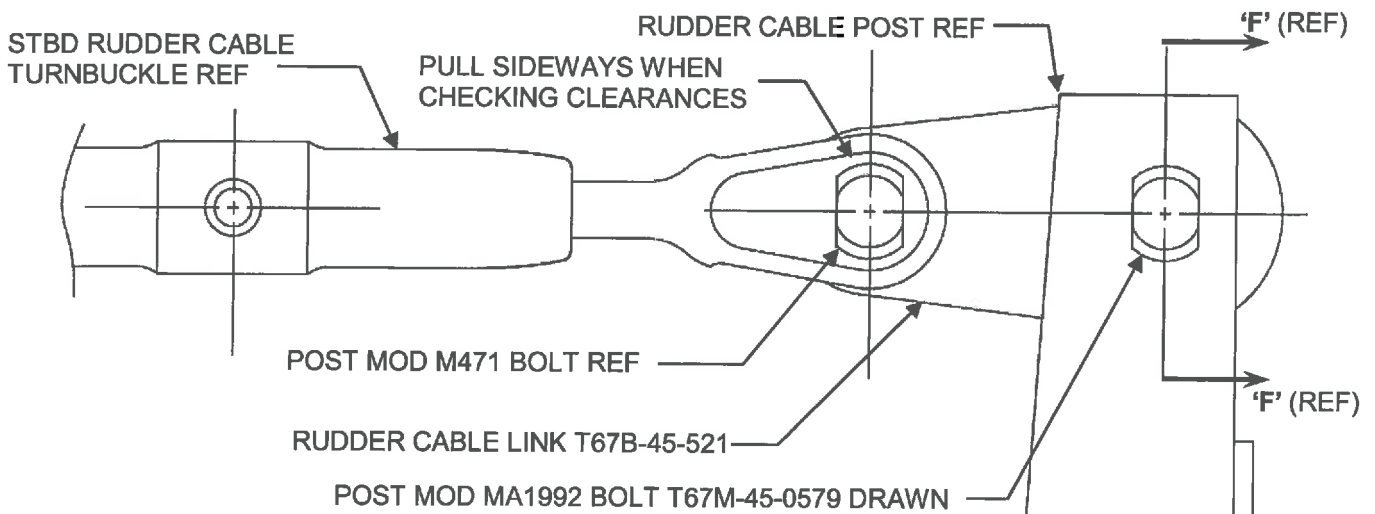
**FIGURE 11B**  
**VIEW ON ARROW 'H' (REFER FIGURE 11A)**

**SHOWING STBD RUDDER CABLE TO LINK ATTACHMENT (PORT RUDDER CABLE OPPOSITE)**

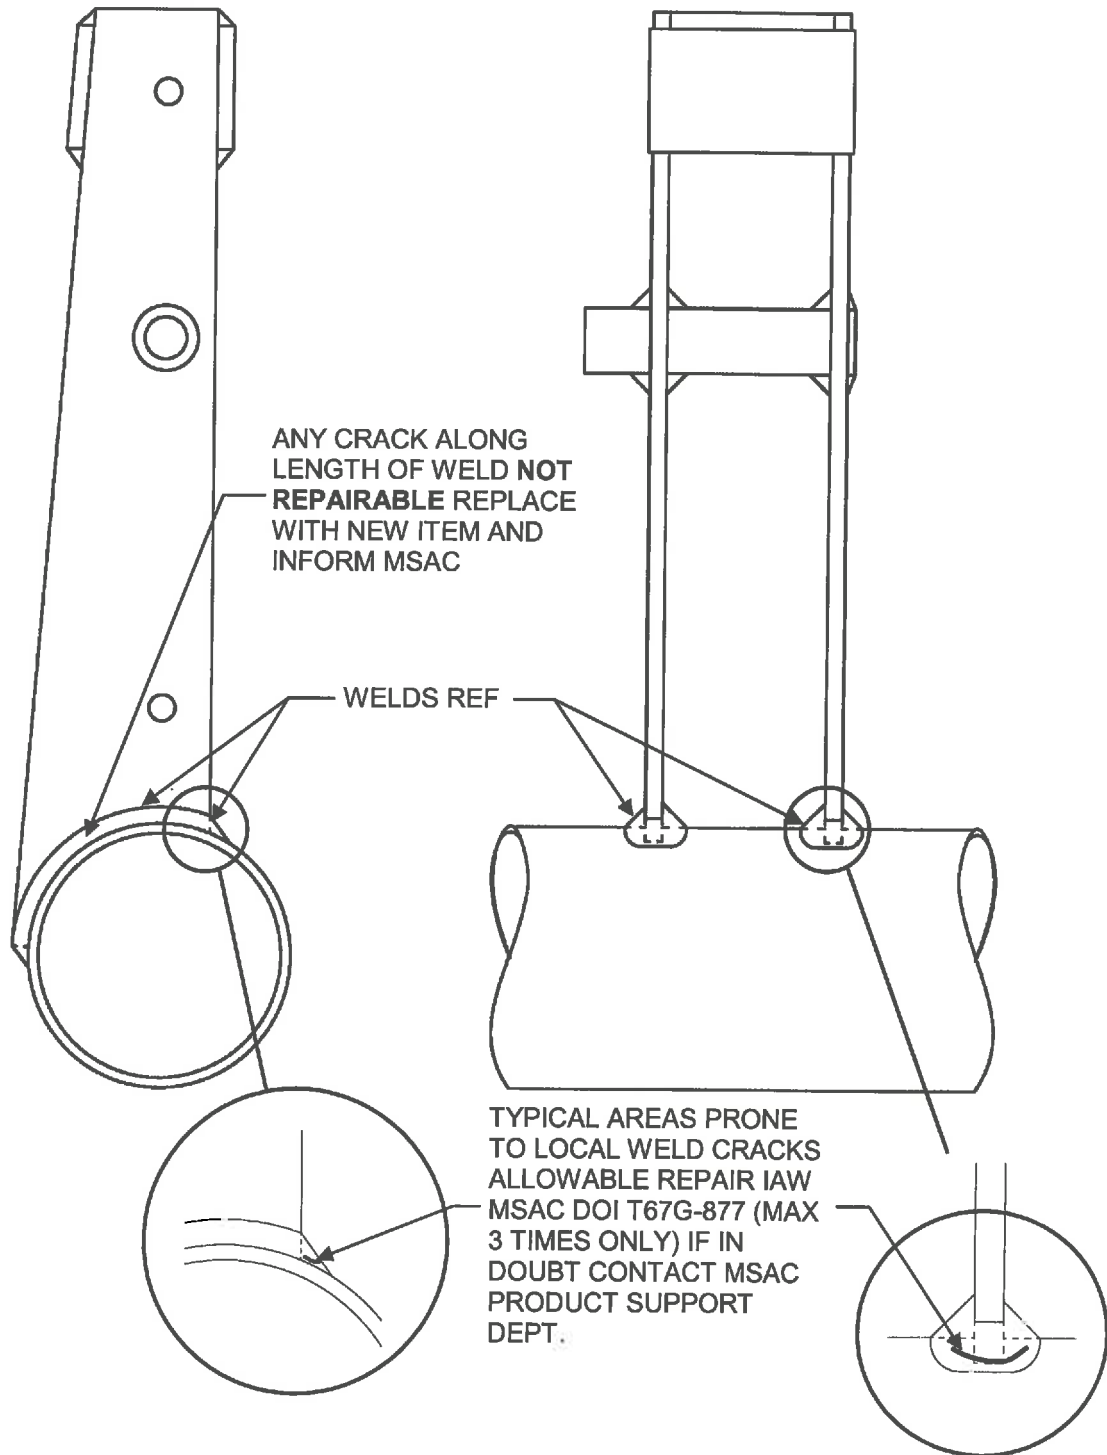
**FIGURE 15**

Note rudder bars may have minor cracks in the welds at the bases of the various lever positions Figure 15 refers. This is a known condition and can be returned to MSAC for repair or repaired IAW with DOI T67G-877 latest issue. Note each individual crack can only be repaired up to a maximum of 3 times. Record to be kept of weld repairs. Replacement bars T67M-45-257 and T67M-45-259 are available from MSAC product support.

**GENERAL PART VIEW ON RUDDER BAR T67M-45-257 OR T67M-45-259 TYPICAL LEVER POST POSITION SHOWING POSITION OF POSSIBLE CRACKING AND PERMITTED REPAIR**
