SERVICE BULLETIN

SB No. 91 Issue No. 1

TITLE INSPECTION OF TORQUE LINK MOUNTING LUGS SAB NOSE WHEEL LEG

T67A, T67B, T67C Series, T67M, T67M-MkII and T67M200.
 All Pre Mod M468, ie SAB undercarriaged aircraft.

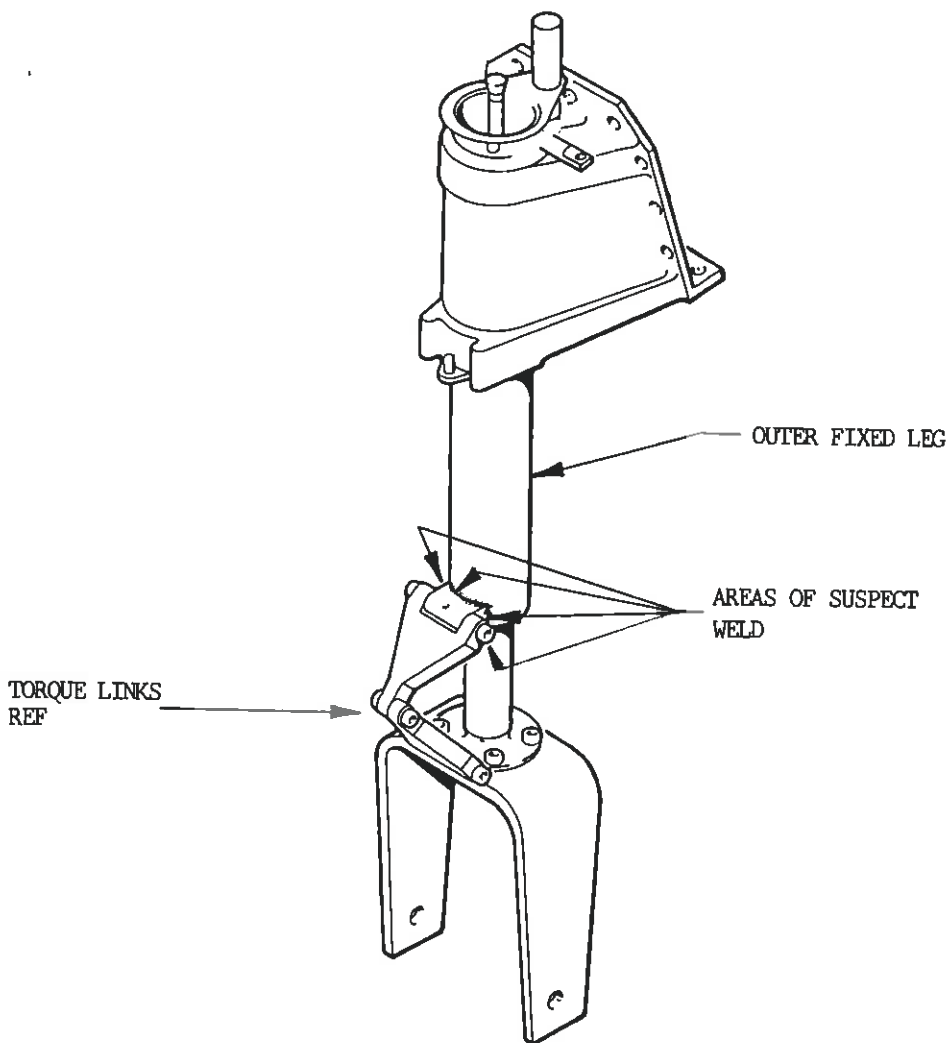
FIG 1
SAB NOSE LEG ASSY

A crack has been reported in the top torque link mounting block weld. Refer Fig. 1.

1. At or before next 50 hours and at 12 monthly intervals.
 - 1.1 a) With reference to Fig. 1 examine the block welded to the lower end of the outer fixed leg. Visually inspect welds around block if a crack is found in the paint covering the welds then continue as paragraph 1.2.
 - 1.1 b) If no crack is visible, aircraft to continue until next 50 hr check for a repeat visual check, ref. paragraph 1.1 a).
 - 1.2 Remove all paint from the area of the weld.
 - 1.3 Carry out a dye penetrant check of the weld area.

Note It is important that the whole area be thoroughly degreased to remove any hydraulic fluid before applying the dye and developer.

- 1.4 (a) If no cracks are found, re-protect with clear lacquer or equivalent and the aircraft may then continue to the next scheduled 50-hour check.
- (b) If any crack is found, the aircraft must not be flown until the component is repaired as in para. 2.

- 2.1 Remove the leg from the aircraft and disassemble in accordance with the appropriate T67 Maintenance Manual, Chapter 4.
- 2.2 Grind away the weld metal in the area affected by the crack(s), and carry out further dye penetrant checks and further removal of metal as necessary until all traces of the crack are removed.
- 2.3 Carry out a weld repair using argon arc (tig) to produce a fillet equivalent in area to at least the original weld.

The weld filler rod recommended is Bostran 41, (BS 2901, Part 1, A32) supplies of which are available from Slingsby Aviation.

- 2.4 Clean leg and repaint.
- 2.5 Reassemble the nose undercarriage in accordance with appropriate T67 Maintenance Manual, Chapter 4 and record repair.
- 2.5.1 If a leg which has been repaired and is subsequently found to have cracked again, it may not be repaired a second time, but must be replaced.
