SERVICE BULLETIN

SB No. 013

TITLE MAIN UNDERCARRIAGE TOP MOUNTING BLOCK

All T67B,M,M-MkII, and M200 aircraft post Mod M198A.

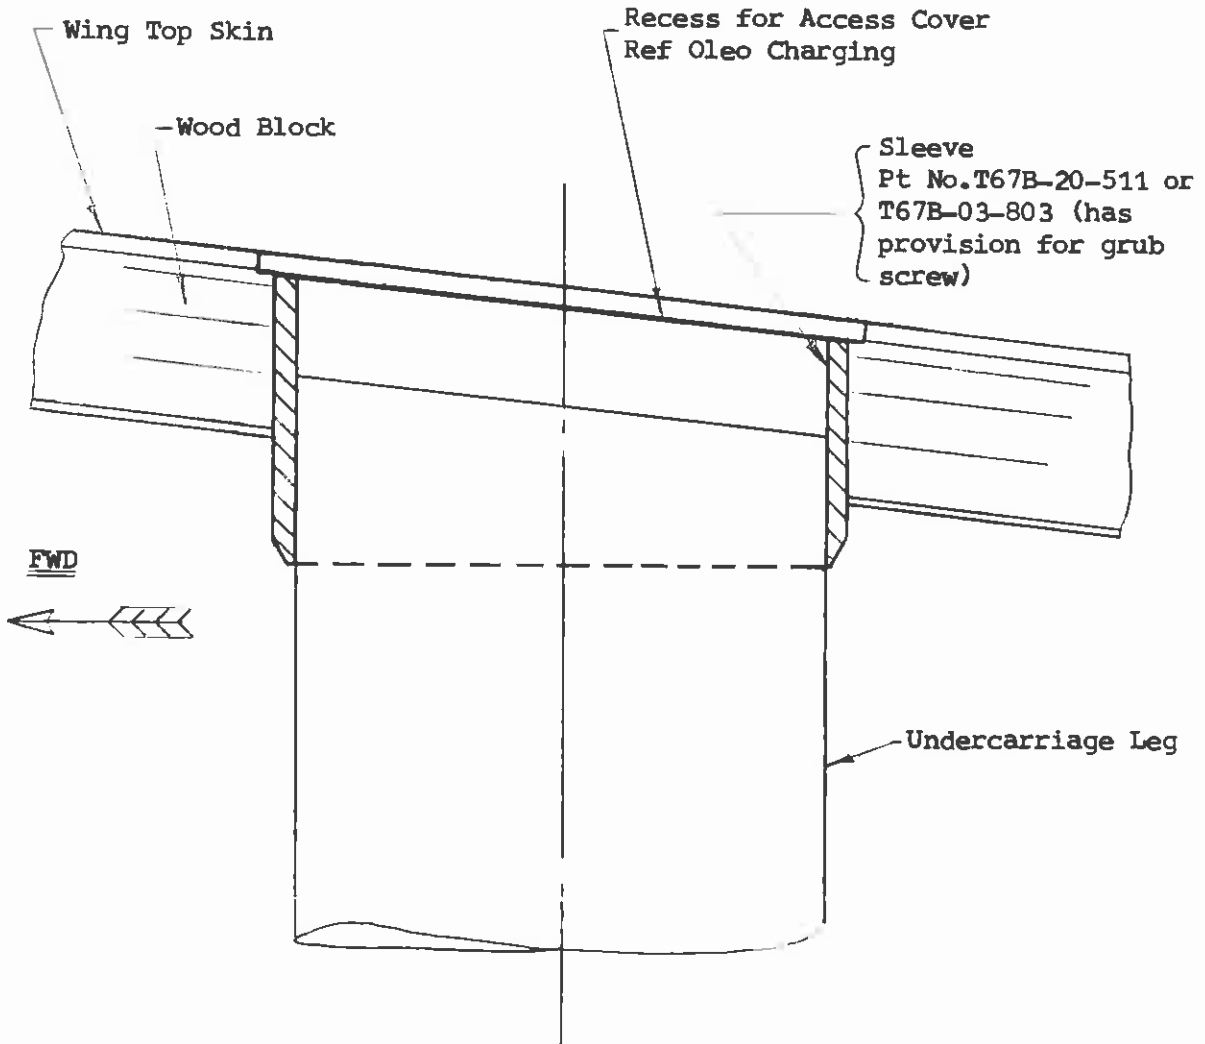
SECTION THROUGH UNDERCARRIAGE TOP MOUNTING
CORRECT POSITION OF SLEEVE

Instances have been reported where the reinforcing sleeve, introduced at Mod M198A has become detached from the plywood block forming the main U/C top mounting block, subsequently sliding down the main undercarriage leg. This leaves the undercarriage leg loose in the top housing.

1. Check that oleo cover (wing top surface) is located centrally in its recess ref. visual inspection.
2. If oleo cover is not located centrally - remove cover.
3. Visually inspect the steel sleeve for correct position and for consistency of bond - see attached sketch for correct position.
4. If any fault is found at the above inspection, Ref. 3, the aircraft is to be grounded, the undersigned contacted immediately so that Mod M239A, introduction of grub screw into sleeve, may be applied.
