SERVICE BULLETIN

SB No. 52 Issue No. 2

TITLE
ELEVATOR HORN WATER INGRESS

All T67 GRP series aircraft.

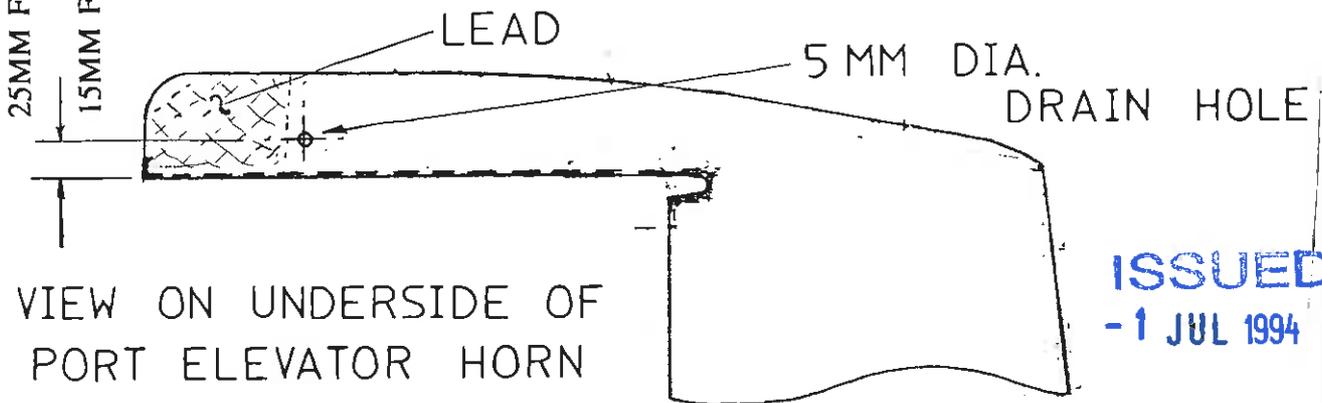
VIEW ON UNDERSIDE OF
PORT ELEVATOR HORN
FIG. 1

An annual inspection on an elevator had found a quantity of water inside the horn balance.

25MM FOR T67B AIRCRAFT
15MM FOR ALL OTHER TYPES

1. Deflect elevators to up position.
2. By tapping the inside face of the horn balance with a coin, the position of the lead balance weight can be ascertained.
3. Ref. Fig 1 drill 5mm dia hole in the lower skin of the horn in the hollow portion as close to the lead balance as possible.
4. Check the condition of the vinyl disc T67B-00-301 which covers the elevator hinge pivot. Renew as necessary.
