Service Bulletin

S.B. No: 168

Title: INSPECTION OF COCKPIT FLOOR BENEATH PORT RUDDER BAR SUPPORT BRACKET

Applicability: T67B, T67C, T67M, T67M-MkII, T67M200, T67M260 and T67M260-T3A

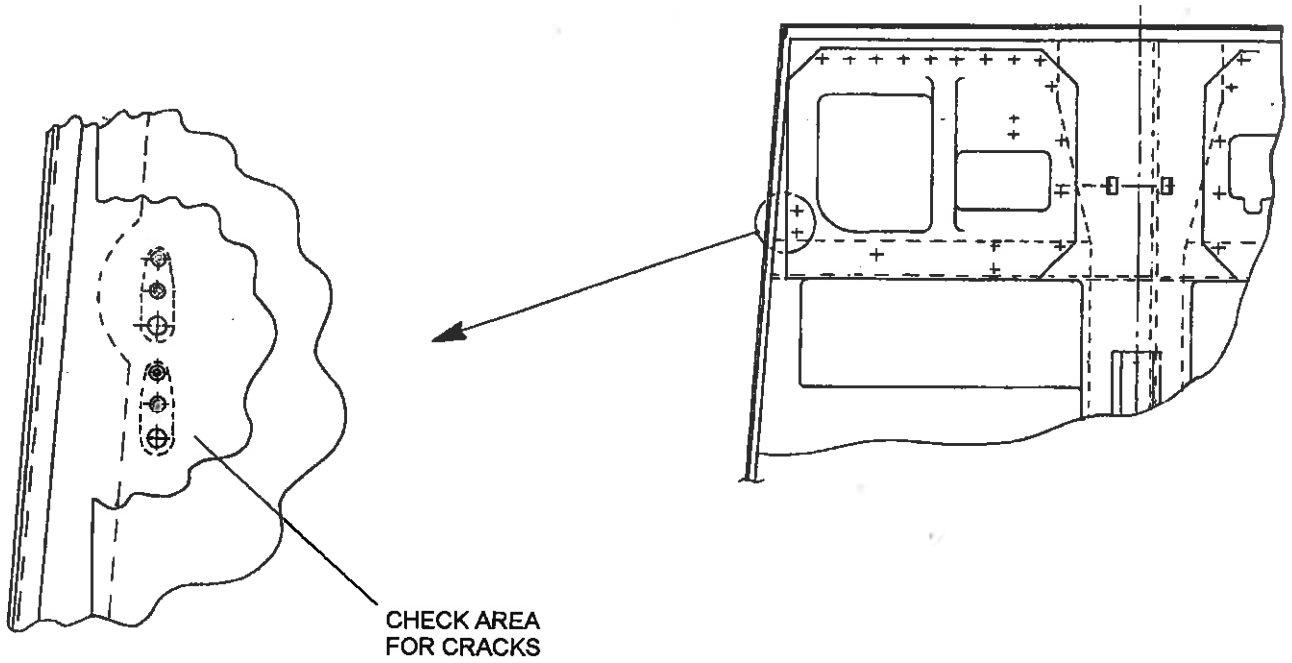
FIGURE 1 CRACK INSPECTION

A case has been reported of damage occurring to the GRP beneath the port rudder bar support bracket and floor panel in the region of the anchor nuts.

1. Check master switch, ignition switch and fuel are OFF. Disconnect external power and hangar aircraft if required.
2. Remove rudder pedals and bars.
3. Remove port floor panel.
4. Perform visual inspection for crack in GRP in region of the two anchor nuts directly below the port rudder bar support bracket and floor panel (ref Figure 1).
5. If signs of cracking exist repair area and install strengthening doubler in accordance with DOI T67C-149 (Ref Mod M919).
6. Following repair in accordance with DOI T67C-149, annotate logbook "SB 168 complied with Mod M919 incorporated."
7. If no cracking was found, then inspection Stage 4 of this Service Bulletin must be repeated at each annual inspection until Mod M919 is incorporated.
