## Service Bulletin

S.B. No: 153

**Title:** SAB UNDERCARRIAGE NOSEWHEEL FORK INSPECTION**Classification:** This Service Bulletin has been classified by SAL as Recommended**Compliance:** At next 150 flying hour check**Applicability:** T67A Post Mod M136A, (SAB T9S), Pre Mod M468 and M791 (Introduction of Fairey Undercarriage) T67B, T67C Series, T67M, T67M-MkII and T67M200

This Issue 2 adds T67A and caters for gaps greater than 4mm Mod M998.

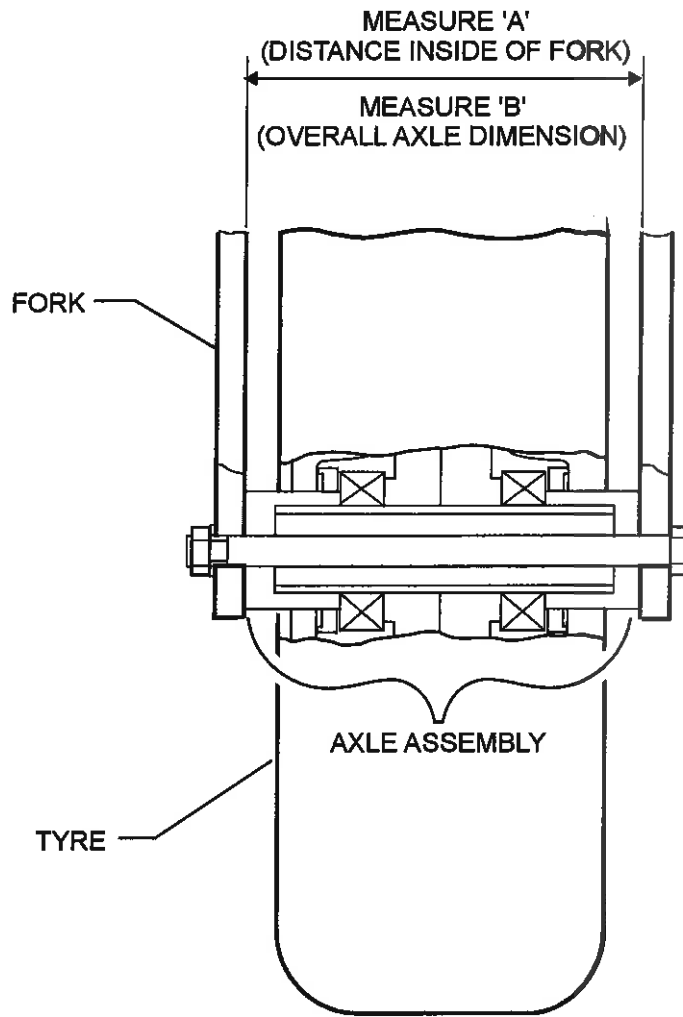
**FIGURE 1**

Cases have been reported of the space between the SAB nose undercarriage forks and the wheel axle being sufficiently wide to cause the forks to bend inwards when tight and ultimately cause the axle nut to loosen. This SB requires a one time inspection to determine the width of the gap and fitting of corrective spaces as applicable.

7.
  - i. If the difference between the two dimensions is less than 15mm, then no further action need be taken.
  - ii. If the difference between the two dimensions is 1.5mm to 4.0mm, then Mod M832 is to be incorporated.
  - iii. If the gap is between more than 4.00mm and 8.0mm, then Mod M998 is to be incorporated.
  - iv. If the gap is more than 8.0mm, then new fork is to be procured.
8. Annotate logbook "SB 153 complied with."
