# SERVICE BULLETIN

SB No. 003

Bendix Magneto Impulse Couplings.

# Service Bulletin

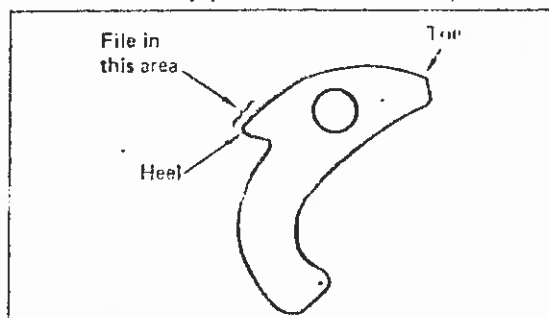
Figure 1

Some improperly heat treated (soft) flyweights have been reported on impulse couplings currently in service. If this condition exists and is not detected, impulse coupling failure could occur, causing possible engine damage or failure. The flyweights must be inspected in accordance with the instructions in this Service Bulletin and if defective (soft) the im-

1. Following published procedures remove the magneto from the engine.
2. Place the magneto in a suitable work stand with the impulse coupling facing up.
3. Use finger pressure to push inward on the toe (see figure 1) of each flyweight so that the flyweight heel protrudes outward.
4. Using a fine # 1, double cut, 1/2 inch wide file, at least 3/32 inch thick, pass the file across the heel of the flyweight attempting to remove material. (See figure 1). If the flyweight has been properly heat treated the file will "glide" smoothly over the heel of the flyweight, removing no material. If the flyweight is not properly heat treated (soft), the file will not "glide" easily across the surface of the flyweight heel, and material will be removed.

5. If an improperly heat treated (soft) flyweight is found, immediately remove and replace the cam assembly and/or the impulse coupling assembly following procedures in the magneto overhaul instructions, and paying strict attention to notes and cautions.
6. Inspect the impulse coupling stop pins for wear and replace as necessary.
7. After flyweights and stop pins have been inspected and the impulse coupling reinstalled on
