Service Bulletin

S.B. No: 172

Title: INSPECTION OF FLAP DRIVE TORQUE TUBE

Applicability: T67A, T67B, T67C, T67M, T67M-MkII, T67M200, T67M260 (Pre Mod M950) and T67M260-T3A

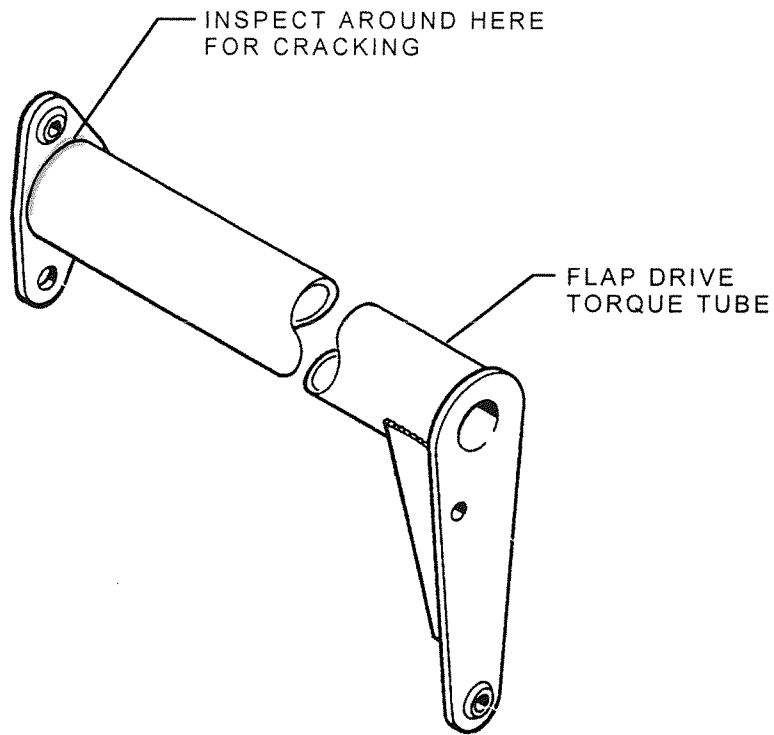
FIGURE 1

A case has been reported of a crack on the flap drive torque tube, pivot to tube brazed joint located at the inboard end of the torque tube.

1. Gain access to the inboard end of the flap drive torque tube.
2. Visually inspect for signs of cracking, i.e. flaked paint etc. in area indicated ref. Figure 1. If in doubt remove paint locally and use dye penetrant as required.
3. If no cracks are present, annotate logbook "SB172 complied with". Note if paint removed, clean and repaint.
4. If cracking is present, obtain new welded item T67G-45-243/244 from Slingsby Aviation Limited. Annotate logbook "SB 172 complied with, Mod M948 invoked".
