Service Bulletin

S.B. No: 169

Title: INSPECTION OF ENGINE AIR INTAKE DUCT MESH AND ALTERNATE AIR DOOR

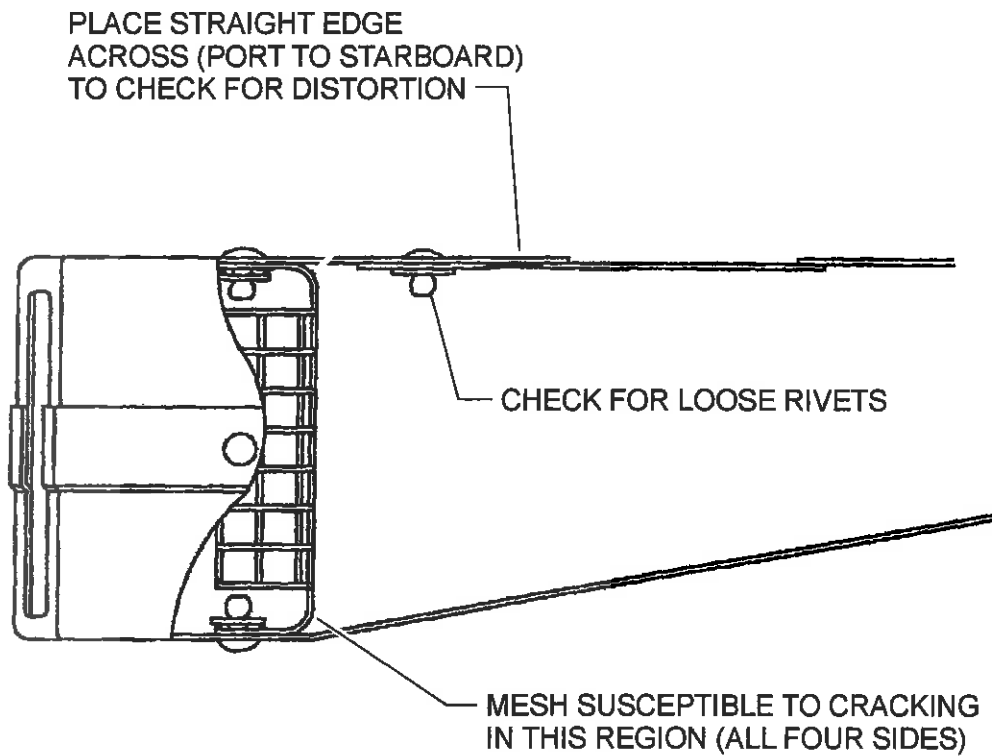
FIGURE 1 AIR INTAKE DUCT T67M-50-101

4. Pre Mod M760, part no. T67M-50-101, Ref. Figure 1:
 - 4.1 Inspect mesh within intake duct for cracking and loose retaining rivets.
 - 4.2 Inspect riveted joint between alternate air door and intake duct for condition and any signs of movement. Movement of alternate air door should be smooth throughout its normal travel.

- 4.3 Place straight edge across top of air duct adjacent to the alternate air door retaining rivets and check for distortion. Any distortion of this face will effect the alternate air door operation.

- 4.4 Should inspections at paragraphs; 4.1, 4.2 and 4.3 be considered to be unsatisfactory, then return intake duct assembly to SAL for modification to Post Mod M760B/M933 standard. Incorporation of Modifications M760B and M933 satisfy the requirements of this Service Bulletin.

- 4.5. Should all inspections at paragraphs; 4.1, 4.2 and 4.3 be considered satisfactory, then proceed as follows:
 - 4.5.1 Repeat inspections as required by paragraphs 4.1, 4.2 and 4.3 of this Service Bulletin every 50 flying hours until modifications M760B/M933 are accomplished. Incorporation of modifications M760B and M933 satisfy the requirements of this Service Bulletin.

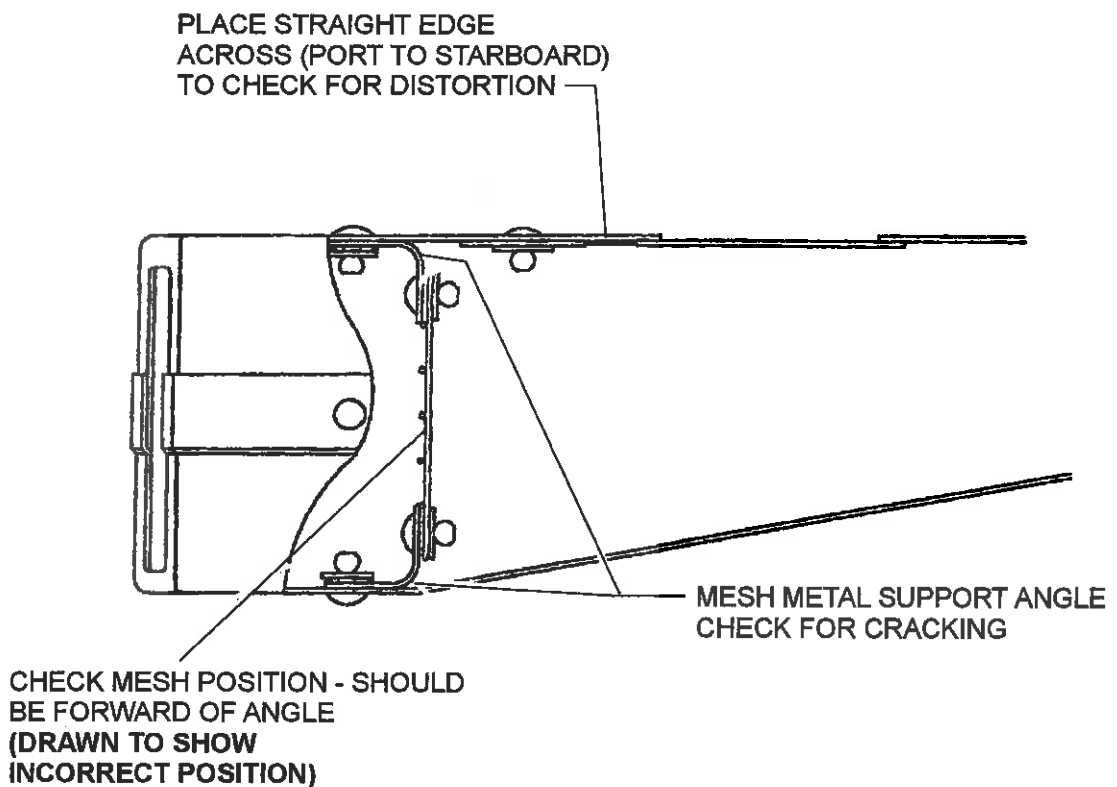
FIGURE 2 AIR INTAKE DUCT T67M-50-103

5. Post Mod M760, Part No. T67M-50-103, Ref. Figure 2:
 - 5.1 Inspect aluminium alloy mesh support angle for cracking.
 - 5.2 Inspect for position of mesh and security, should be forward of support angle. If mesh noted to be aft of angle, then check for security every fifty flying hours until Mod M933 incorporated, ref. paragraph 5.3 below.

- 5.3 Should inspection at paragraph 5.1 reveal any cracking in the angle, then angle is to be replaced with composite angle in accordance with Mod M933. Return duct to SAL for Mod M933 incorporation. Incorporation of Modification M933 satisfied the requirements of this Service Bulletin.

- 5.4 If no cracking is found, ref. paragraph 5.1, then inspect every fifty flying hours until modification M933 is incorporated. Incorporation of Modification M933 satisfies the requirements of this Service Bulletin.

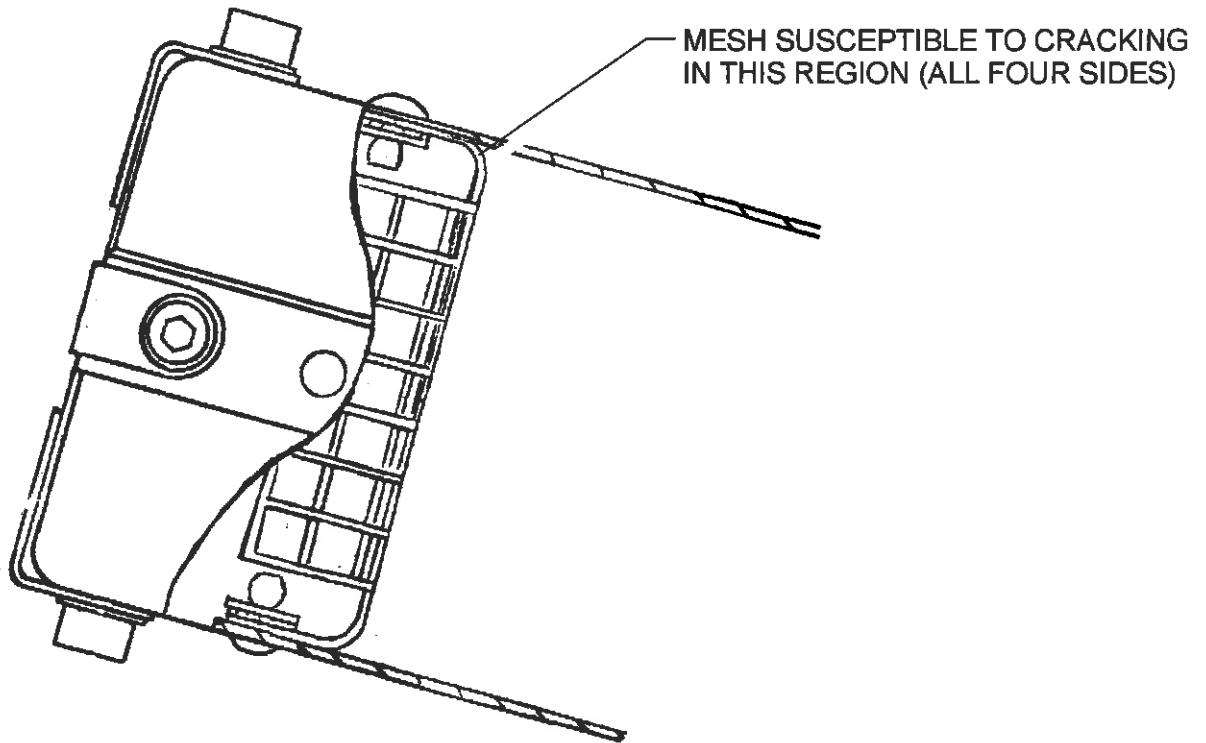
FIGURE 3 AIR INTAKE DUCT T67G-50-107

6. Pre Mod M759, part no. T67G-50-107, ref. Figure 3:
 - 6.1 Inspect mesh within intake duct for cracking and loose retaining rivets.
 - 6.2 Should inspection at paragraph 6.1 be considered to be unsatisfactory, then return intake duct assembly to SAL for modification to Post Mod M759B/M933 standard. Incorporation of Modifications M759B and M933 satisfy the requirements of this Service Bulletin.
 - 6.3. Should inspection at paragraph 6.1 be considered to be satisfactory, then proceed as follows:
 - 6.3.1 Repeat inspections as required by paragraph 6.1 of this Service Bulletin every fifty flying hours until modifications M759B/M933 are accomplished. Incorporation of modifications M759B and M933 satisfy the requirements of this Service Bulletin.

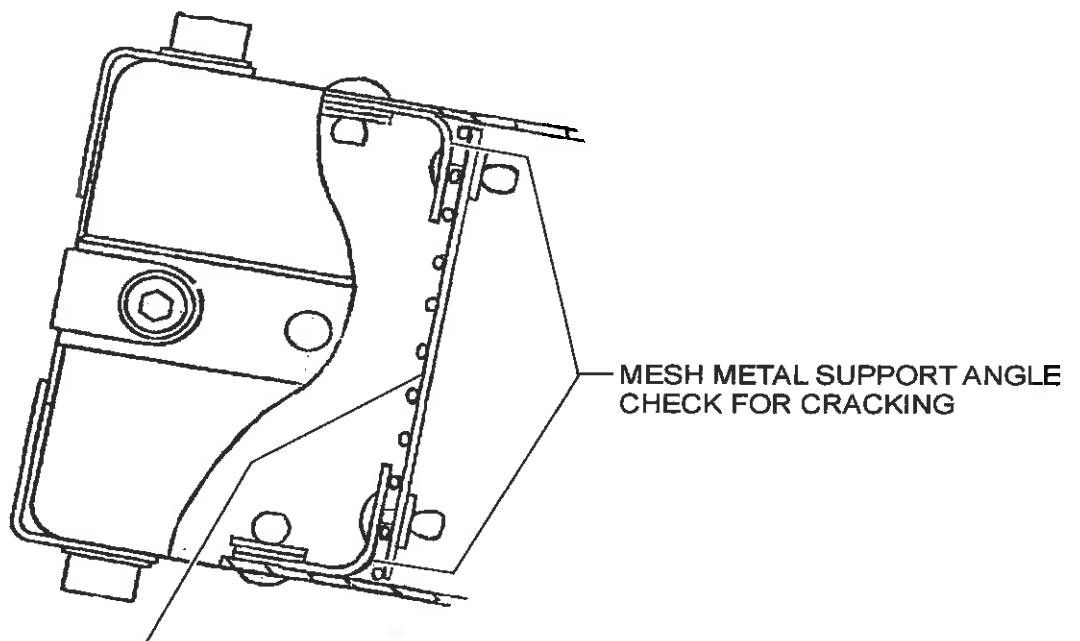
FIGURE 4 AIR INTAKE DUCT T67G-50-109

7. Post Mod M759, Part No. T67G-50-109, ref. Figure 4:
- 7.1 Inspect aluminium alloy mesh support angle for cracking.
 - 7.2 Inspect for position of mesh and security, should be forward of support angle. If mesh noted to be aft of angle then check for security every fifty flying hours until Mod M933 incorporated, ref. paragraph 7.3 below.

CHECK MESH POSITION - SHOULD
BE FORWARD OF ANGLE
(DRAWN TO SHOW
INCORRECT POSITION)

- 7.3 Should inspection at paragraph 7.1 reveal any cracking in angle, then angle is to be replaced with composite angle in accordance with Mod M933. Return duct to SAL for Mod M933 incorporation. Incorporation of Modification M933 satisfies the requirements of this Service Bulletin.

- 7.4 If no cracking is found, ref. Paragraph 7.1 then inspect every 50 flying hours until modification M933 is incorporated. Incorporation of Modification M933 satisfies the requirements of this Service Bulletin.
