SERVICE BULLETIN

SB No. 69 Issue No. 1

INSPECTION OF ELECTRIC TRIM SWITCH HOLDER

T67M260-T3A and T67 Series Post Mod M443 (Electric Trim).

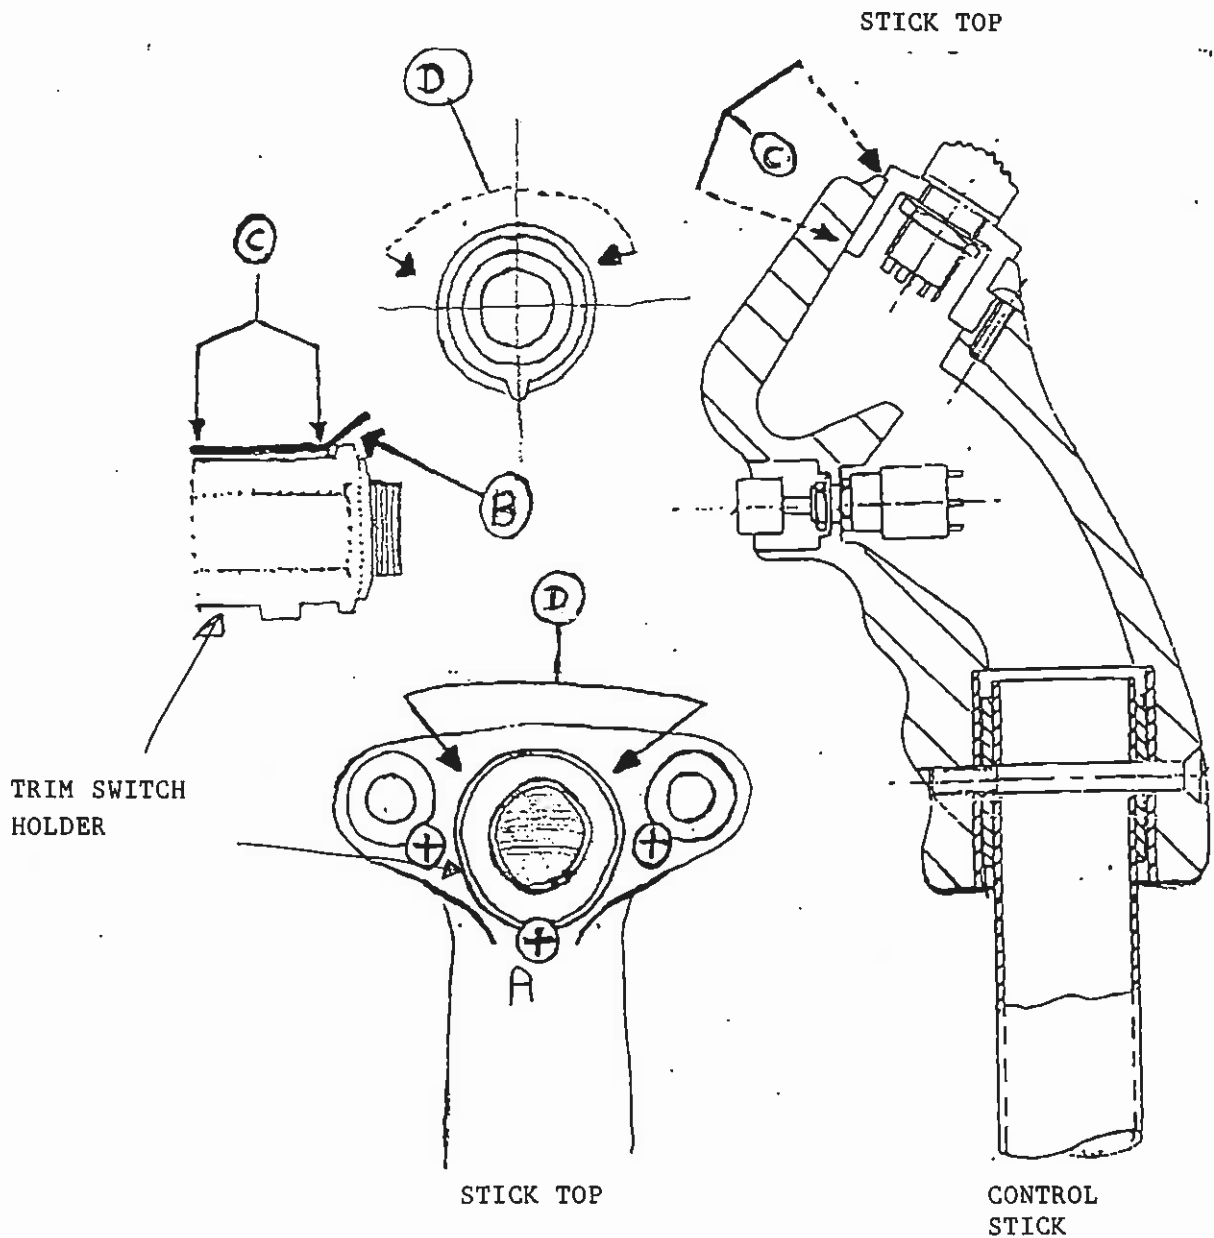
Some aircraft have been found to have trim switch holders which are a loose fit in the stick top.

Often, if the trim switch holder clearance is excessive, the holder will tend to rock upwards at a point opposite the fixing screw. The wires connected to the rear of the trim switch exert the slight force required to cause this.

The width of the heatshrink will determine how much shimming will occur around the circumference of the switch. Once it has been determined how wide the heatshrink will need to be for shimming it will be bonded to the switch (See Dimension 'D').

- 1) Remove central securing screw ('A' on Diagram) and remove holder and trim switch complete being careful not to break wire connections.
- 2) Cut heatshrink (Part No. 126-36-028) to a length so as to allow for handling during installation as illustrated by view B and dimension C.
- 3) Cut heat shrink to width required.

- 4) Bond heatshrink to switch holder using Permabond 126-51-206.
- 5) Trim excess heatshrink flush with shoulder at top of holder.
- 6) Refit holder compete with trim switch into stick top and secure with securing screw 'A'. Take care when re-installing wiring that no wires are trapped or excessively bent, or that connections are not overstrained.
- 7) Annotate aircraft log book "Service Bulletin No.69 complied with".
- 8) If this procedure fails to solve the problem of loose trim switch holder, please contact Slingsby aviation.
