**SERVICE BULLETIN**

SB No. 034

RUDDER UPPER AND LOWER HINGE SUPPORT ANGLES - INSPECTION

All T67 variants.

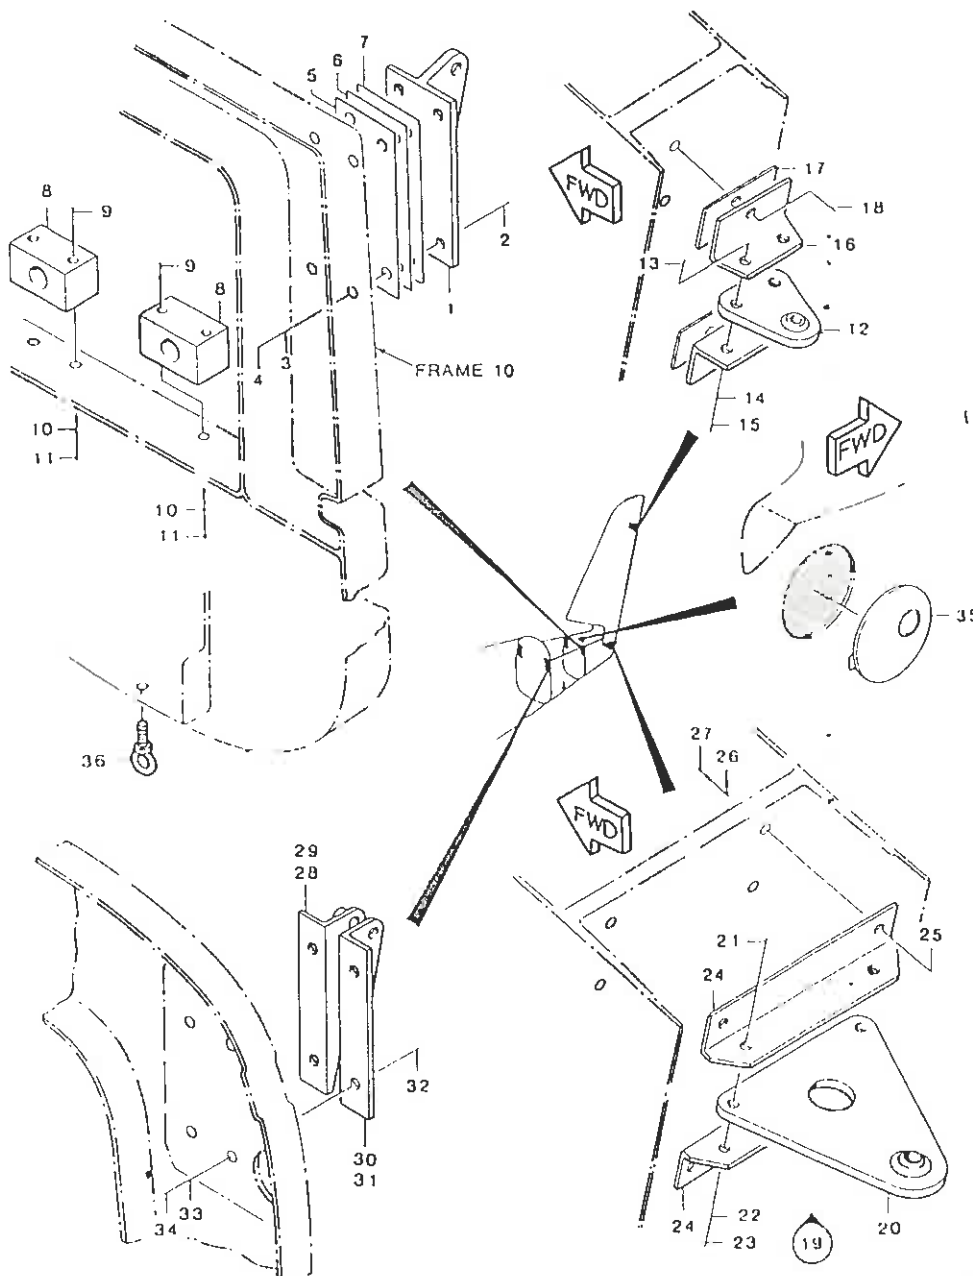
Isolated incidents of exfoliation corrosion have been reported on rudder hinge brackets (ref. 16 and 24).

1. Inspect the rudder hinge angles, 4 off in total, for exfoliation corrosion.
2. If any exfoliation corrosion is found, contact Slingsby Aviation Product Support Dept.

Note: Mod M394 introduces anodised rudder hinge angles.
