Service Bulletin

S.B. No: 187

Title: INSPECTION FOR CLEARANCE BETWEEN RUDDER PEDAL AND MIXTURE/PROP. SPEED BRACKET. ALSO INCLUDES GENERAL RUDDER PEDAL CLEARANCES.

Applicability: T67M200 (Works No. 2264 & 2265 only) and T67M260

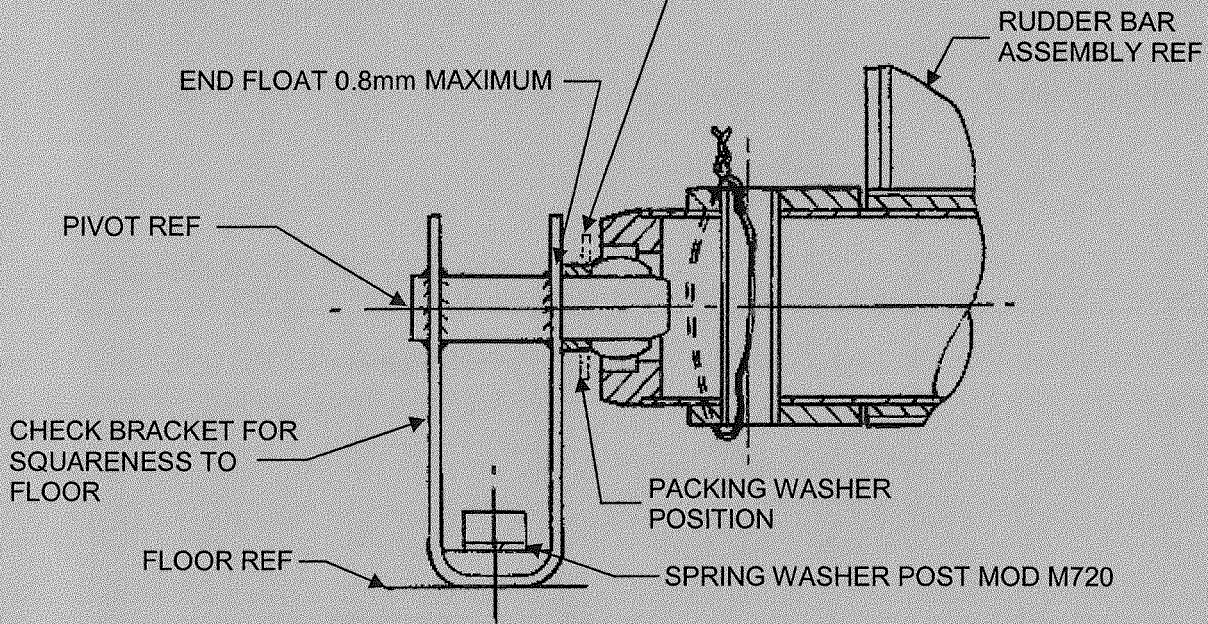
FIGURE 2

4. Check rudder pedal bar end float is no greater than 0.8mm. If it is greater than 0.8mm then rectify end float IAW paragraph 9. Refer Figure 2.
5. Check that the Rudder Pedal bar port outboard support bracket, ref. Figure 4, is square to floor and not "lozenged" and there is no deformation to its base. Check floor panel under area of bracket, inspect for cracking which could allow the bracket to lean. If necessary remove floor panel and check for signs of cracking in the floor around the anchor nuts on Pre Mod M919 aircraft or the anchor nut mounting plate Post Mod M919 aircraft, refer Figure 3. Any GRP damage will be shown as a white shadow on the GRP, with cracking felt as a rough edge. A light shining up through the floor will show a shadow.

9. Referring to Figure 2 ensure at each rudder bar pivot position that there is one spacer T67M-45-507 OR one off washer 126-23-748 and up to a maximum of two off washers 126-23-749, i.e. 3 washers maximum.

If end float greater than 0.8mm, then 1 off packing washer may be added at each pivot position as required, i.e. 126-23-105 washer or 126-23-748 washer or 126-23-749 washer.

If packing washers are required on the right hand rudder bar (T67M-45-259), then the packing washer, (or the thicker washer if a thick and thin washer are required) should be placed at the outboard pivot. When end float of 0.8mm maximum is achieved, ensure that the brake cylinders are not subject to undue side load. If in doubt, contact SACL.

Note; it is imperative that the combination of packing washers is adhered to as any more than the stated amount may allow the rudder bar mounting bracket pivots to become out of safety.

RUDDER BAR END FLOAT AND ITS SUPPORT BRACKET

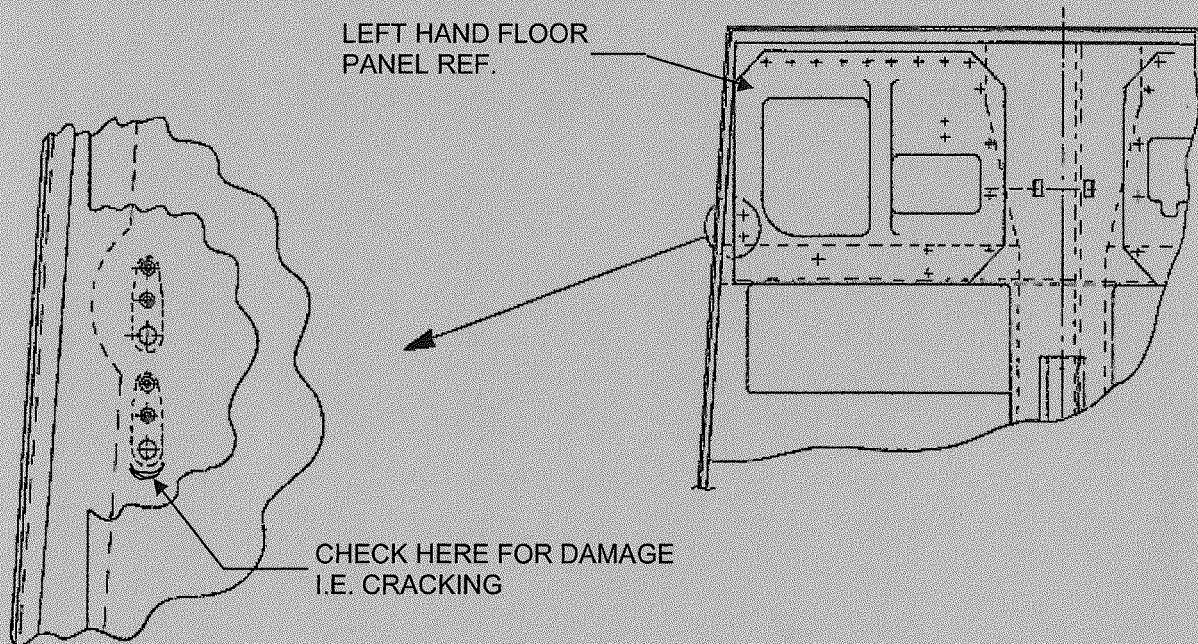
FIGURE 3

AREA OF FLOOR REQUIRING INSPECTION (PRE MOD M919 DRAWN)

6. If floor is found to be cracked or broken then repair IAW DOI T67C-149 incorporating Mod M919. If Mod M919 has been previously incorporated and floor is damaged, inform SACL.

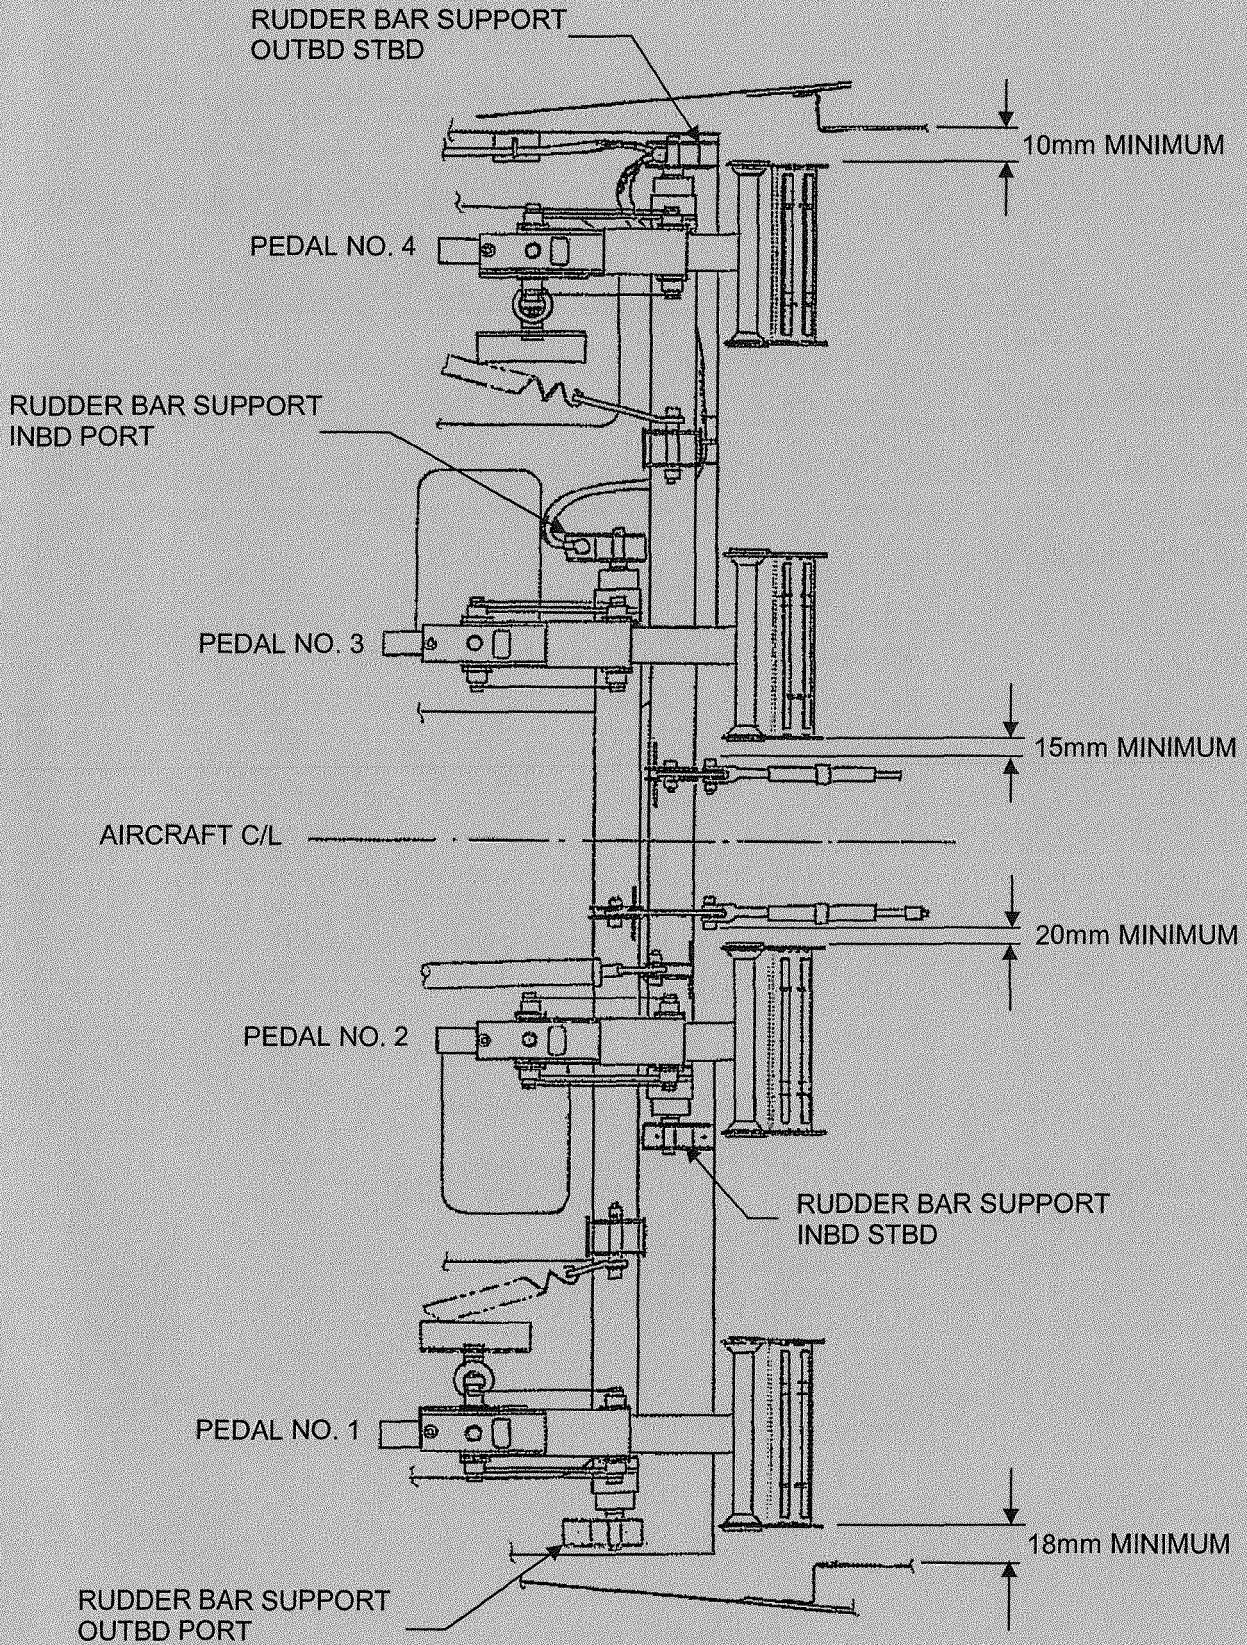
FIGURE 4

8. Check the remaining rudder bar support brackets, ref. Figure 4, are square to floor and not "lozenged" and there is no deformation to their bases. If any bracket is found to be suspect replace with new item. Inform SACL of any damaged bracket. Assemble item as per paragraph 7 and ensure end float is as stated in paragraph 9. Ensure bonding leads are correctly fitted, carry out bonding check refer relevant aircraft's Maintenance Manual.

13. Upon completion of rudder movement set-up ref. Paragraph 11 above, ensure minimum clearances of trim panel to pedal side plates and rudder cable to pedal side plates are met Refer Figure 4. Refer paragraph 9 for packing washers.

RUDDER PEDAL CLEARANCES TO SIDE PANEL AND RUDDER CABLES

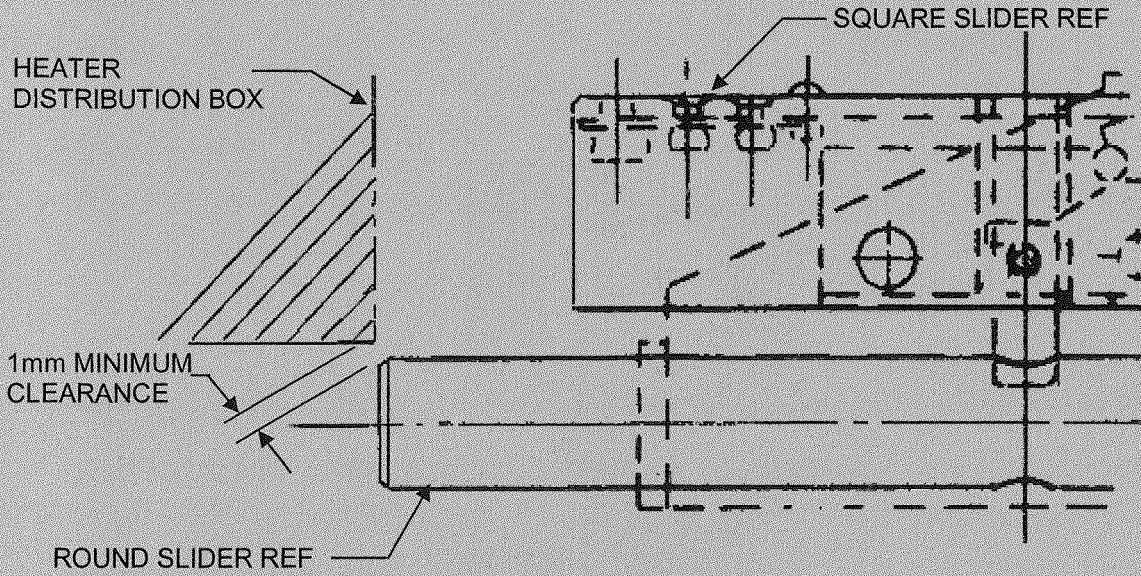
FIGURE 5

14. Ensure clearance of the no. 2 pedal slider to heater box clearance, is greater than 1mm, Figure 5 refers. Inform SACL if clearance is not achievable.

PEDAL NO. 2 TO HEATER BOX CLEARANCE

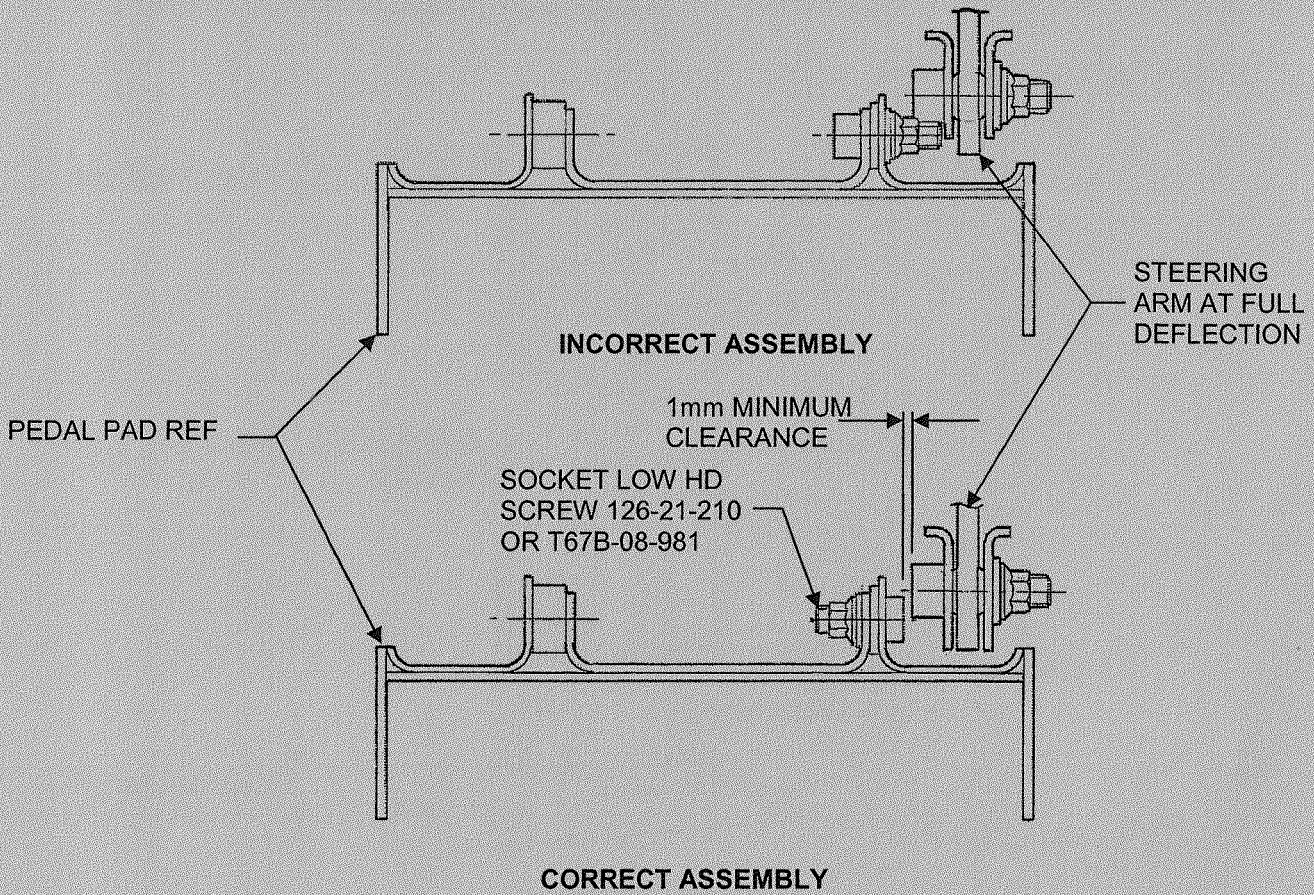
FIGURE 6

17. Ensure head orientation of rudder cable link low pan head bolt T67M-45-570 is outboard. T67M260 Maintenance Manual Figure 5-7 refers.
18. Ensure Pedal no 2 Pedal pad pivot bolt head height is less than 5mm and orientated, as shown in Figure 6. A minimum of 1mm clearance is required, if not, fit part no 126-21-210 or T67B-08-981, this invokes Mod M671 "Introduction of Low Head Rudder Pedal Pad Pivot Bolts – Pedal No. 2".

PEDAL NO. 2 TO STEERING ARM INTERFACE

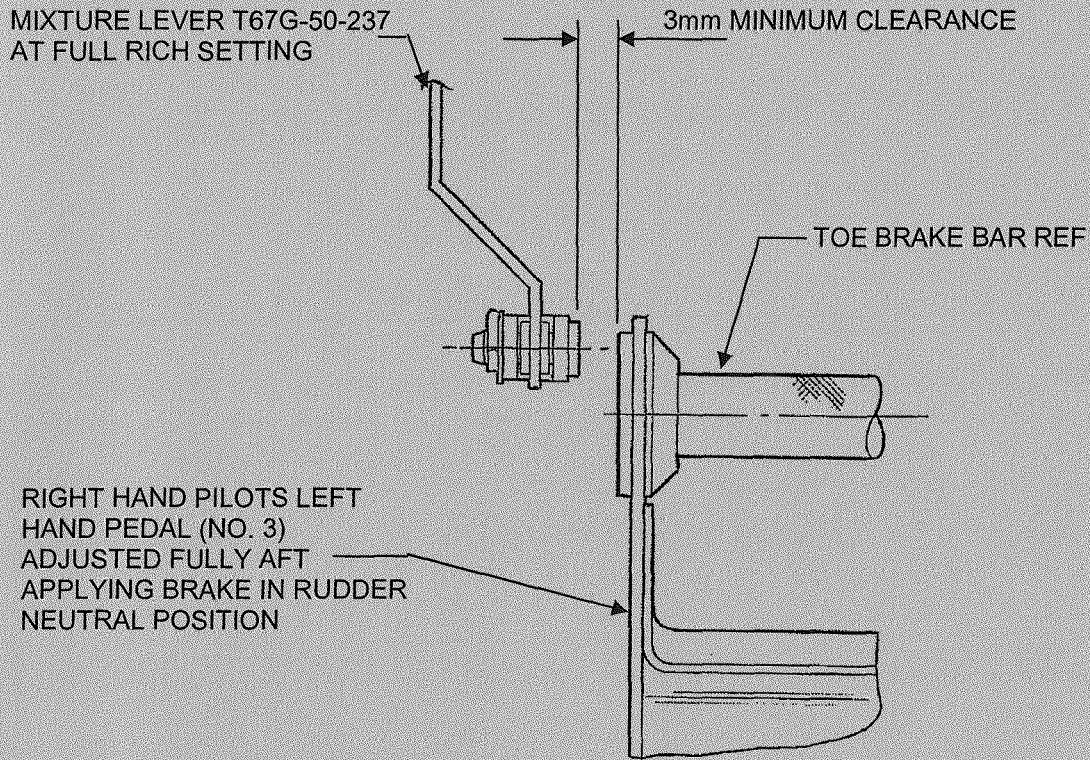
FIGURE 7

19. Ensure that the requirements of SB 99, "Inspection and Rectification of Rudder Pedal Sliders", has been achieved.
20. Ensure, that a minimum clearance of 3mm is achieved between Pedal No 3 and Mixture Lever operating arm, refer Figure 7. Refer paragraph 9 for packing washers.

VIEW LOOKING FORWARD ONTO NO.3 RUDDER PEDAL
