SERVICE BULLETIN

SB No. 130 Issue No. 1

TITLE INSPECTION OF RUDDER PEDALS FOR ADJUSTMENT RESTRICTION
CLASSIFICATION

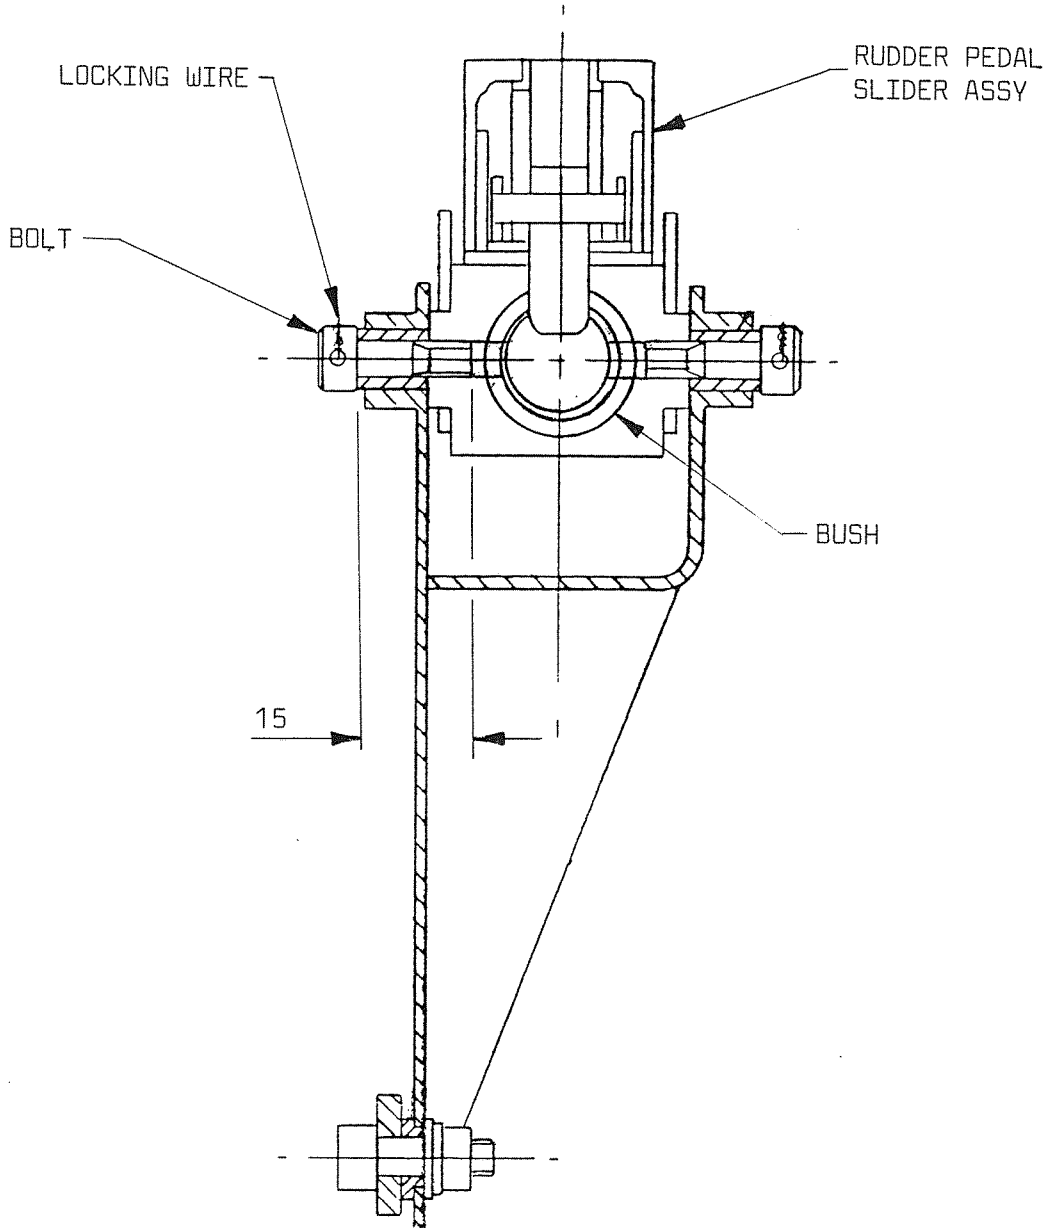
Fig 1
VIEW ON RUDDER PEDAL SLIDER HOUSING

A case has been reported of the pivot bolt fouling the rudder pedal slider assembly, preventing proper adjustment.

1. Inspect the rudder pedal assembly and check for full, free and smooth movement of adjustment slider.
2. If slider movement is restricted or appears stiff, inspect slider bush and pivot bolts for any visual signs of fouling, ref. Fig. 1.
3. If fouling occurs, adopt the following procedure:
 - i) Remove bolt or bolts that are fouling and shorten by 1mm to 15mm nominal length from bottom of head. Etch prime the cut face of the bolt.
 - ii) Ream out internal diameter of bush to 16.00mm - 16.05mm to remove any deformation caused by fouling.
 - iii) Replace shortened bolt and renew locking wire.
4. Alternatively, invoke Mod M808 to replace all pivot bolts.
5. Annotate log book "SB 130 complied with".
