# Service Bulletin

S.B. No: 125

**Title:** INSPECTION OF WIRING LOOMS AT REAR OF INSTRUMENT PANEL FOR CHAFING

**Applicability:** T67A, T67B, T67C Series, T67M, T67M-MkII, T67M200, T67M260 and T67M260-T3A

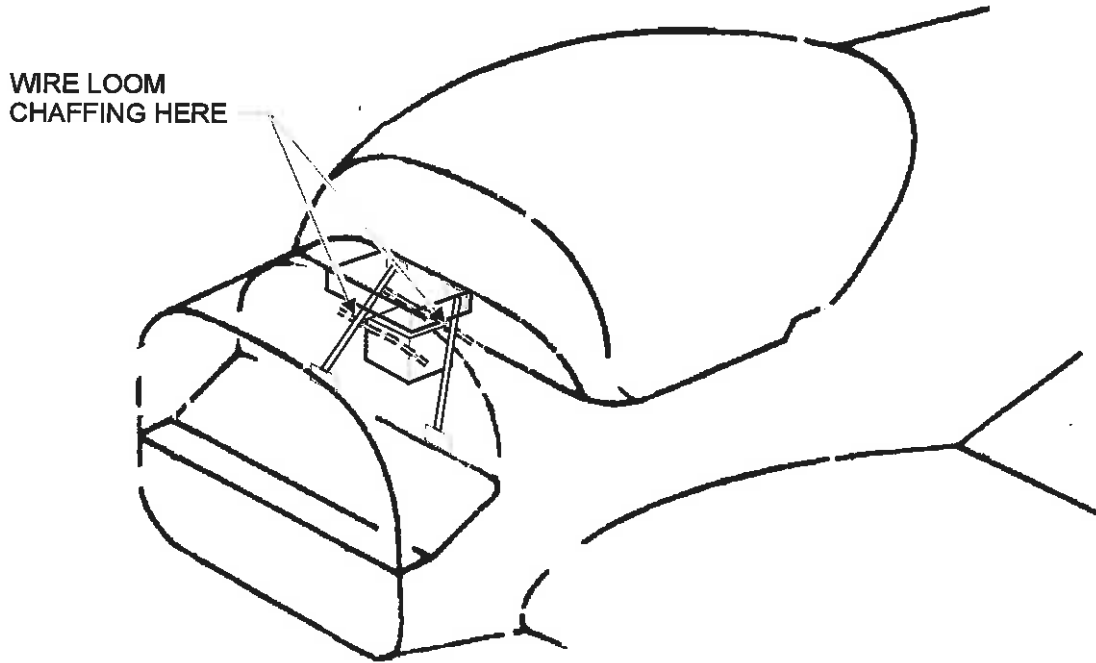
FIGURE 1

Cases have been reported of wiring looms to the rear of the Comm/Nav panel chafing to the point of bare wires shorting on the strut preform support, Part No. T67G-10-553, on the T67M260-T3A. Additionally, cases have been reported of instrument mounting GRP preform chafing instrument panel loom and causing fuel pump malfunctions.

1. Gain access to the rear of the instrument panel.
2. Inspect looms for signs of chafing or the possibility of chafing by the equipment racks, support struts or preform edges, ref. Figure 1.
3.
  - i. Any wires found damaged beyond the outer jacket should be replaced or repaired as necessary. Ensure loom is repositioned to minimise chafing.
  - ii. A loom identified as in danger of chafing should be repositioned, secured and protected with spiral wrap or other anti-chafing material.
4. Maintenance Manual will add wiring/loom checks with regard to inspection for chafing at next amendment.
5. Annotate Log Book "SB 125 complied with".
