SERVICE BULLETIN

SB No. 132 Issue No. 1

TITLE INSPECTION FOR WATER IN BUMP STOP

T67M260 and T67M200 (Post Mod M675).

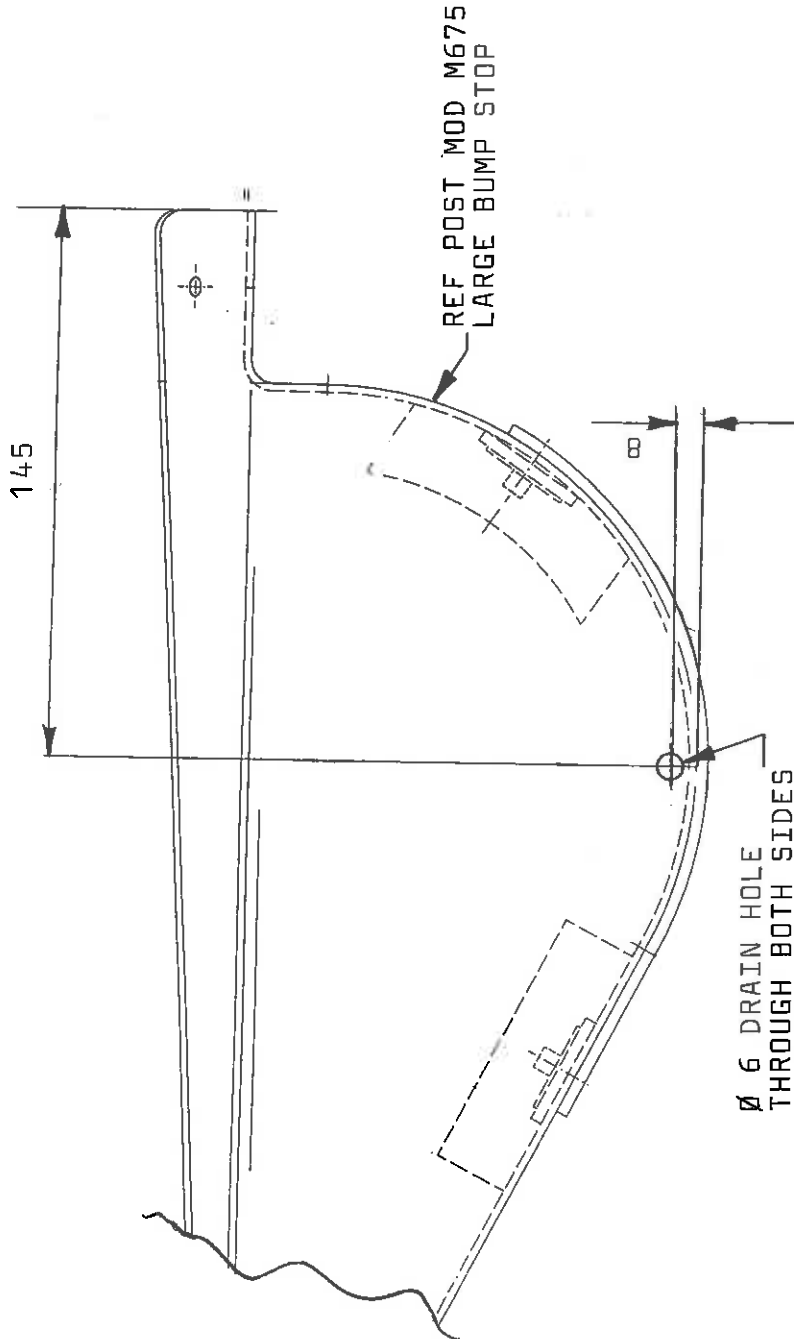
FIG 1 ENLARGED
LOCATION OF BUMP STOP DRAINAGE HOLE

A case has been reported of water collecting in the bump stops of the T67M200 Post Mod M675 large rudder and T67M260 aircraft.

1. Drill 6mm dia hole through both sides of the bump stop in the position shown in Fig.1.
2. Ensure no water remains in bump stop.
3. T67M200 (Post Mod M675) only
 - (i) Inspect fuselage drainage hole and ensure it is not covered by the bump stop.
 - (ii) If drainage hole is covered by bump stop, drill a new hole in the position shown in Fig.2.
4. Annotate Log Book "SB 132 complied with".
