**SERVICE BULLETIN**

SB No. 77 Issue No. 1

**INSPECTION OF OIL COOLER DUCT TO ENGINE MOUNTING FRAME CLEARANCE**

**APPLICABILITY:** T67M260-T3A Pre Mod M628

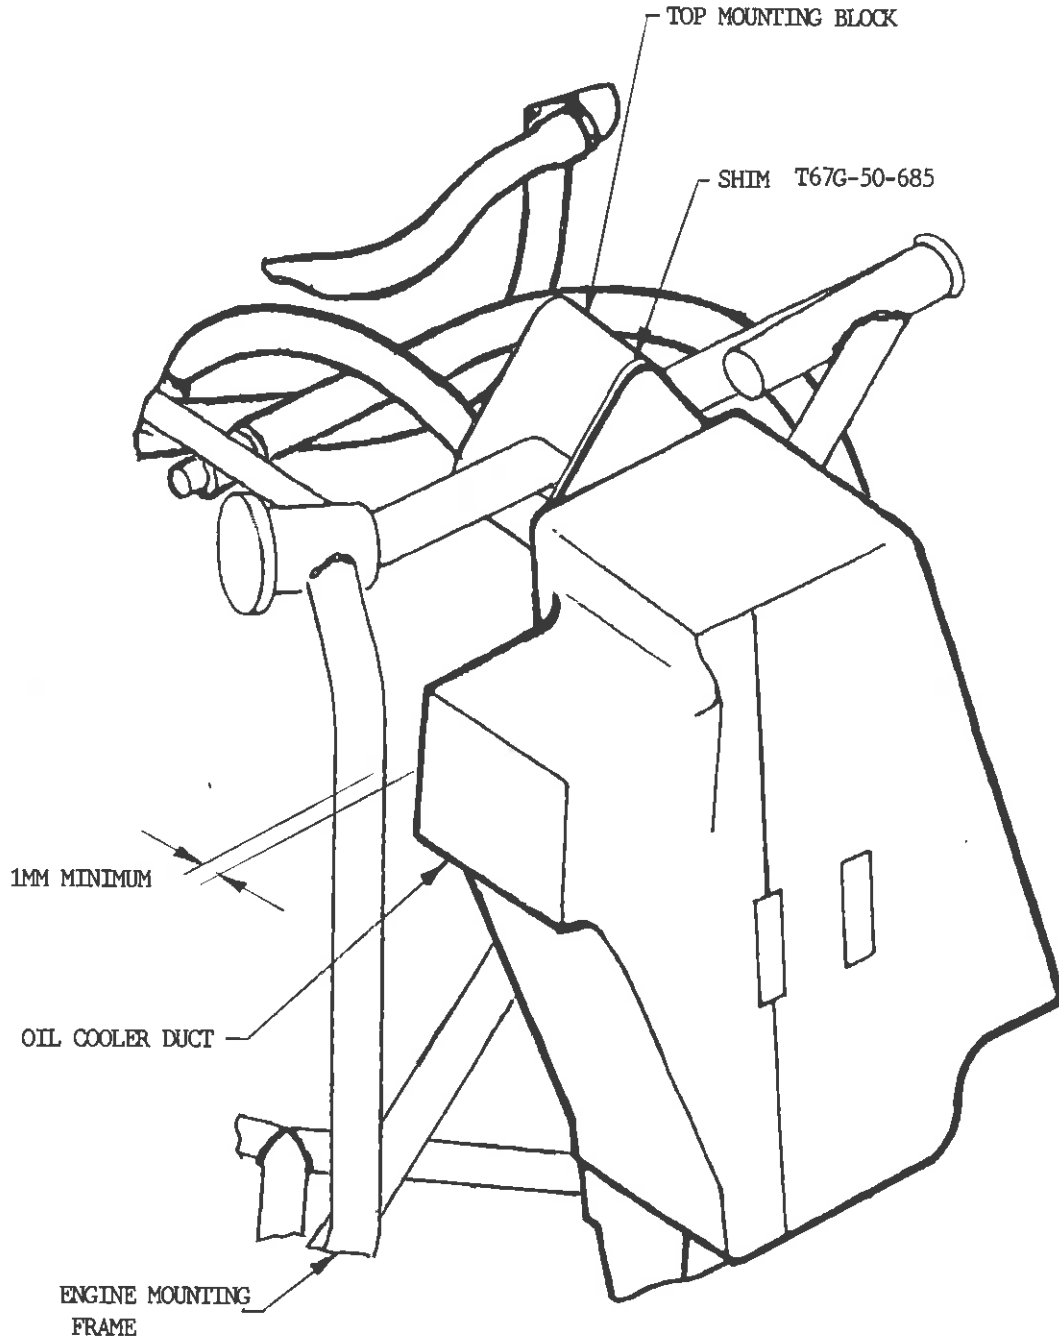
FIG 1

It has been reported that on a few aircraft the oil cooler glass fibre duct has been rubbing against the engine mounting frame.

1. Remove cowlings.
2. Check for scrubbed paint on engine mounting frame ref. Fig. 1.
3. Check that at least 1mm clearance exists between duct and engine mounting frame.
4. If mounting frame is worn or clearance less than 1mm, fit shim T67G-50-685 where indicated by Fig. 1.
5. Annotate in log book Mod M660 applied if shim fitted.
