**SERVICE BULLETIN**

68

**CANOPY LATCH CORRECT OPERATION INSPECTION**

T67C, T67M and T67M200 Aircraft, Post Mod M129 (Split Canopy), T67M-MkII, T67M260 and T67M260-T3A.

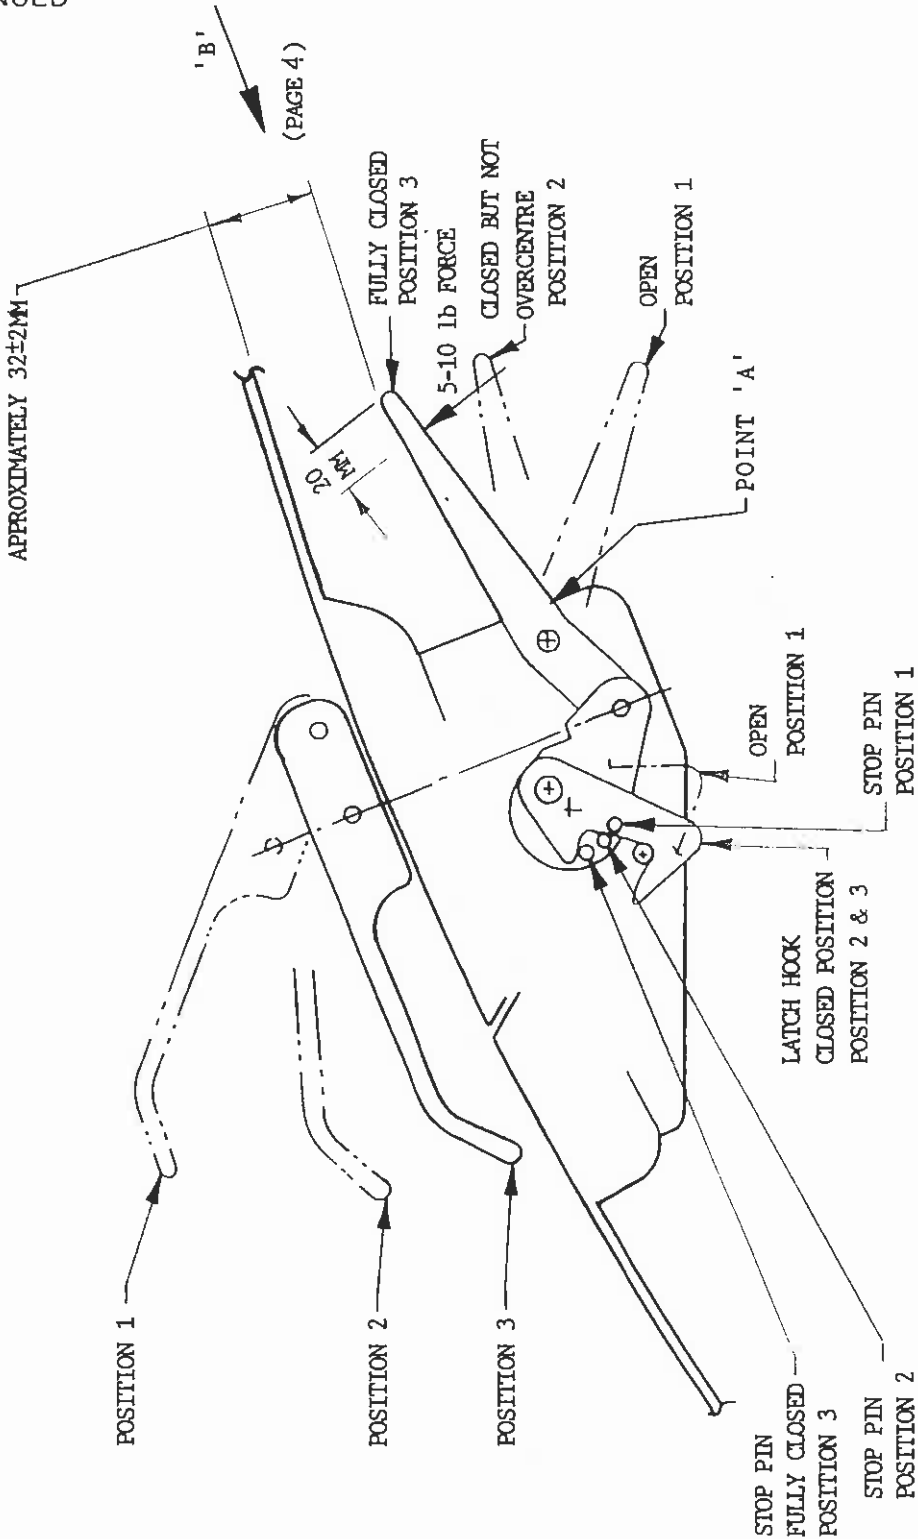
Fig 1

An incident has occurred where the canopy latch was apparently closed correctly but when engine revs were increased beyond 1500 RPM the canopy opened.

Fig. 1 page 2 shows 3 positions of the canopy mechanism:

Position 1 - Open/Unlatched

Position 2 - Latched but mechanism not over centre

Position 3 - Correctly closed, mechanism fully over centre.

- (i) Remove canopy mechanism and latch covers
- (ii) Close canopy fully. Ensure internal handle is in its correct position (Ref Fig.1).
- (iii) Check that stop pin is just touching latch hook. If not adjust in accordance with Maintenance Manual, Section 3, paragraphs 3.2.
- (iv) Check closure load is 5-10 lbs as indicated on Fig. 1.
- (v) Replace mechanism and latch covers, in accordance with Maintenance Manual, Section 3, paragraphs 3.2.
- (vi) Maintenance Manuals to be amended to reflect points contained in (ii), (iii) and (iv).
