**SERVICE BULLETIN**

SB No. 55 Issue No. 2

TITLE **SPECIAL INSPECTION OF THROTTLE CABLE - T67 GRP AIRCRAFT**

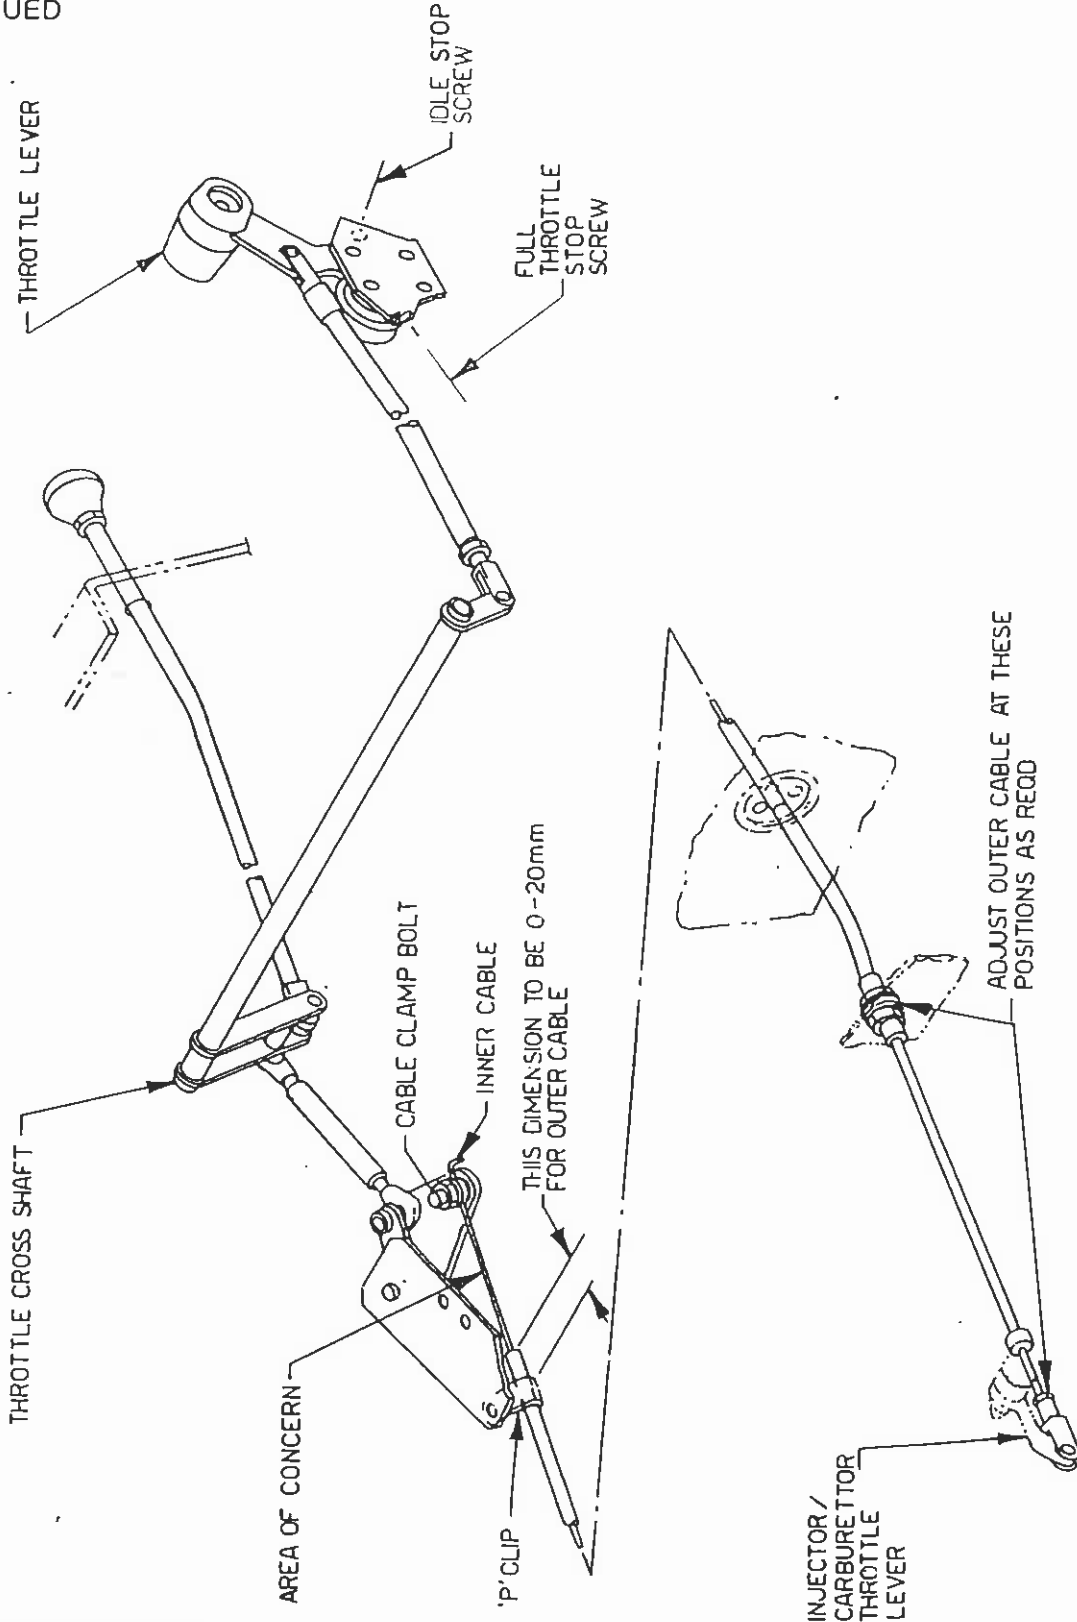
FIGURE 1  
(POST MOD M326 DRN)  
(T67M & T67MMK II SIMILAR)

There have recently been cases of breakage of the throttle cable on T67 g.r.p. aircraft. In these cases the cable has broken at the cockpit end at a point where the inner cable emerges from the outer cable, see Figure 1.

1. Set the throttle lever to the idle position, and measure the clearance at the idle stop screw.
2. Slacken cable clamp bolt, and disconnect the throttle cable at the carburettor/fuel injector.
3. Withdraw the cable about 2 cm. - this ensures that all the affected part of the inner cable will be visible.
4. Visually examine the inner cable for evidence of kinking or cracking - if either is found the cable must be replaced.

5. Check that the length of the outer cable which extends aft beyond the "P" clip, is between 0 and 2 cm. If necessary, adjust the cable position to lie within this tolerance by slackening the "P" clip, repositioning the cable, and retightening the "P" clip. It may be necessary to also adjust the outer cable clamp position at the engine end of the cable. When retightening the "P" clip, ensure that it is angled to equalize sideways bending of the inner cable during operation.
