**SERVICE BULLETIN**

92

**TITLE INSPECTION AND RECTIFICATION OF FUEL VENT AND HYDRAULIC RESERVOIR TUBE, PLUS VENT PIPE INLET RE-ORIENTATION****CLASSIFICATION****SAL have classified this Service Bulletin as Highly Recommended****COMPLIANCE At or before next 50 hr check****APPLICABILITY:**

T67M260-T3A. Works No. 2109. 2110, 2123 to 2128, 2130 to 2158, 2160 to 2233.

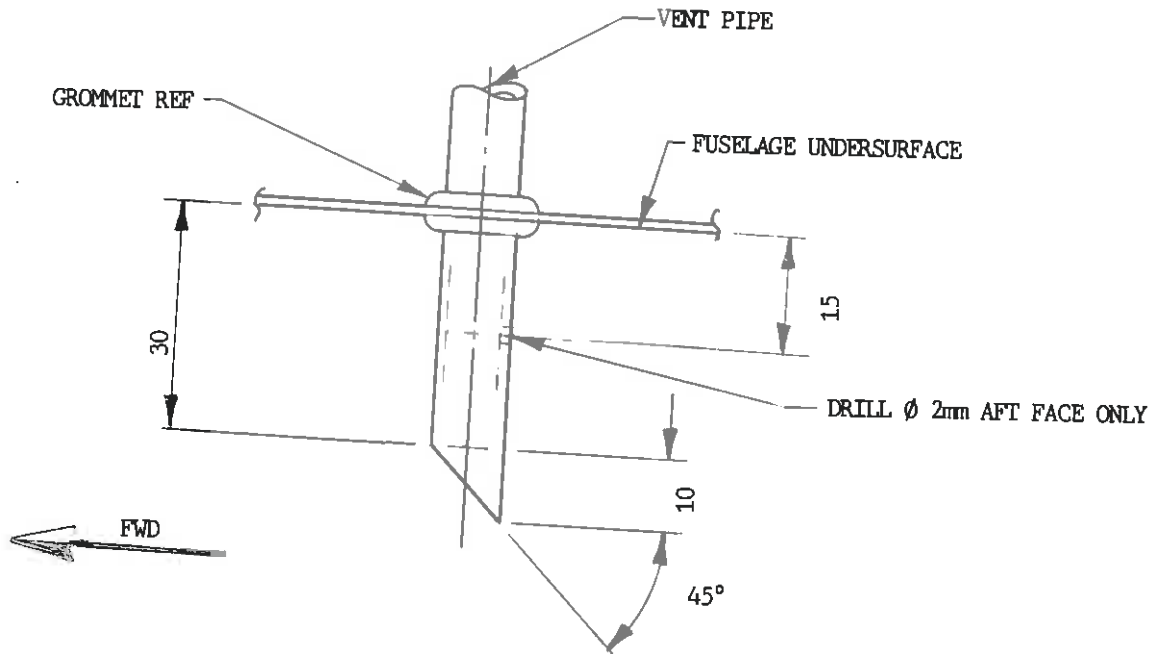
FIG 1  
WING FUEL TANK VENT (MOD M701)

Cases have occurred where the fuel tank vent tubes have been found to be of a brittle nature, and the hydraulic fluid line between reservoir and the brake cylinders, soft and swollen causing leakage.

On further investigation it was found that the tube of the incorrect specification had been authorised, as an alternative. All stock of the incorrect specified material has now been withdrawn and the correct ester based polyurethane tube procured as a replacement, Ref. Slingsby Stock Code Number 126-36-002. During the course of this inspection, the opportunity is being taken to re-orientate the vent pipe inlets through 180° to prevent any possibility of draining the fuel during flight when the fuel tanks are full. This action invokes a modification, Mod M701.

1. Inspect the fuel tank vent pipes below the centre section.
  - i) If the vent pipes are found to be stiff and hard, replace.
  - ii) If the vent pipes do not appear to have a yellow cast to them, replace.
  - iii) If in doubt, replace.
2. During inspection or during course of replacement, re-fit vent tubes with opening facing forward. Drill 2mm hole in aft face. Ref Fig. 1.

This action invokes modification M701. Annotate in aircraft logbook "Mod M701 incorporated".
