# Service Bulletin

S.B. No: 187

**Title:** INSPECTION FOR CLEARANCE BETWEEN RUDDER PEDAL AND MIXTURE/PROP. SPEED BRACKET AND FOR GROUND TOWING DAMAGE. ALSO INCLUDES GENERAL RUDDER PEDAL CLEARANCES.

**Applicability:** T67M200 (Works No. 2264 & 2265 only), T67M260 and T67M260-T3A.

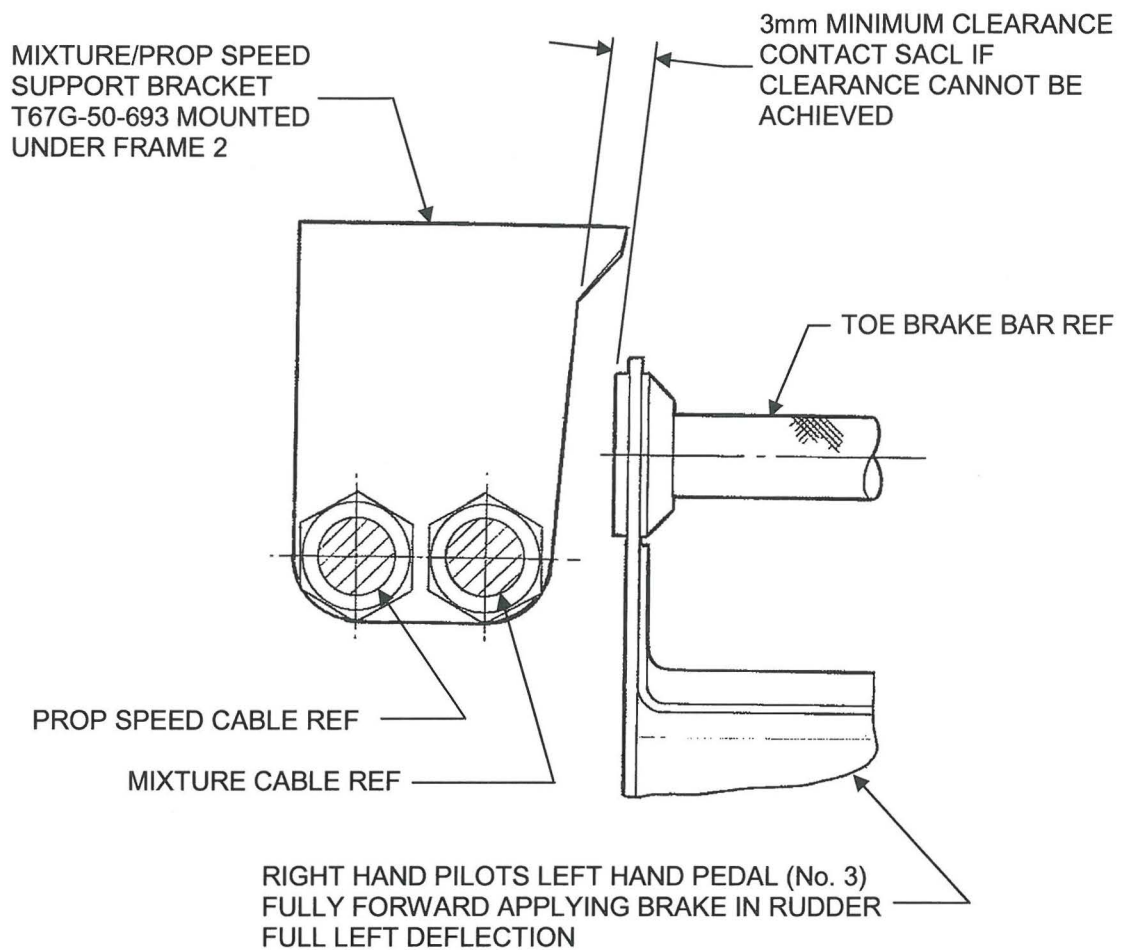
1. With Right Hand pilots left pedal (Pedal No. 3) adjusted fully forward, with left rudder applied, apply brake together with a left hand side force on the pedal. Check for clearance on mixture/propeller speed cable support bracket. Refer Figure 1.

2. Clearance should be a minimum of 3mm. Figure 1 refers.
  - 2.1 If the clearance is less than 3mm, the following inspection and corrective actions, paragraphs 3 to 32, shall be carried out in order to increase the clearance up to the required minimum of 3mm.

**FIGURE 1**  
**SHOWING CLEARANCE MIXTURE/PROP SPEED BRACKET TO No. 3 PEDAL**

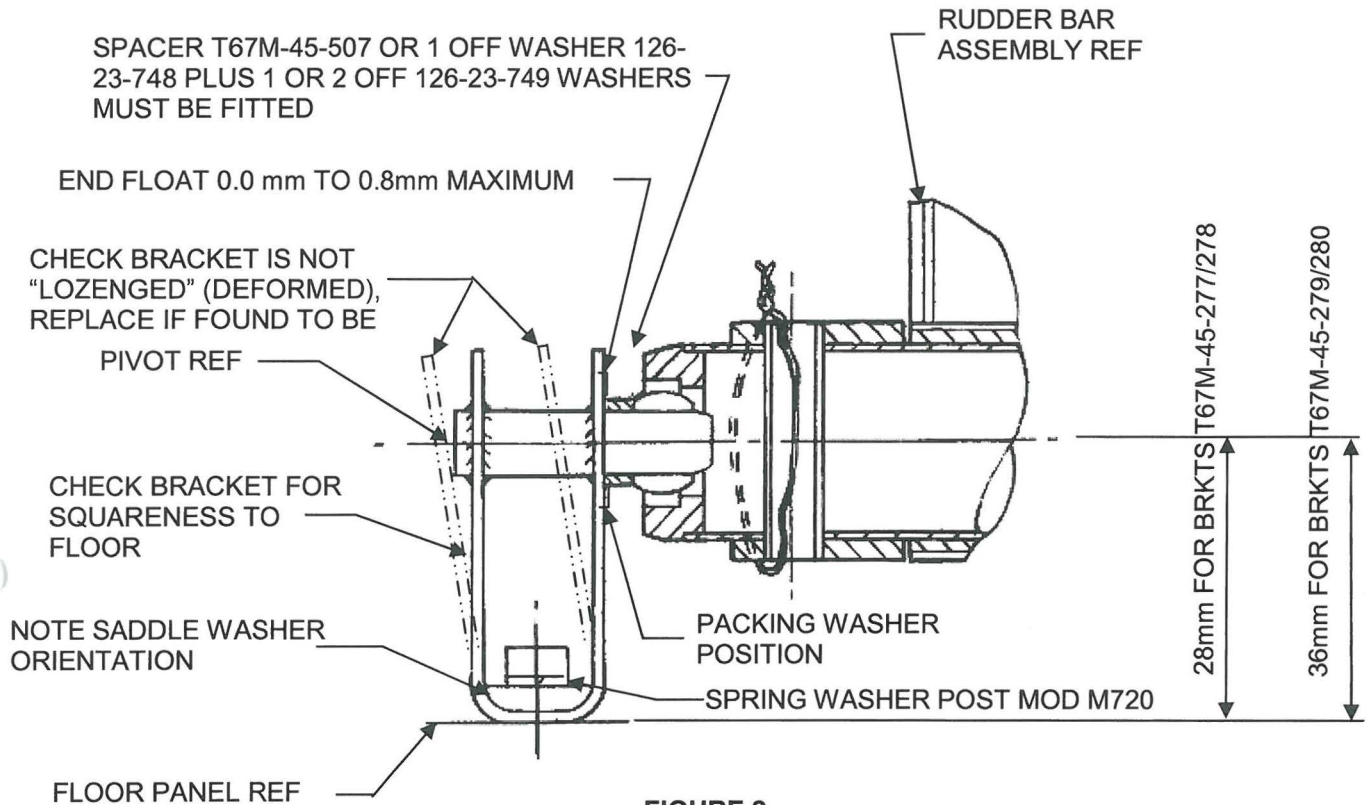
FIGURE 2

4. Check rudder pedal bar end float is no greater than 0.8mm. Acceptable end float is 0.0mm to 0.8mm. If end float is greater than 0.8mm then rectify IAW paragraph 14. Refer Figure 2.

5. Check that the Rudder Pedal bar port outboard support bracket, ref. Figure 2 and 4, is square to floor and not "lozenged" and there is no deformation to its base. Check floor under removable floor panel in area of bracket, inspect for cracking which could allow the bracket to lean. Remove the floor panel, and on Post Mod M945 aircraft fuel panel on lower fuselage front may be removed, check for signs of cracking in the floor around the anchor nuts on Pre Mod M919 aircraft or the anchor nut mounting plate Post Mod M919 aircraft, refer to Figure 3. Any GRP damage will be shown as a white shadow on the GRP, with cracking felt as a rough edge. A light shining up through the floor will show a shadow.

**RUDDER BAR END FLOAT AND ITS SUPPORT BRACKET**

8. Should Rudder bar support bracket be damaged, replace with a new item. Ensure brackets are secured with a torque of 58lbf in (6.5Nm). Ensure spring washers are fitted; Mod M720 "Introduction of Spring Washers to Rudder Pedal Lay-shaft Mounting Bracket Screws" refers. Ensure when refitting brackets that the saddle washer, T67M-45-537, is re-fitted and is assembled with its corner radius into the brackets radius, refer Figure 2. Ensure that the shorter, (28mm), mounting brackets, T67M-45-277/278, are supporting Rudder Pedal Bar T67M-45-257, i.e. Port Rudder Bar, refer Figures 2 and 4.

14. Referring to Figure 2 ensure at each rudder bar pivot position that there is one spacer T67M-45-507 OR one off washer 126-23-748 and up to a maximum of two off washers 126-23-749, i.e. 3 washers maximum.

If end float greater than 0.8mm, then 1 off packing washer may be added at each pivot position as required, i.e. 126-23-105 washer or 126-23-748 washer or 126-23-749 washer.

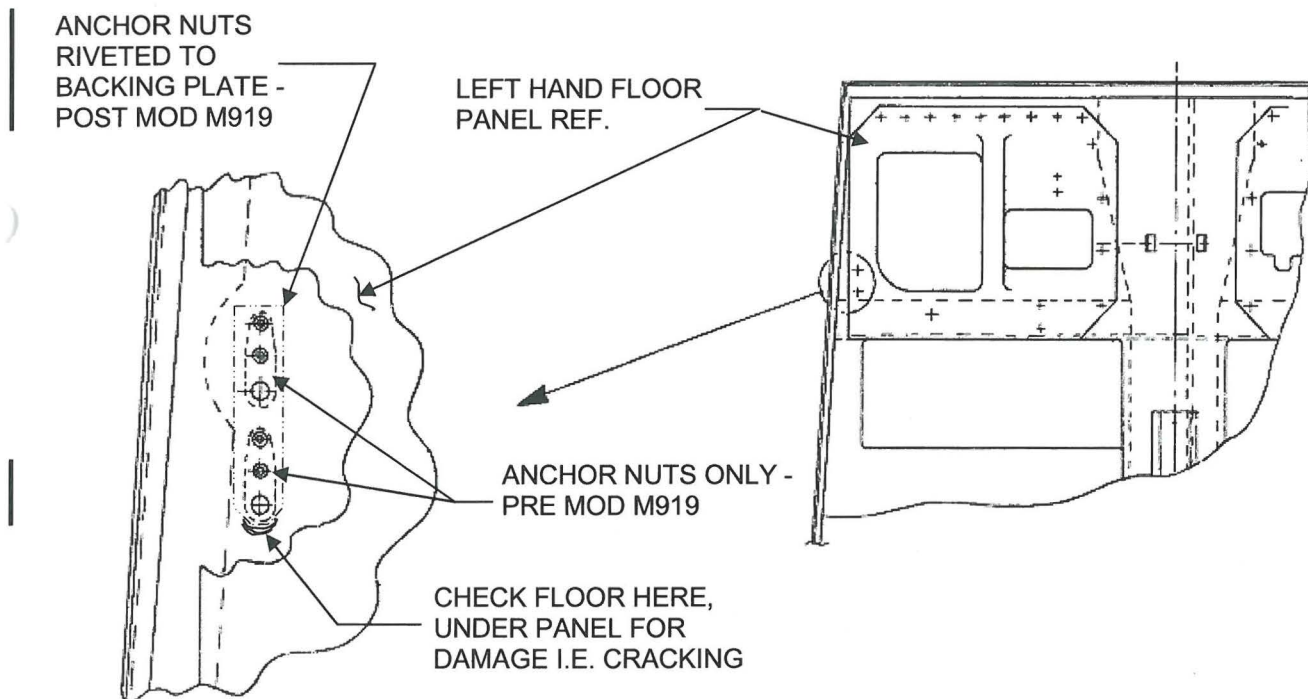
FIGURE 3

**AREA OF FLOOR REQUIRING INSPECTION**

6. If floor under port outboard support bracket position is found to be cracked or broken then repair IAW DOI T67C-149 issue 4 and subsequent, incorporating Mod M919. If Mod M919 has been previously incorporated and floor is damaged, inform SACL.

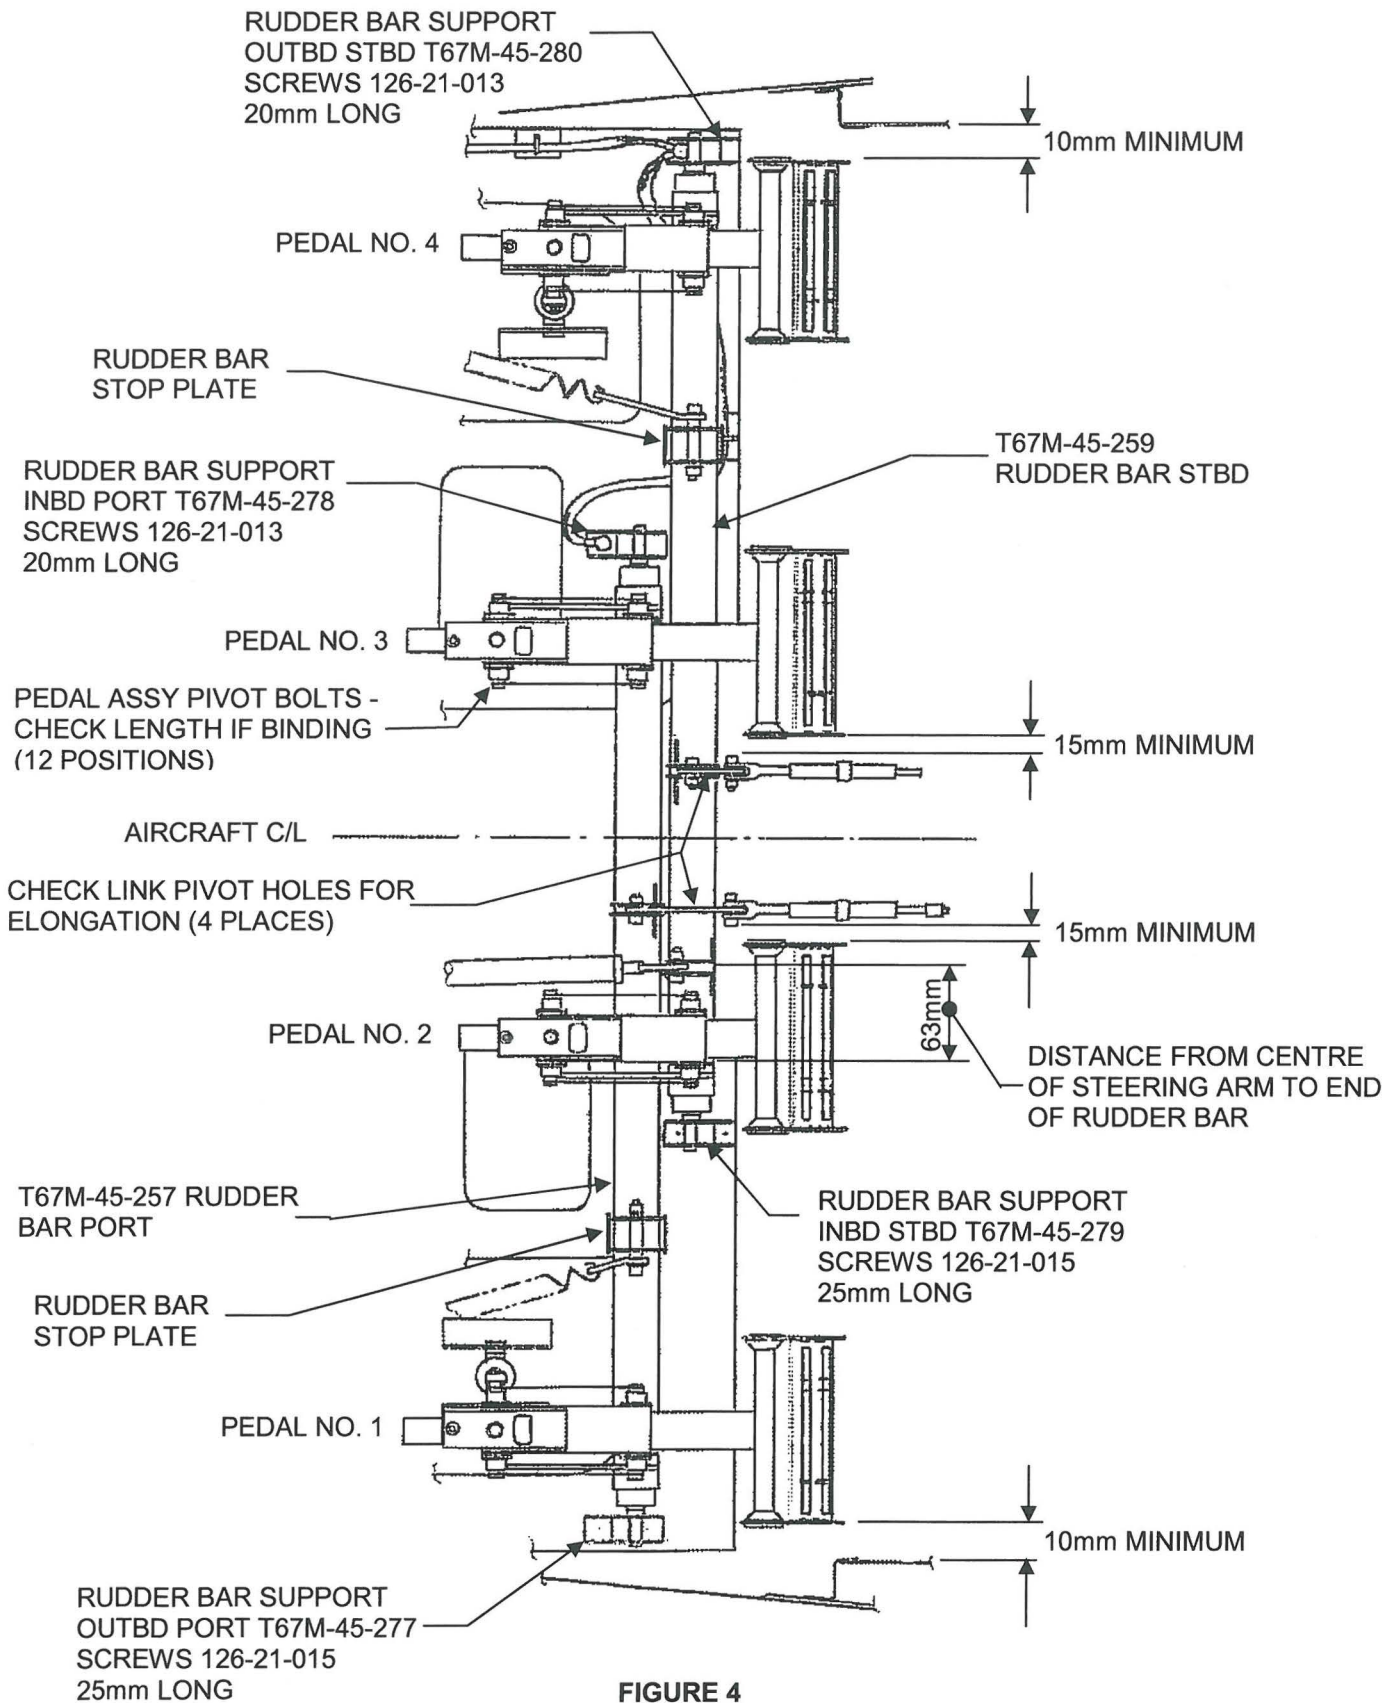
FIGURE 4

9. Check the remaining rudder bar support brackets, are square to floor and are not "lozenged" and there is no deformation to their bases, reference Figures 2 and 4. If any bracket is found to be suspect replace with new item. Check floor under any damaged support bracket by removing panel. Ensure washers and brackets are correctly assembled refer paragraph 8 above. Inform SACL of any damaged bracket or additional floor damage. Assemble item as per paragraph 8 and ensure end float is as stated in paragraph 14. Ensure bonding leads are correctly fitted, carry out bonding check refer relevant aircraft's Maintenance Manual. Ensure correct length screws for attaching the rudder bar support brackets have been fitted in the correct positions, refer Figure 4.

19. Upon completion of rudder movement set-up ref. Paragraph 17 above, ensure minimum clearances of trim panel to pedal side plates and rudder cable to pedal side plates are met Refer Figure 4. Refer paragraph 14 for packing washers.

RUDDER PEDAL CLEARANCES TO SIDE PANEL AND RUDDER CABLES

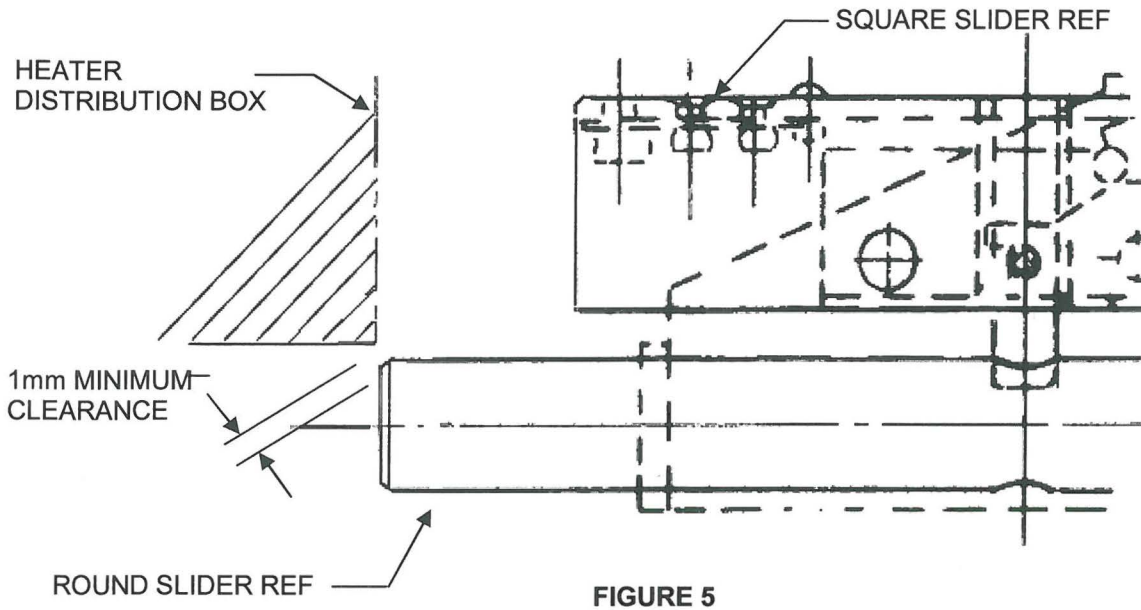
20. Ensure clearance of the no. 2 pedal slider to heater box clearance, is greater than 1mm, Figure 5 refers. Inform SACL if clearance is not achievable.

PEDAL NO. 2 TO HEATER BOX CLEARANCE

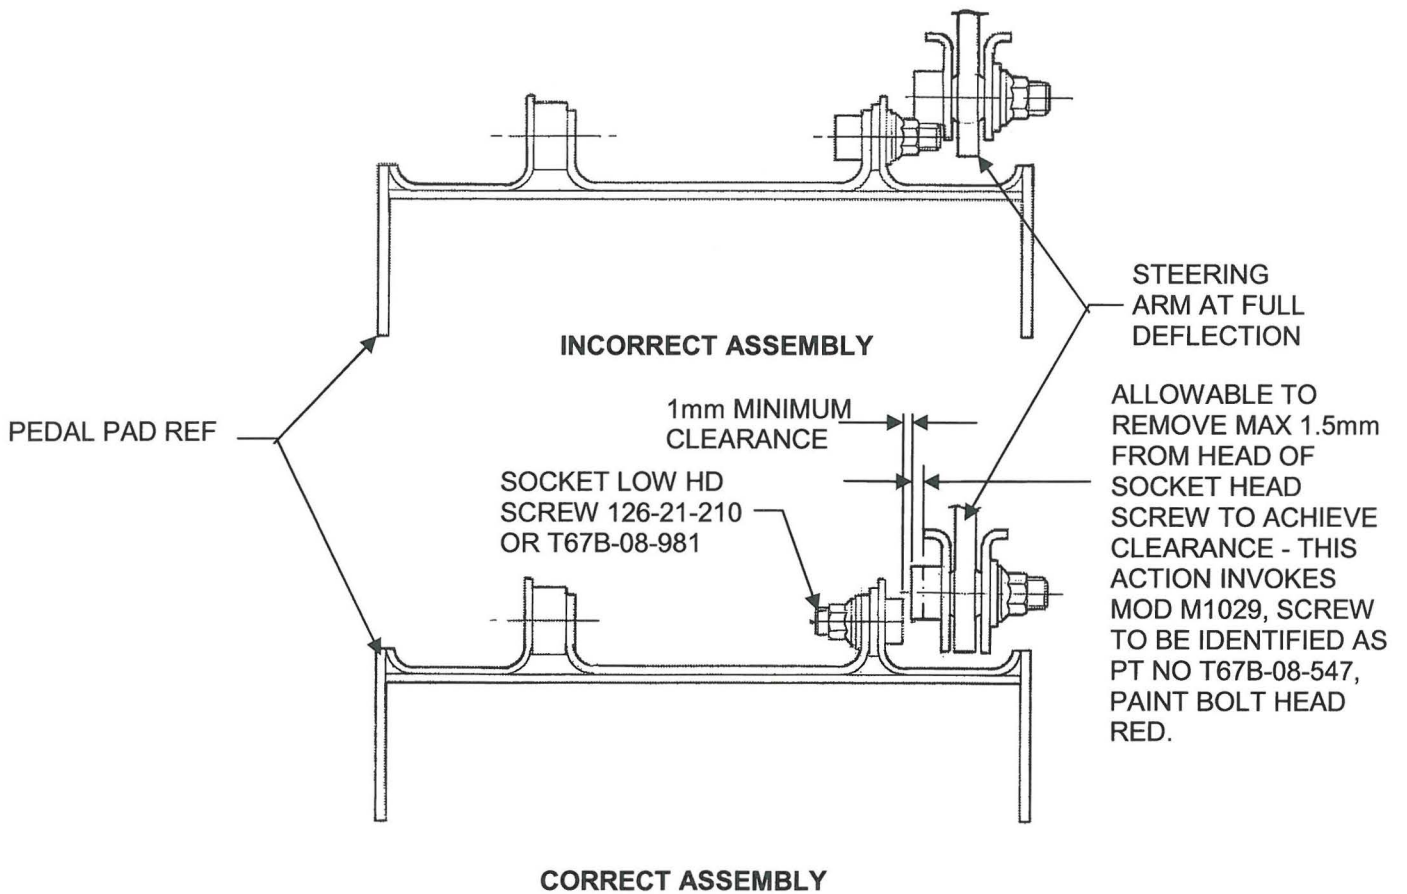
23. Ensure head orientation of rudder cable link low pan head bolt T67M-45-570 is outboard. T67M260 Maintenance Manual Figure 5-7 refers.
24. Ensure Pedal no 2 Pedal pad pivot bolt head height is less than 5mm and orientated, as shown in Figure 6. A minimum of 1mm clearance is required, if not, fit part no 126-21-210 or T67B-08-981, this invokes Mod M671 "Introduction of Low Head Rudder Pedal Pad Pivot Bolts – Pedal No. 2". If clearance is not still achieved check distance of steering arm from bar end, Figure 4 specifies. If the distance is incorrect, then return rudder bar to SACL for re-worked/new item. Alternatively if clearance of 1mm is still not achievable remove up to a maximum of 1.5mm from the steering arm screw this invokes Modification action M1029, Figure 6 refers, and paint modified screw head red.

PEDAL NO. 2 TO STEERING ARM INTERFACE

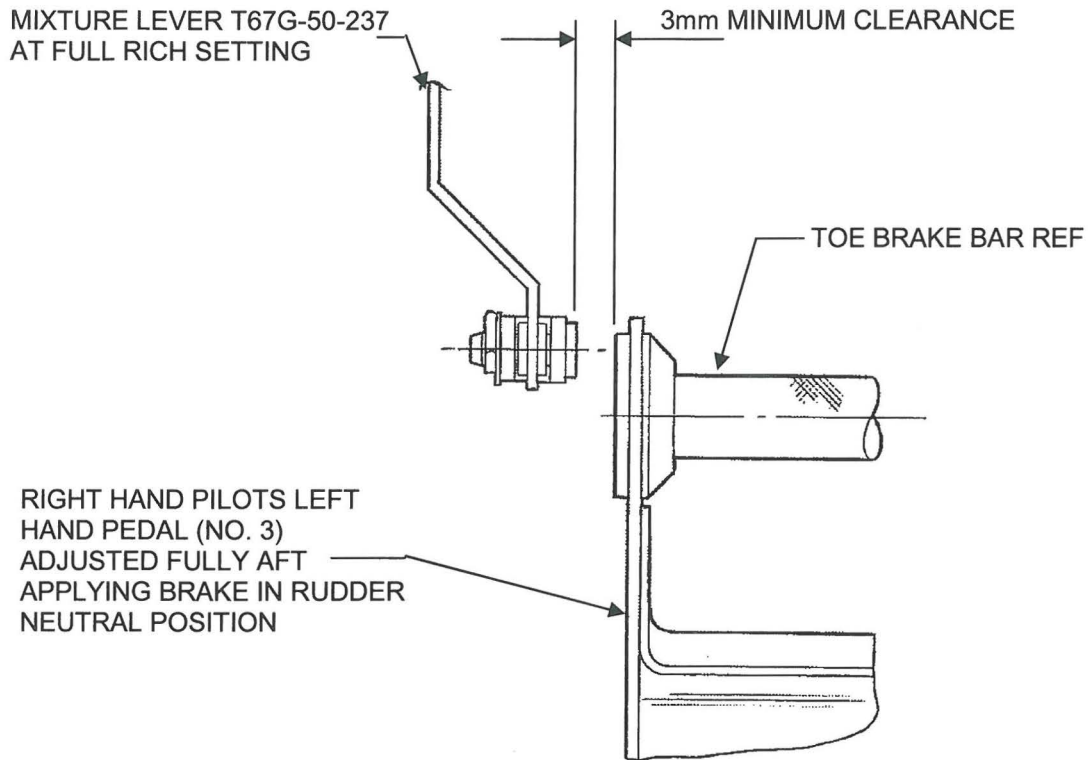
FIGURE 7

27. Ensure, that a minimum clearance of 3mm is achieved between Pedal No 3 and Mixture Lever operating arm, refer Figure 7. Refer paragraph 14 for packing washers.

VIEW LOOKING FORWARD ONTO NO.3 RUDDER PEDAL

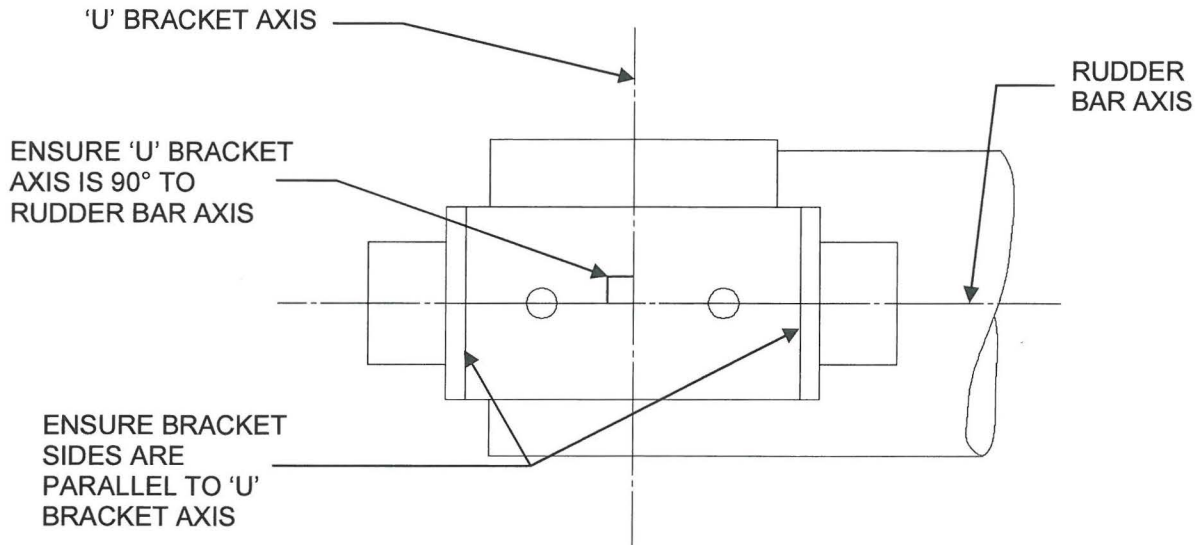
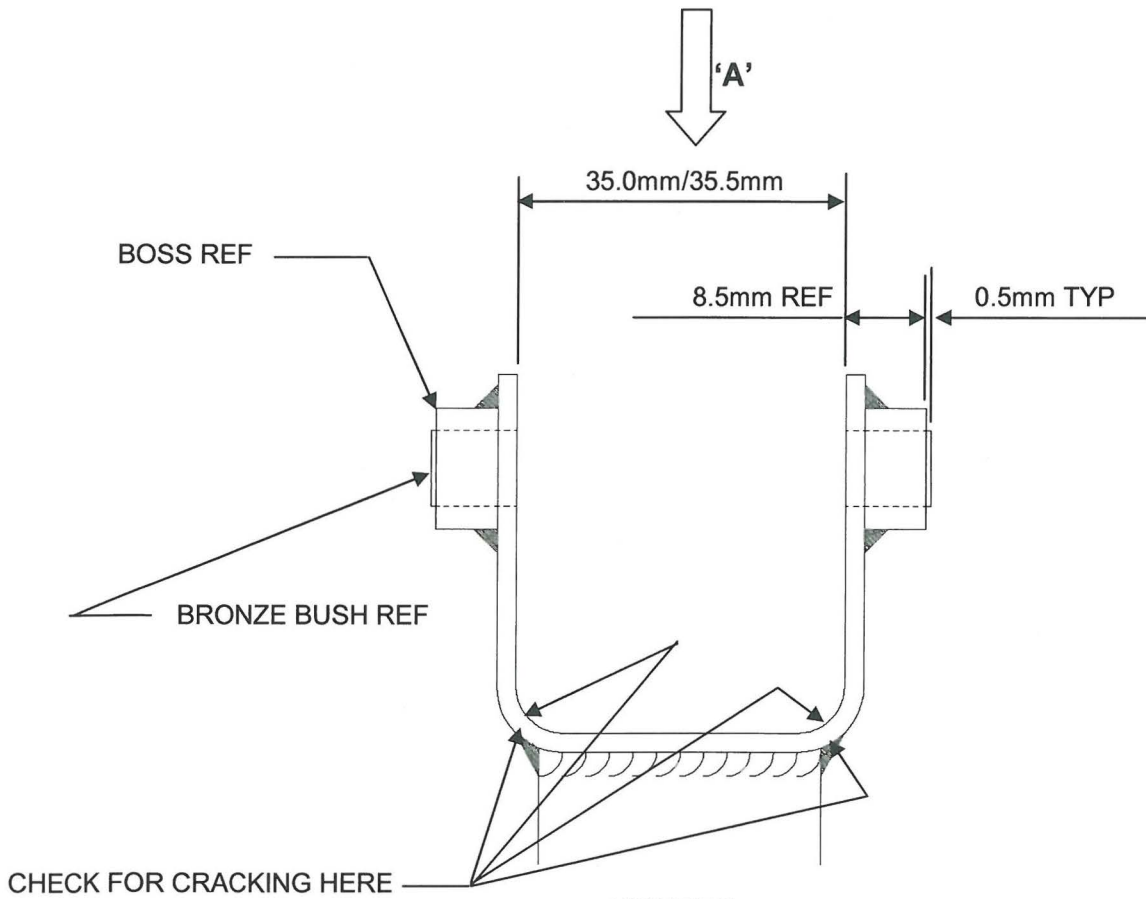
FIGURE 9

15. Check that the 'U' brackets are parallel and square to the rudder bar axis, Figure 9 View on 'A' refers, this alignment is important at rudder position 3 with reference to attaining the required clearance between pedal and mixture bracket, ref paragraphs 1 and 2. Also ensure that the rudder pedal carriages have full and free movement. If binding is suspected then check the 'U' bracket internal dimension. This should measure 35.0mm to 35.5mm, also check that the pivot bush protrudes from its boss by 0.5mm. If the bracket internal dimension is greater or less, or if out of alignment then the bracket should be checked for cracking, refer Figure 9. If cracking is found then return rudder bar to SACL for rework. Finally check length of carriage pivot bolts, reference Figure 4, if binding is noted then replace bolts with bolt part number T67B-08-537 this introduces a bolt 15 mm long, measured from under head, and invokes Mod M808 "Introduction of Shortened Pivot Bolt to Rudder Pedal Slider Assembly Mounting". Also refer to SB130 "Inspection of Rudder Pedals for Adjustment Restriction".

'U' BRACKET ON RUDDER BARS  
(4 POSITIONS)

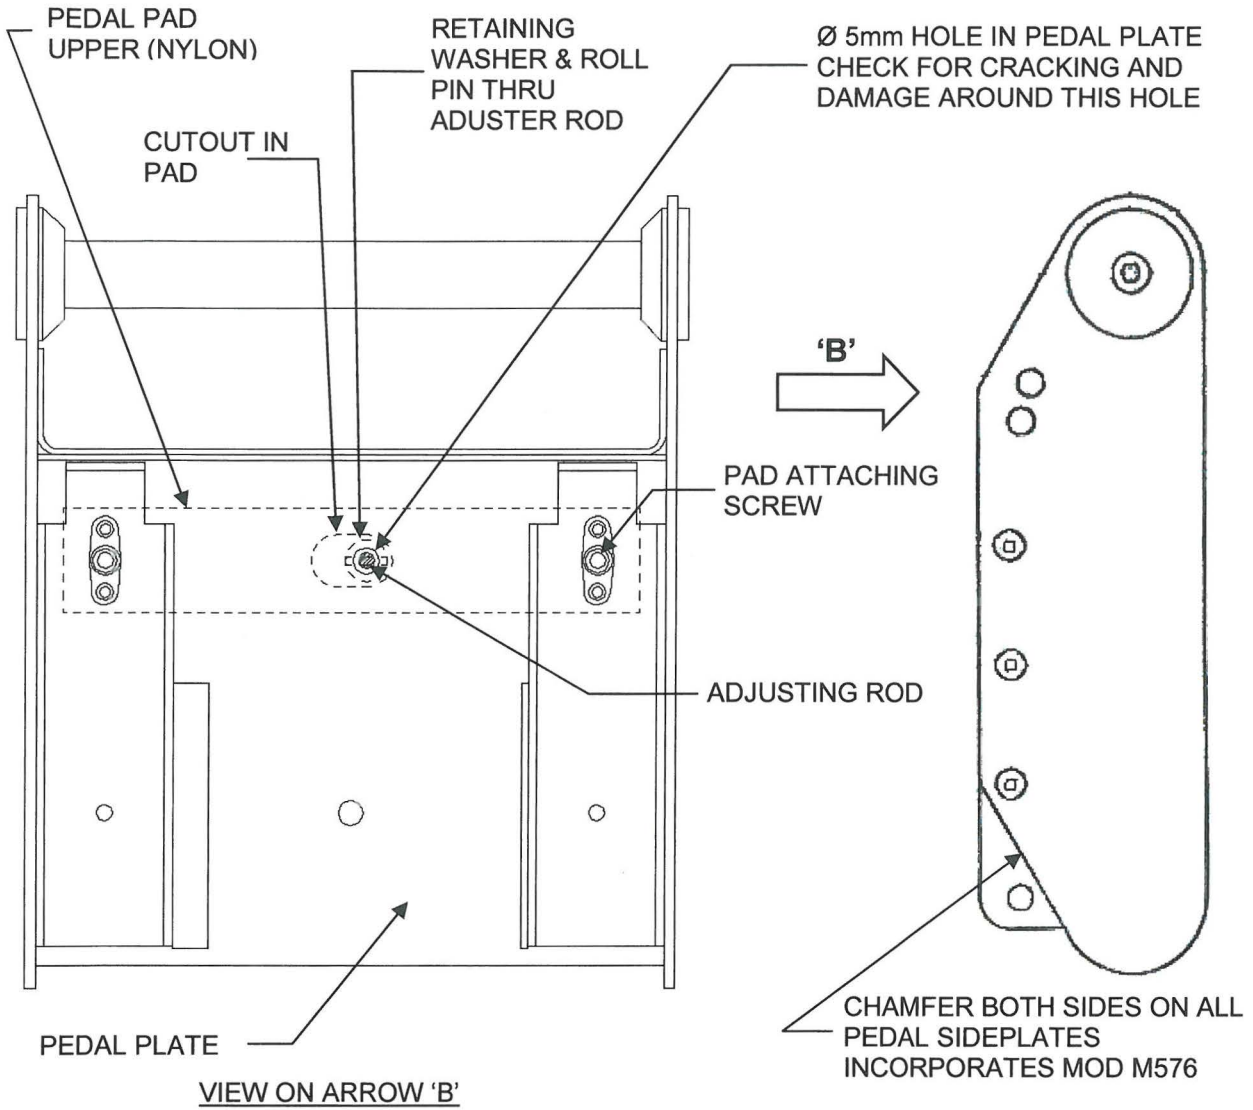
**FIGURE 10**

28. Ensure Mandatory Mod M576 has been invoked; CAA AD 013-05-94 refers. Pedal side plate should be as Figure 10.
29. Check structural integrity of pedal pad assembly especially around adjuster pushrod hole pedal plate, Figure 10 View on Arrow 'B' refers, if plate is cracked or damaged the pedal pad is to be repaired. Ensure riveting is secure, if rivets are loose then they have to be rectified. Contact SACL for new pedal pad assembly, materials and any applicable repair scheme.

**TYPICAL RUDDER PEDAL ASSEMBLY SHOWING SIDEPLATE CHAMFERING AND PEDAL ADJUSTER ROD ATTACHMENT**

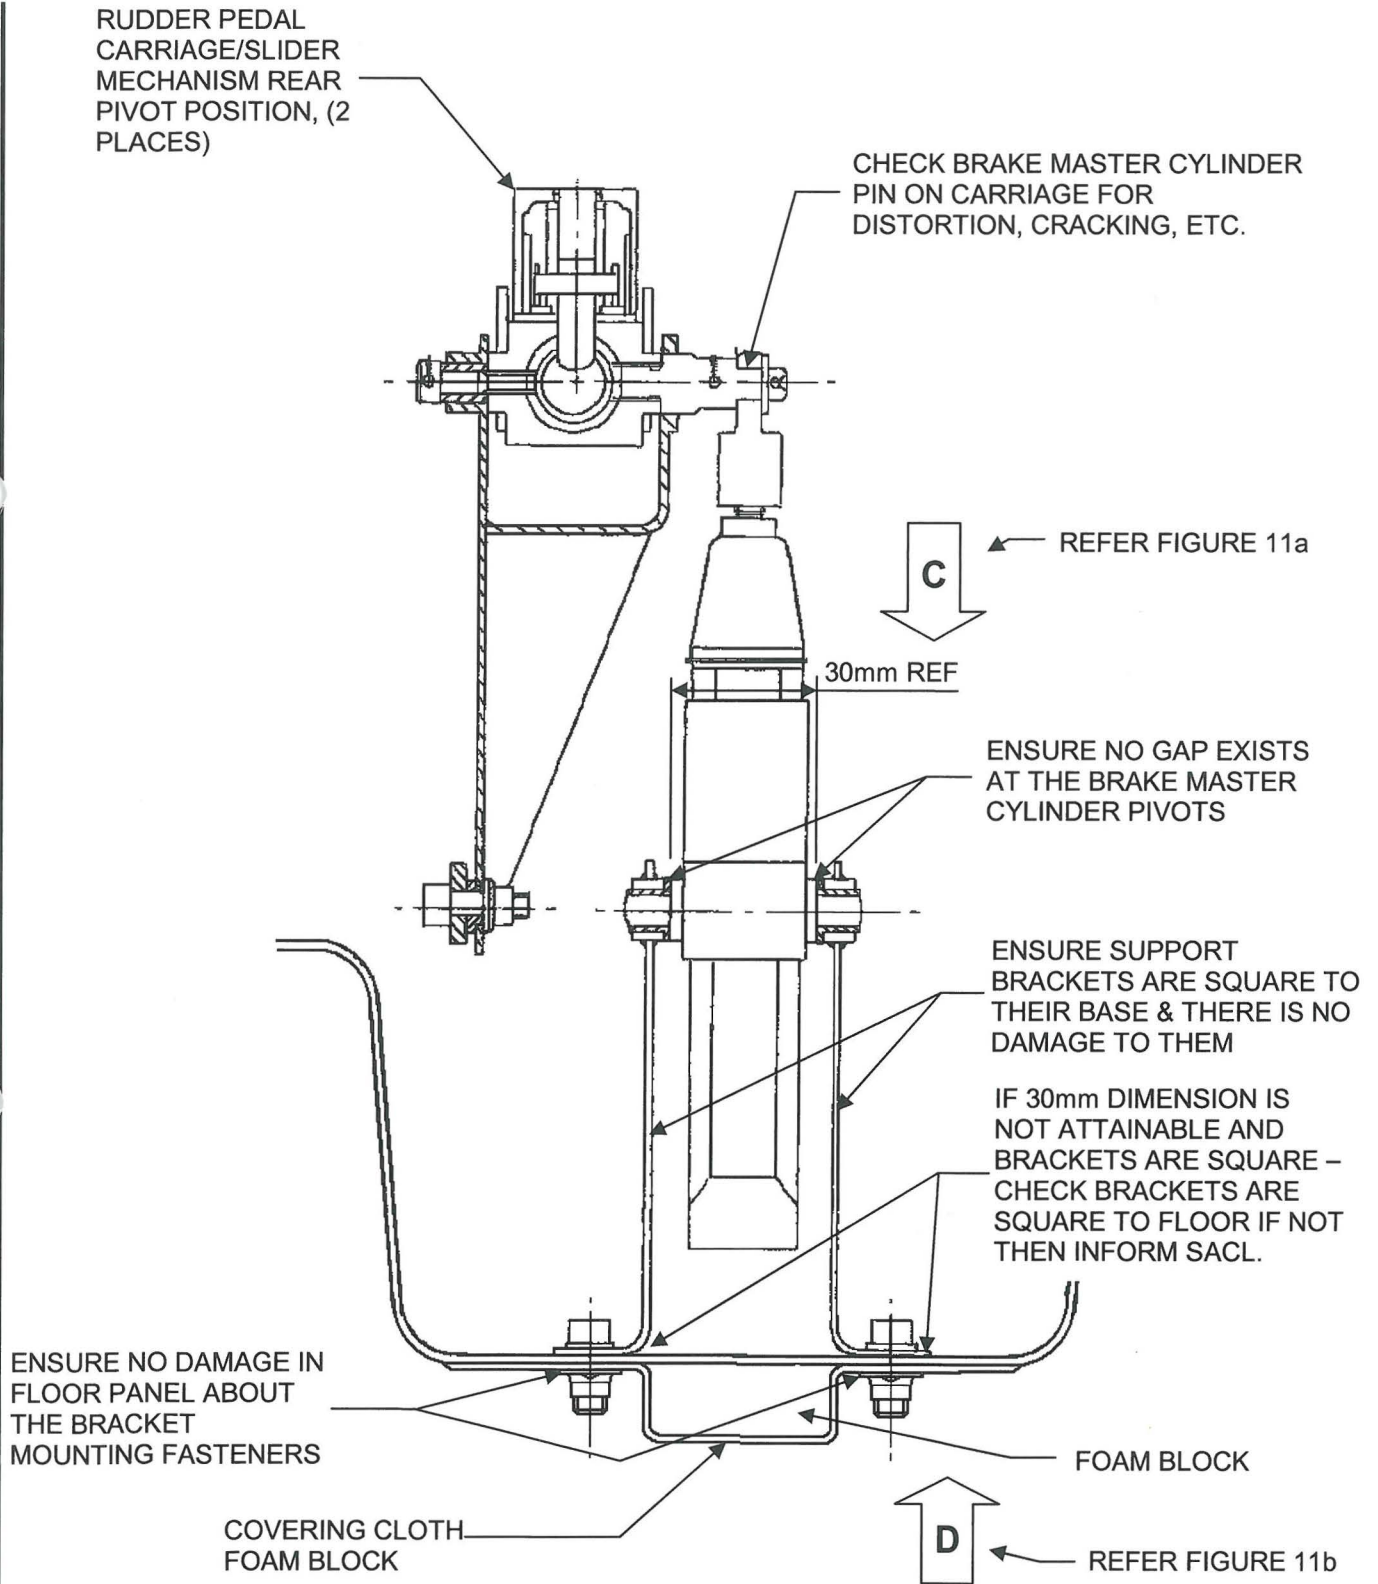
10. Ensure that there is no gap at the brake master cylinder pivot points and that the support brackets are securely mounted to the floor panel, i.e. not loose, they should not deflect if base fastenings are sound. If bracket is seen to be suspect, i.e. out of square, twisted or bent, remove brackets and replace with new brackets if damaged. Check that there is no damage to the bracket anchorages in the removable floor panel, damage will show as whitening in the laminate surrounding the anchor nuts and foam reinforcement block, if in doubt remove panel and check anchor nuts for security. Figure 11 refers. If the floor panel is found to be damaged it is to be repaired or new panel fitted, refer to SACL Customer Support Department. If damage found then proceed as indicated by paragraphs 11 and 12. When rectified ensure all clearances and checks are accomplished as related to in this Service Bulletin.

Note: This check should be accomplished with the rudder pedal and brake system operating through to their extremes, as a gap can appear during the operation of the system, if the system is not correctly aligned or assembled.
11. If either the rudder bar support brackets or the brake master cylinder support brackets or floor panel or floor panel mountings are damaged then the entire rudder operating system should be thoroughly checked for damage to fittings, rudder pedal stops, rudder horn, cables, rear fuselage stops, etc. If any damage is found please report back to SACL. Damaged items are to be repaired or replaced. When replacing brackets ensure attaching screws are torque loaded to 50<sup>+5/-0</sup> lb. in.
12. If damage is found ref. Paragraph 10, then brake master cylinder to rudder pedal carriage attachment pin is to be checked for deformation/cracking, Figure 11 refers.

**FIGURE 11**  
**BRAKE MASTER CYLINDER SUPPORT BRACKETS**

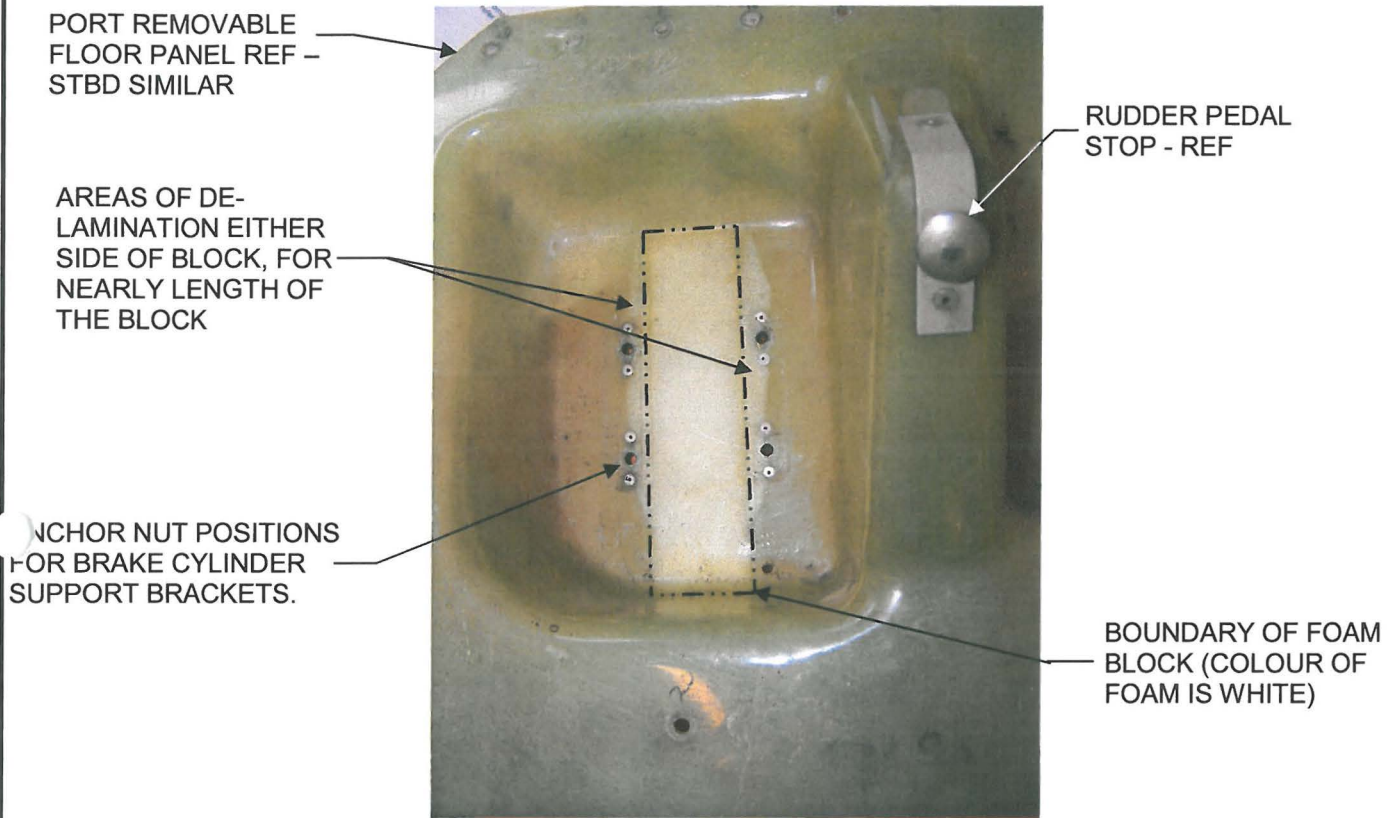
Further to issue 2 an incident has been reported of the brake master cylinder becoming detached from its support brackets causing de-lamination to the port GRP floor panel. This failure occurred during aircraft taxiing. The failure was the direct result of the aircraft towing angle being exceeded.

**FIGURE 11a**  
**PHOTOGRAPH ON ARROW C**  
**VIEW INTO TOPSIDE OF REMOVABLE PANEL SHOWING EXTENT OF DE-LAMINATION**

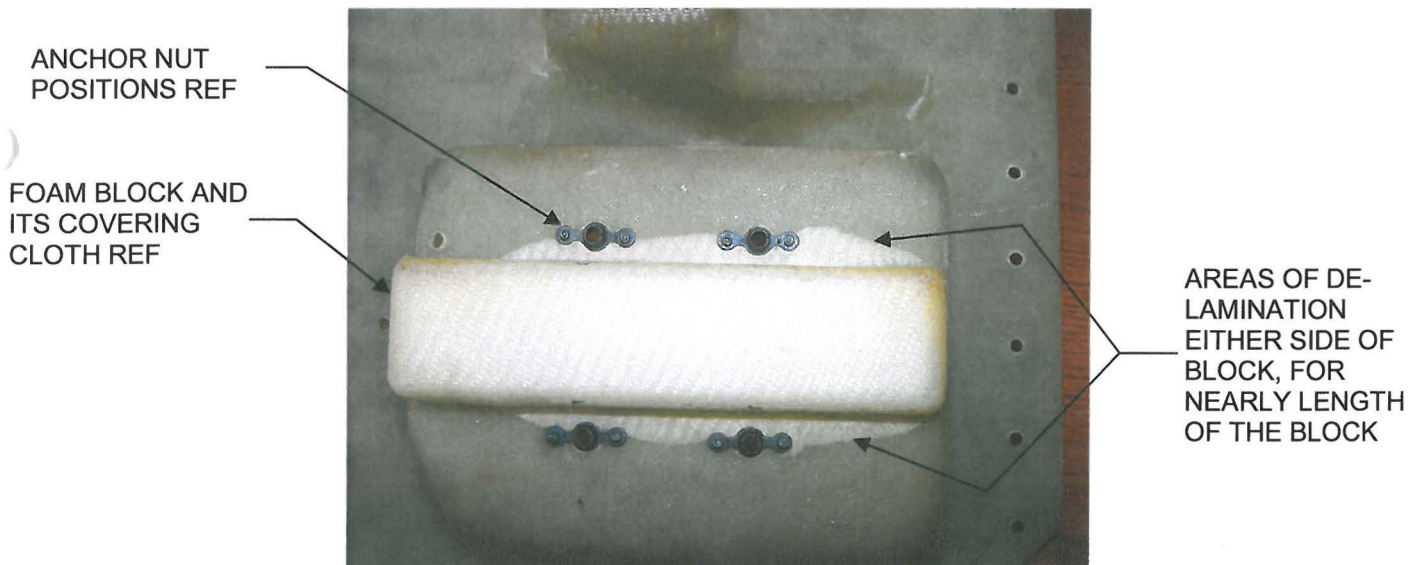
**FIGURE 11b**  
**PHOTOGRAPH ON ARROW D**  
**VIEW ON UNDERSIDE OF REMOVABLE PANEL SHOWING EXTENT OF DE-LAMINATION**

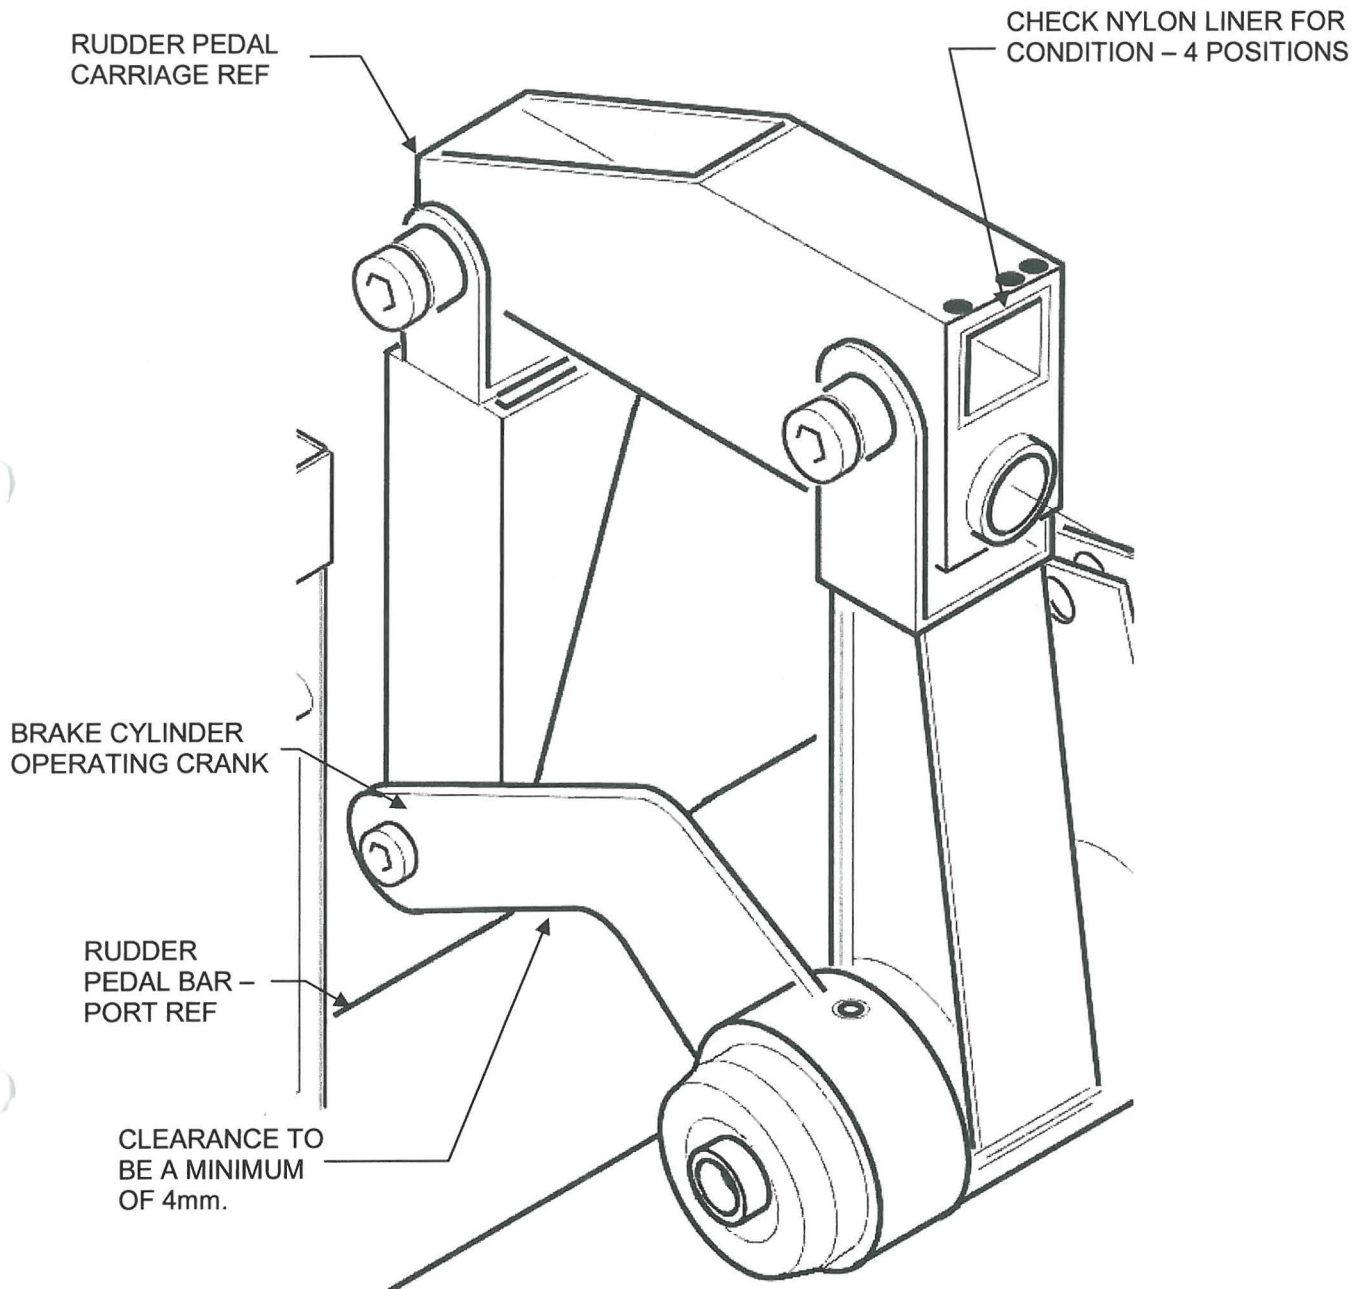
FIGURE 12

26. Ensure the nylon liners in the rudder pedal carriages are in good condition and not worn, Figure 12 refers, replace liners if unsatisfactory. Return carriages to SACL for replacement of liner.

30. Ensure that the brake operating crank, as shown at Figure 12, has a minimum clearance of 4mm relative to the rudder pedal bar following all checks and rectifications. Allow for various brake conditions, refer paragraph 31.2. Should bar show signs of chaffing check depth of groove. If depth is 0.0mm to 0.5mm, remove rudder bar, blend out groove, repaint and refit. If the groove is to a depth greater than 0.5mm, remove rudder bar and return to SACL for repair or replacement.

BRAKE CRANK CLEARANCE AND NYLON SLIDER POSITION
