SERVICE BULLETIN

SB No. 015 Issue No. 1

TITLE	RUDDER PEDAL TO SIDEWALL AND RUDDER CABLE CLEARANCES
CLASSIFICATION	This Service Bulletin has been classified as mandatory by the CAA
COMPLIANCE	(a) Before further flight) after receipt (b) Within 50 flying hours) of this Bulletin

RUDDER PEDAL TO SIDEWALL AND RUDDER CABLE CLEARANCES

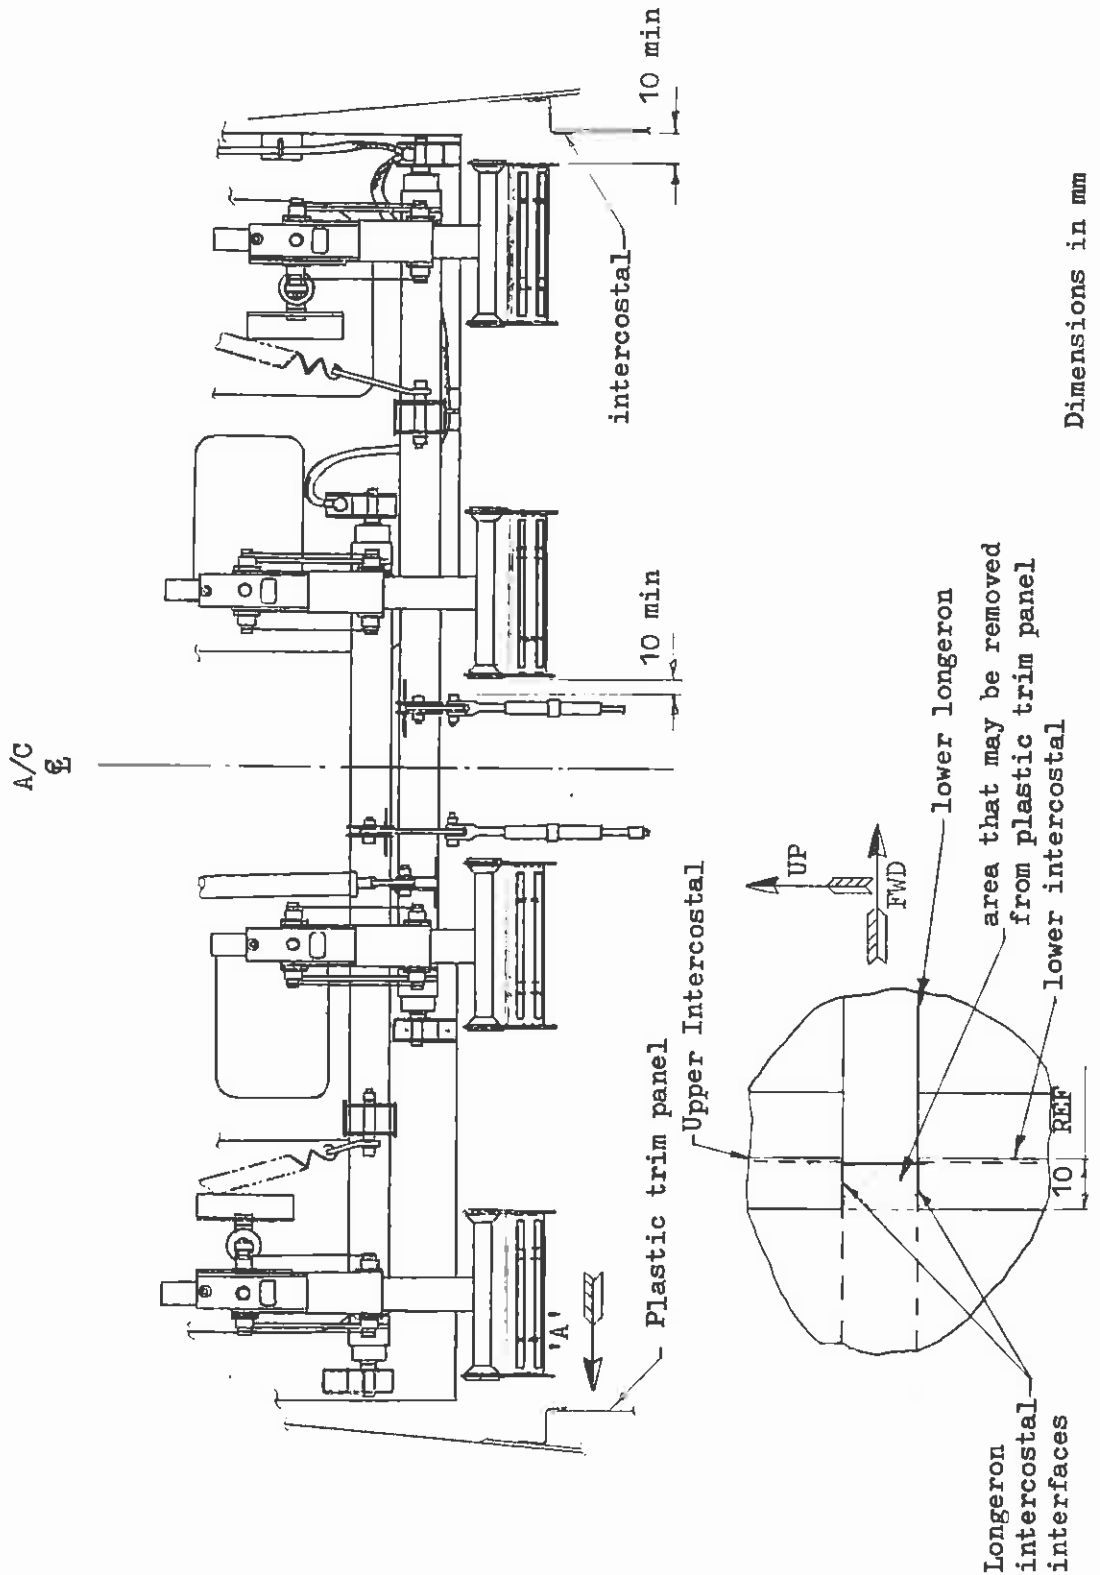
FIGURE 1

A recent report has highlighted the possibility of the left hand pilots left hand rudder pedal fouling the fuselage plastic trim panel. This Service Bulletin (S.B. No 015) describes the inspection of clearances between plastic trim panel and rudder cable with rudder pedals, and rectification actions required to achieve clearances.

Check the minimum rudder pedal to intercostal clearance and the minimum rudder pedal to rudder cable turnbuckle bolt clearance in any configuration port and starboard, with a light sideways force on the pedals (aprox. 10 lbf or 4.53 kg) applied in a direction to minimise the gaps.

- a) More than 10mm proceed to para 3.2.
- b) Between 5mm and 10mm the aircraft is to be placarded "No Aerobatics", and the aircraft may not be used for aerobatics or spinning until Mod M232 "Introduction of Rudder Pedal Packing for Increased Clearance of Surrounding Components" is incorporated at the next 50 hour check. See para 3.2.
- c) Less than 5mm Mod M232 is to be incorporated before further flight (excluding any necessary positioning flights for incorporation of the mod). See also Para 3.2.

3.2.1 Check that the plastic trim panel is under intercostal ideally by 10mm, ref. view on Arrow 'A' Fig.1.

3.2.2 Check for distortion in plastic trim panel.

3.3.1 If plastic trim panel is not under intercostal place it under. If difficulty is encountered whilst attempting to replace plastic trim panel the following solutions are recommended:

(i) Remove excess Redux etc at intercostal/longeron interface. Do not damage items.

(ii) Apply hot air to plastic trim panel and push into position.

(iii) Cut a small notch in plastic trim panel the width of longeron and intercostal, apply hot air to fit into position.

3.3.2 Apply hot air to plastic trim panel to restore it to its original shape. Continue as paragraph 3.3.1 if required.
