Service Bulletin

S.B. No: 163

Title: INSPECTION OF FUEL VALVE TORQUE SHAFT UNIVERSALS

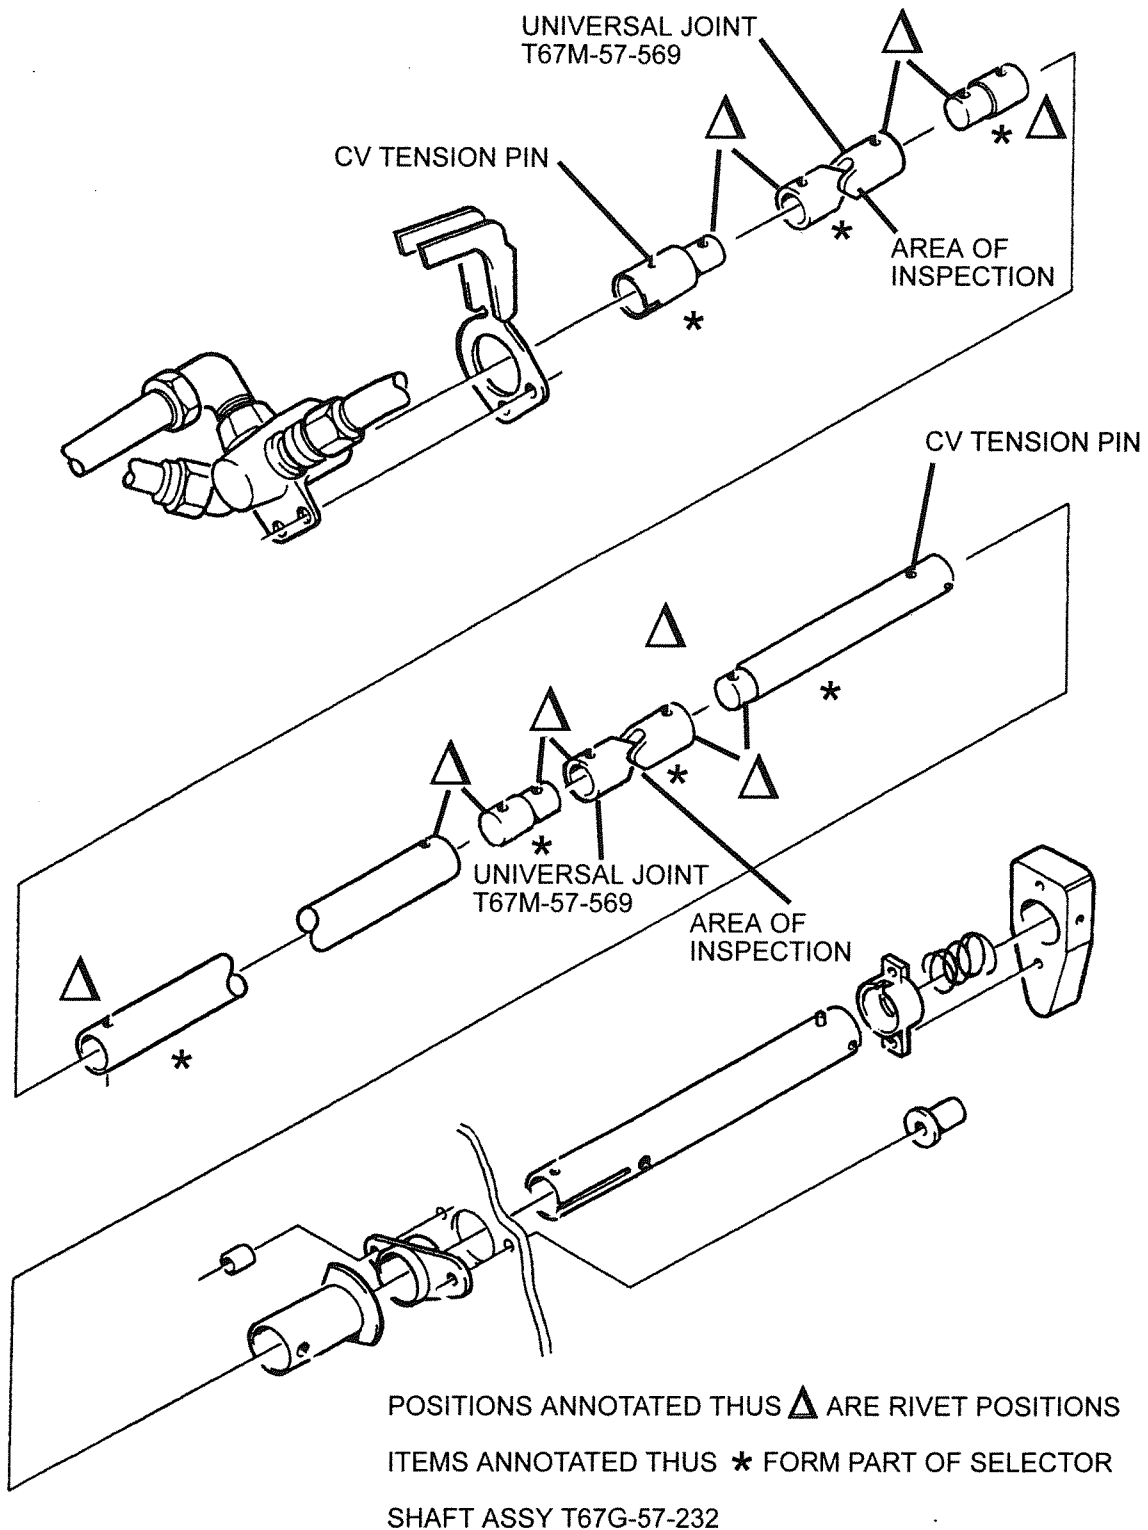
FIG. 1 FUEL SELECTOR VALVE SHAFT DETAIL (T67M260, T67M260-T3A)

There have been two cases found of "worn" universal joints in the fuel selector valve torque shaft on the T67M260 type aircraft.

1. At the next 150 hour check (or 100 hour check) gain access to the fuel selector valve torque shaft situated behind the forward console fascia. Ref Fig. 1 and Fig. 2.
2.
 - i) Inspect the pivot area of the universal joint/s for wear; do not use excessive force.
 - ii) Inspect the pivot area of the universal joint/s for physical damage e.g. splayed forks, hammer marks, pivot pin damage, using torch and mirror.
3. If no evidence of wear or physical damage are found, annotate logbook "SB163 accomplished".
4. a. T67M260 and T67M260-T3A

If there is any evidence of wear or physical damage then remove the torque shaft assembly T67G-57-232 and replace either the torque shaft assembly or the relevant universal joint (T67M-57-569) on the shaft. Reassemble torque shaft assembly back into the aircraft. Annotate logbook "SB163 accomplished".

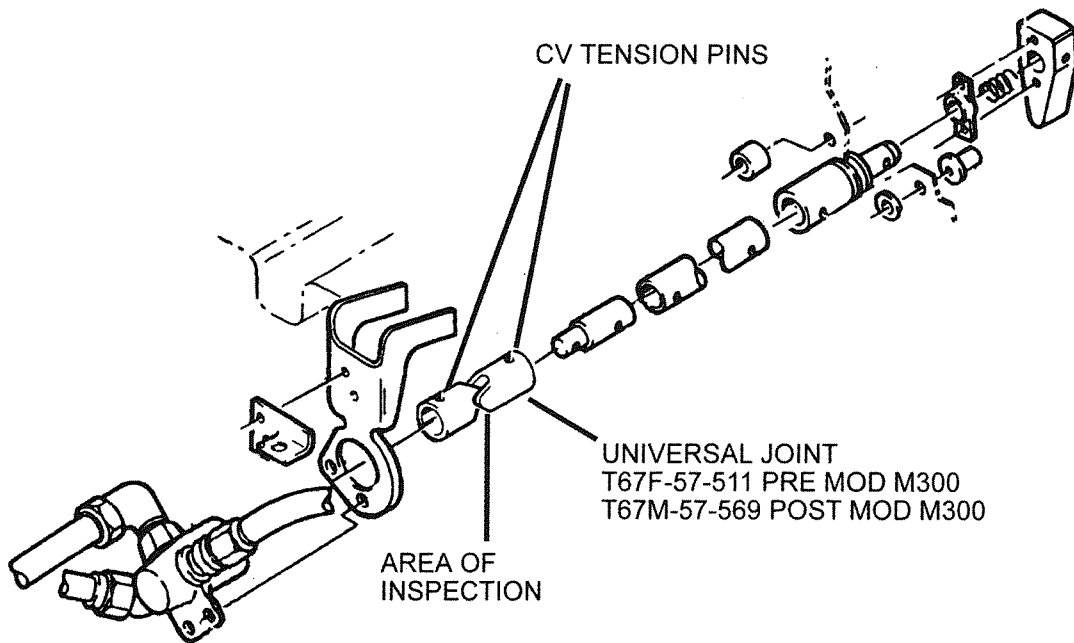
**FIG. 2 FUEL SELECTOR VALVE SHAFT DETAIL
(T67C POST MOD M156, T67M-MKII, T67M200)**

6. T67C Post Mod M156, T67M-MkII and T67M200 only: IPC is incorrectly drawn ref universal joint. Figure 2 shows correct configuration. IPC will be amended in due course.

If there is any evidence of wear or physical damage to the universal joint then remove the universal joint, (T67F-57-511 Pre Mod M300, T67M-57-569 Post Mod M300) from fuel selector valve and shaft adapter assembly. Reassemble back into aircraft new relevant universal joint.
