## Service Bulletin

S.B. No: 82

- Title:** INSPECTION OF WING WALKWAY AREAS
- Classification:** This Service Bulletin has been classified by the CAA as Mandatory.
- Compliance:** Within seven days\* of issue of this Service Bulletin and repeat inspections at 150 (or 100 USA) flying hour intervals until Mods M669B or M669C invoked.  
\*Unless complied with at Issue 1 (issued 18th July 1995).
- Applicability:** T67B, T67C Series, T67M, T67M-MkII, T67M200, T67M260 (Works Nos 2234 and 2235 only) and T67M260-T3A
- Issue 2:** Applicability to T67M260 and T67M260-T3A.. Paragraph 1 re-written and note to paragraphs 2b, 3 and 4 added.

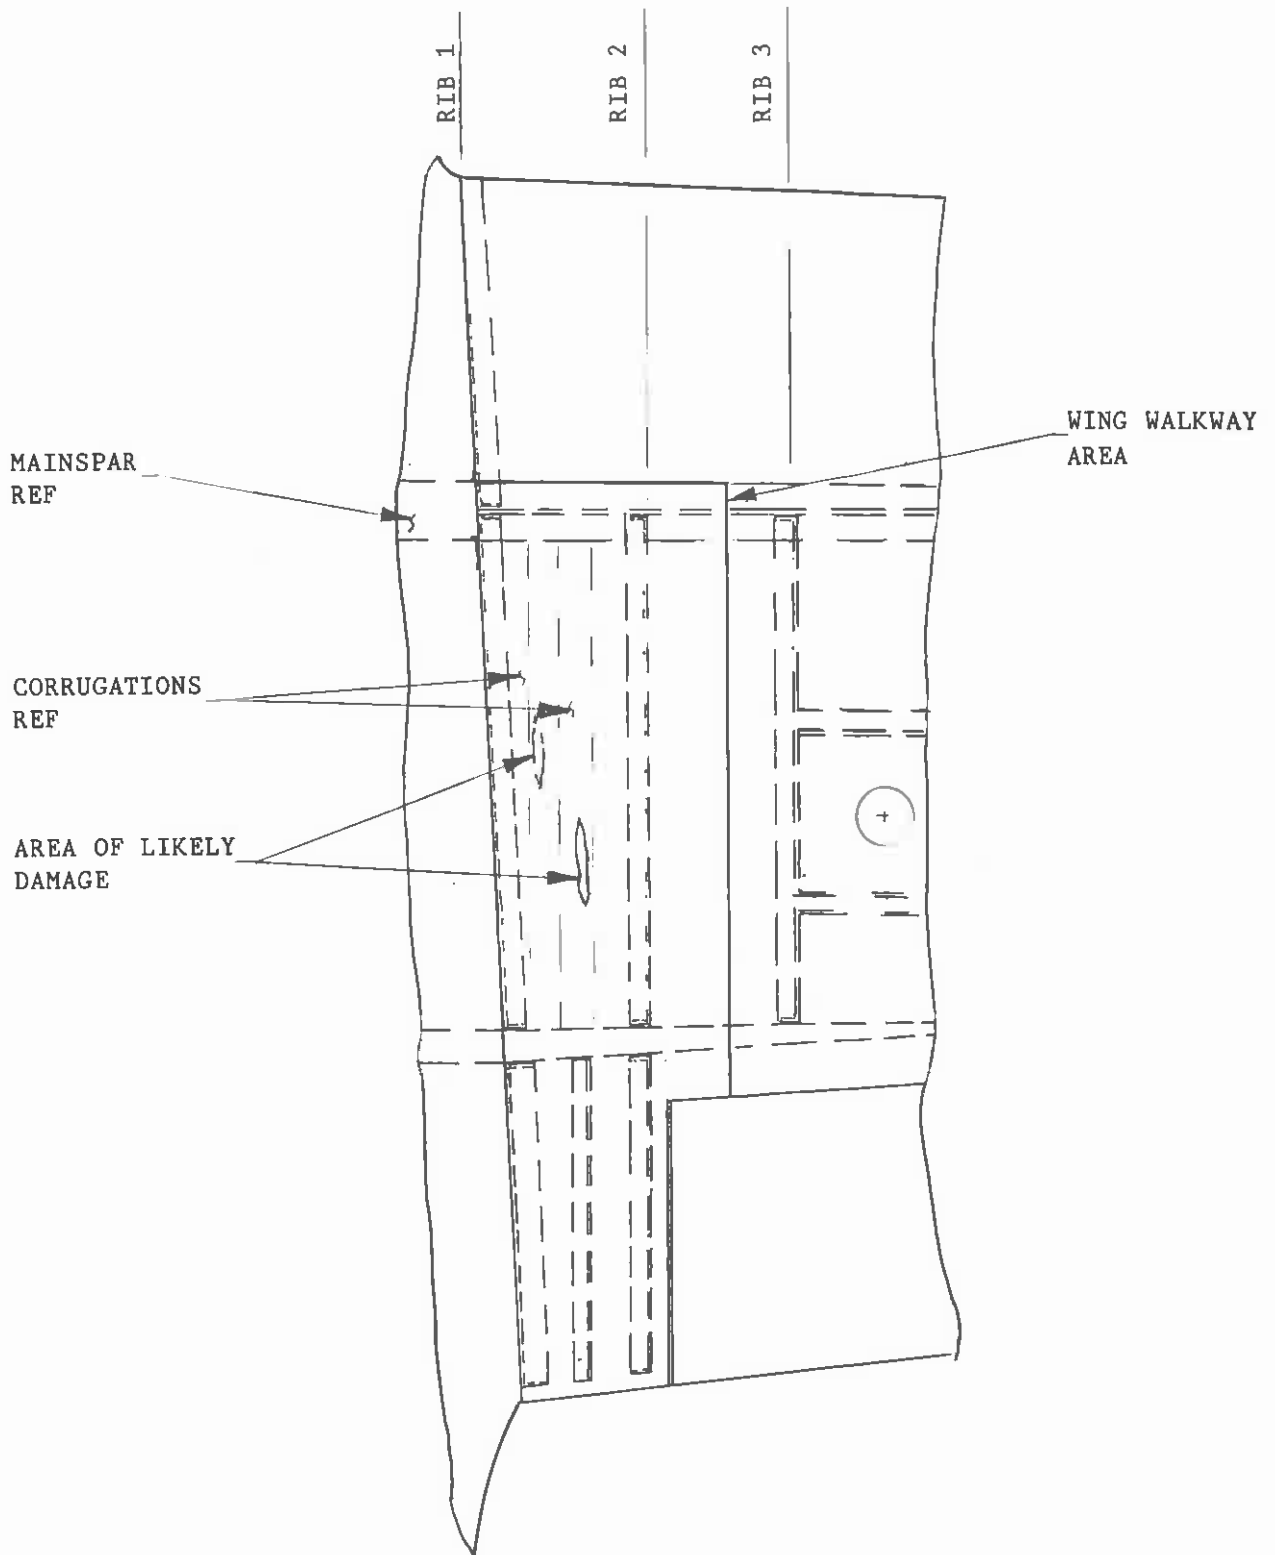
FIG 1 PLAN VIEW STBD WING PORT SIMILAR

Two cases have been reported of delamination in the skin and corrugations in the area of the wing walkway. Ref. Fig. 1.

Subsequent to Issue 1, SAL were informed of similar delaminations in the wing walkway corrugations of the T67M260-T3A.

1. At next 150/100 hour check, visually inspect wing walkway area by either viewing through flap drive access hole in undersurface of wing or through Rib 1. Also press down over wing walkway area: there should be no signs of delamination on corrugation or "spongy" feel to walkway.
2. If wing is found to be undamaged, then either:
  - a. Add this inspection to the 150/100 hour check, or
  - b. Invoke Mod M669C. Ref Drg No. T67F-03-003 repair procedure paragraph 2b. Not applicable T67M260 or T67M260-T3A.
3. If wing is found to be suspect or has damage, remove wing walk tape and surface finish to ascertain degree of damage.
  - i. If a crack (ie broken fibres) in the GRP laminate is greater than 6mm (¼") long, then invoke Mod M669B. Ref. Drg No. T67F-03-003 Repair Procedure, paragraph 2a.

- ii. If damage is minimal, ie delamination or crack in GRP laminate of less than 6mm ( $\frac{1}{4}$ " ) invoke Mod M669C. Ref. Drg No T67F-03-003 Repair Procedure , paragraph 2b.
