SERVICE BULLETIN

SB No. 001

Issue No. 1 Aircraft Type T67A

Aileron Control Circuit Inspection

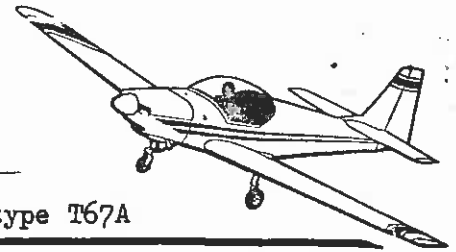
Remove the outboard inspection cover from each wing. Check the clearance between the bolt tail and the bellcrank mounting bracket in area 'A' of Fig.1 is at least 1.5mm (0.060"). If the clearance is less than this the bolt tail must be shortened.

Ensure that the bolt is still in safety by at least 2 thread pitches 1.6mm (0.063").

When replacing the nut ensure the bonding braid is re-positioned as shown in Fig.1
