## Service Bulletin

S.B. No: 188

**Title: INSPECTION FOR RUDDER PEDAL CLEARANCES BETWEEN RUDDER PEDALS AND THE AIRCRAFT STRUCTURE AND COMPONENTS ALSO INSPECTION FOR GROUND TOWING DAMAGE.**

**Applicability:** T67B, T67C series, T67M (excluding works no. 1999), T67M-MkII and T67M200 (excluding works no. 2264 & 2265).

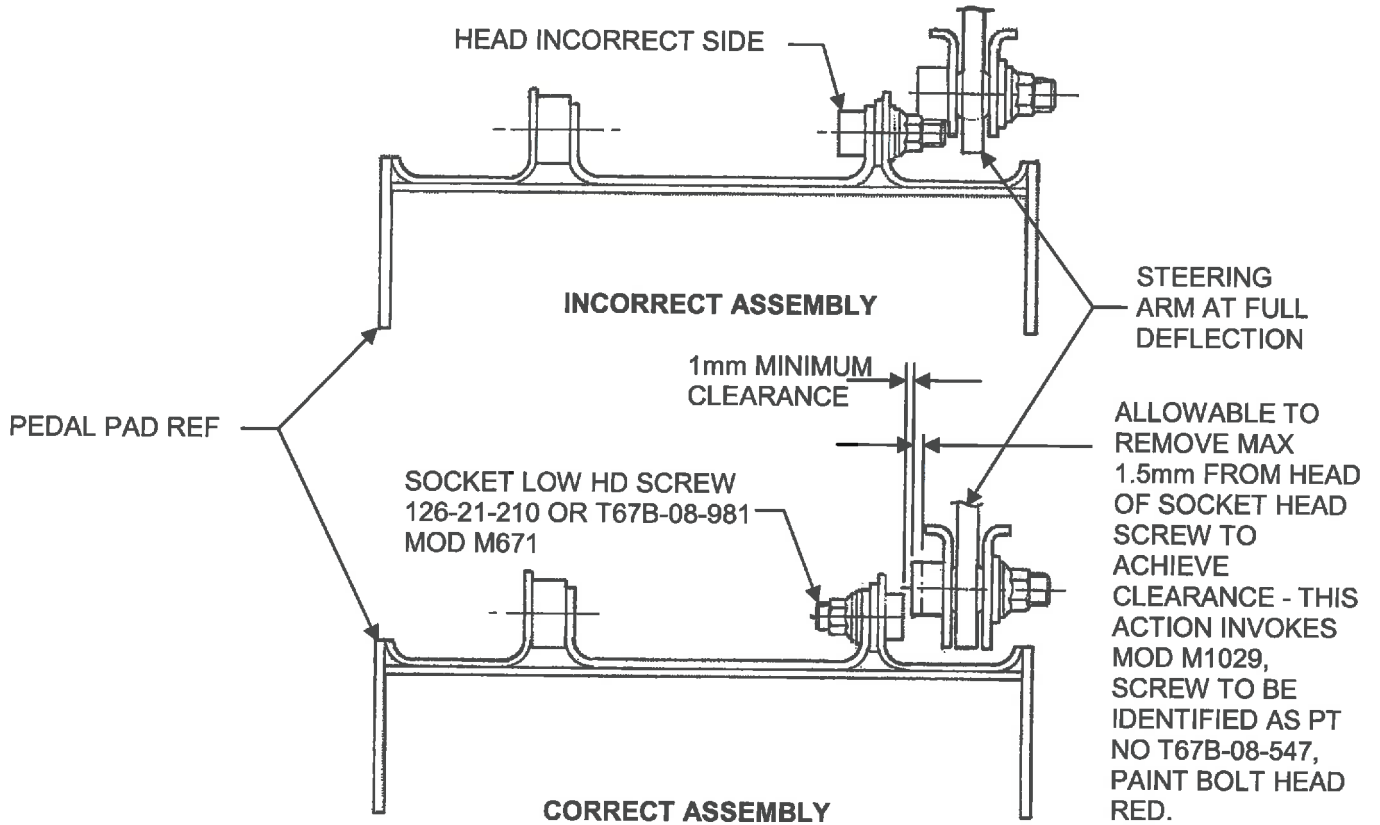
FIGURE 3

19. Upon completion of rudder movement set-up ref. Paragraph 17 above. Ensure minimum clearances of trim panel to pedal side plates and rudder cable to pedal side plates are met Figure 3 refers. If necessary to obtain the required clearances, Mod M232 "Introduction of Rudder Pedal Packing for Increased Clearance of Surrounding Components" may be required to be invoked. Refer paragraph 14 for packing washers on rudder bar.

21. Ensure head orientation of rudder cable link bolt head is outboard, Figure 3 refers, this is a Low Pan Head bolt T67M-45-570 on Post Mod M471 "Introduction of Pan Headed Bolt on Rudder Cable Turnbuckles", aircraft.

28. Ensure rudder pedal carriage socket head caps screws are wire locked and bonded in with adhesive 126-51-024, use minimum amount, Mod M162 "Wire Locking of Rudder Pedals – Upper Pivots", refers. See Figure 3.

**RUDDER PEDAL CLEARANCES TO SIDE PANEL AND RUDDER CABLES**

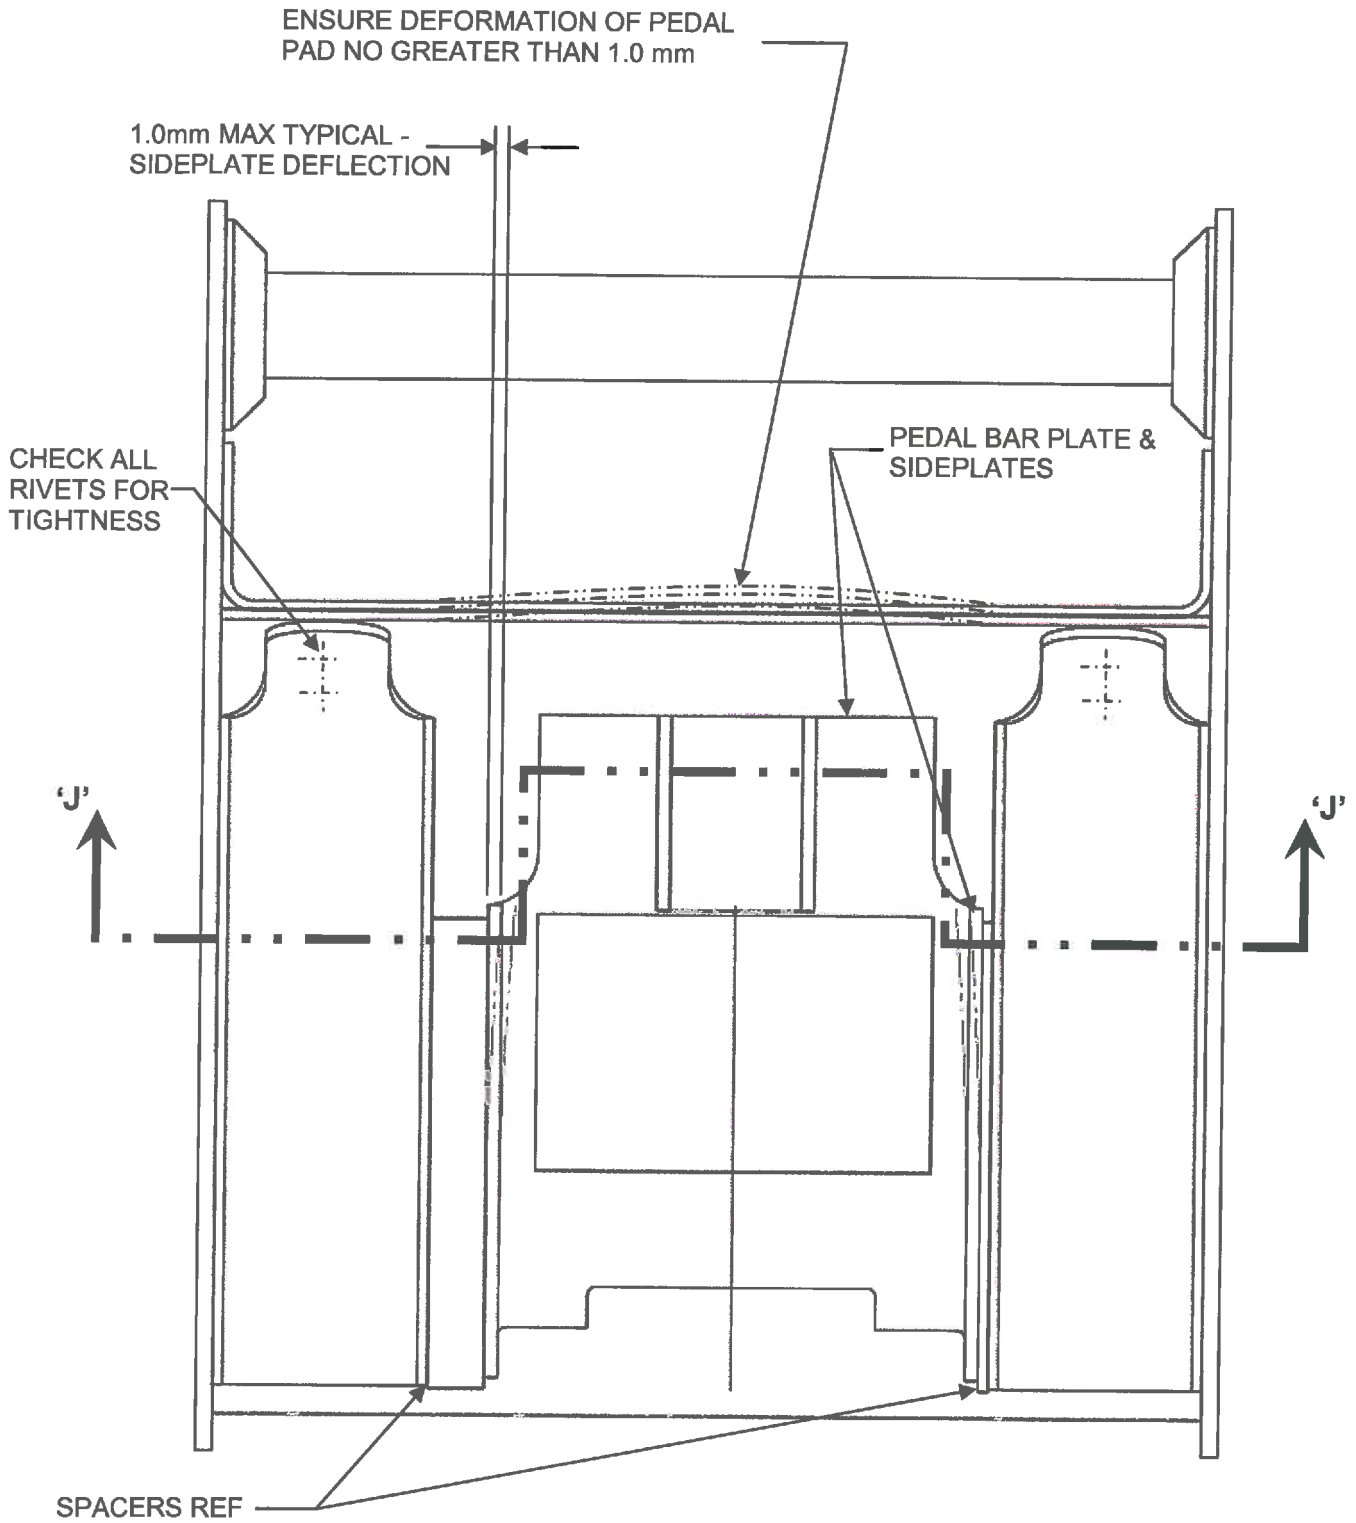
Note: When carrying out aircraft ground running at high RPM it is advisable to use effective chocks wherever possible and not rely upon the aircraft brake system alone because the aircraft may be dragged along with the wheels locked. In this situation, any further pressure on the brake pedals will be ineffective and cause damage to the rudder pedal pads, support plates and sliders. Typical deformation found is shown at Figures 12, 13 and 14. If any similar damage is found, part/s are to be returned to MSAC for rectification.

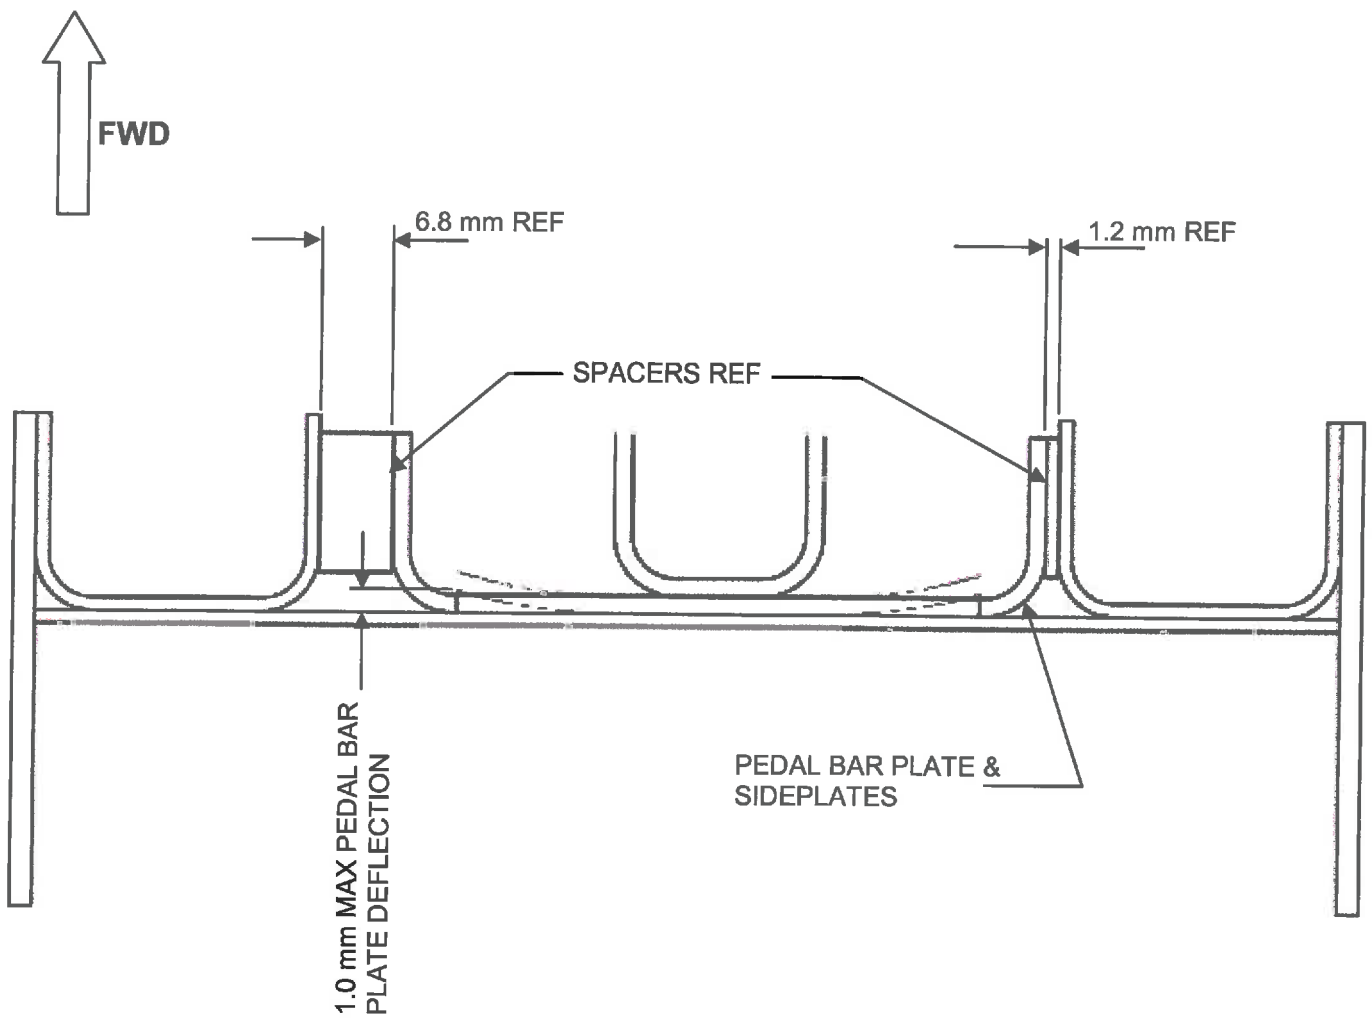
FIGURE 13

VIEW ON ARROW 'J' (REFER FIGURE 12)

SHOWING VIEW ON FORWARD FACE OF PEDAL  
(NOTE: APPLICABLE TO ALL PEDALS)
