# Service Bulletin

S.B. No: 187

**Title:** INSPECTION FOR CLEARANCE BETWEEN RUDDER PEDAL AND MIXTURE/PROP. SPEED BRACKET AND FOR GROUND TOWING DAMAGE. ALSO INCLUDES GENERAL RUDDER PEDAL CLEARANCES.

**Applicability:** T67M200 (Works No. 2264 & 2265 only), T67M260 and T67M260-T3A.

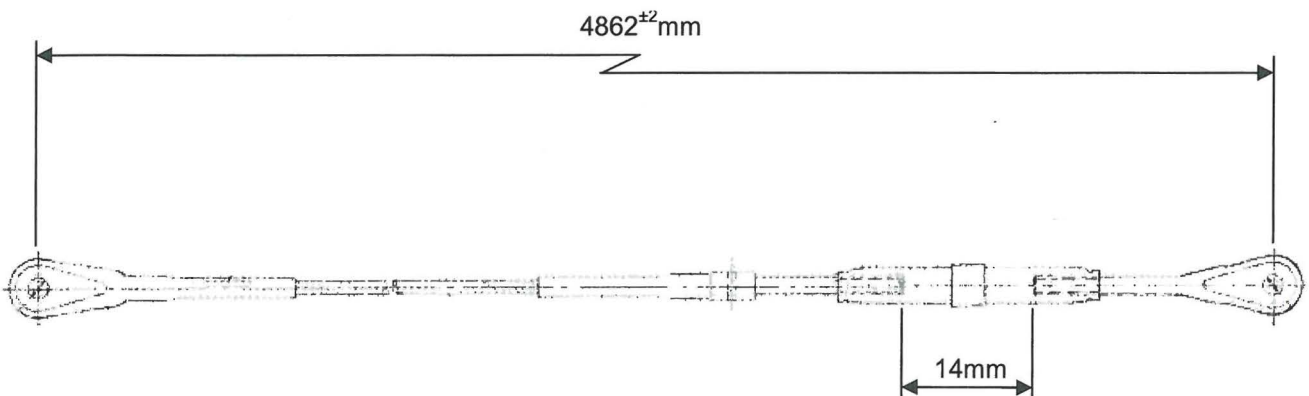
FIGURE 7

27. Ensure, that a minimum clearance of 3mm is achieved between Pedal No 3 and Mixture Lever operating arm, refer Figure 7. Refer paragraph 14 for packing washers.

VIEW LOOKING FORWARD ONTO NO.3 RUDDER PEDAL
